# Satellite-Based Damage Assessment of Affected Villages in Maungdaw District

(Assessment based on satellite imagery recorded on the mornings of 22 October, 3 and 10 November 2016)

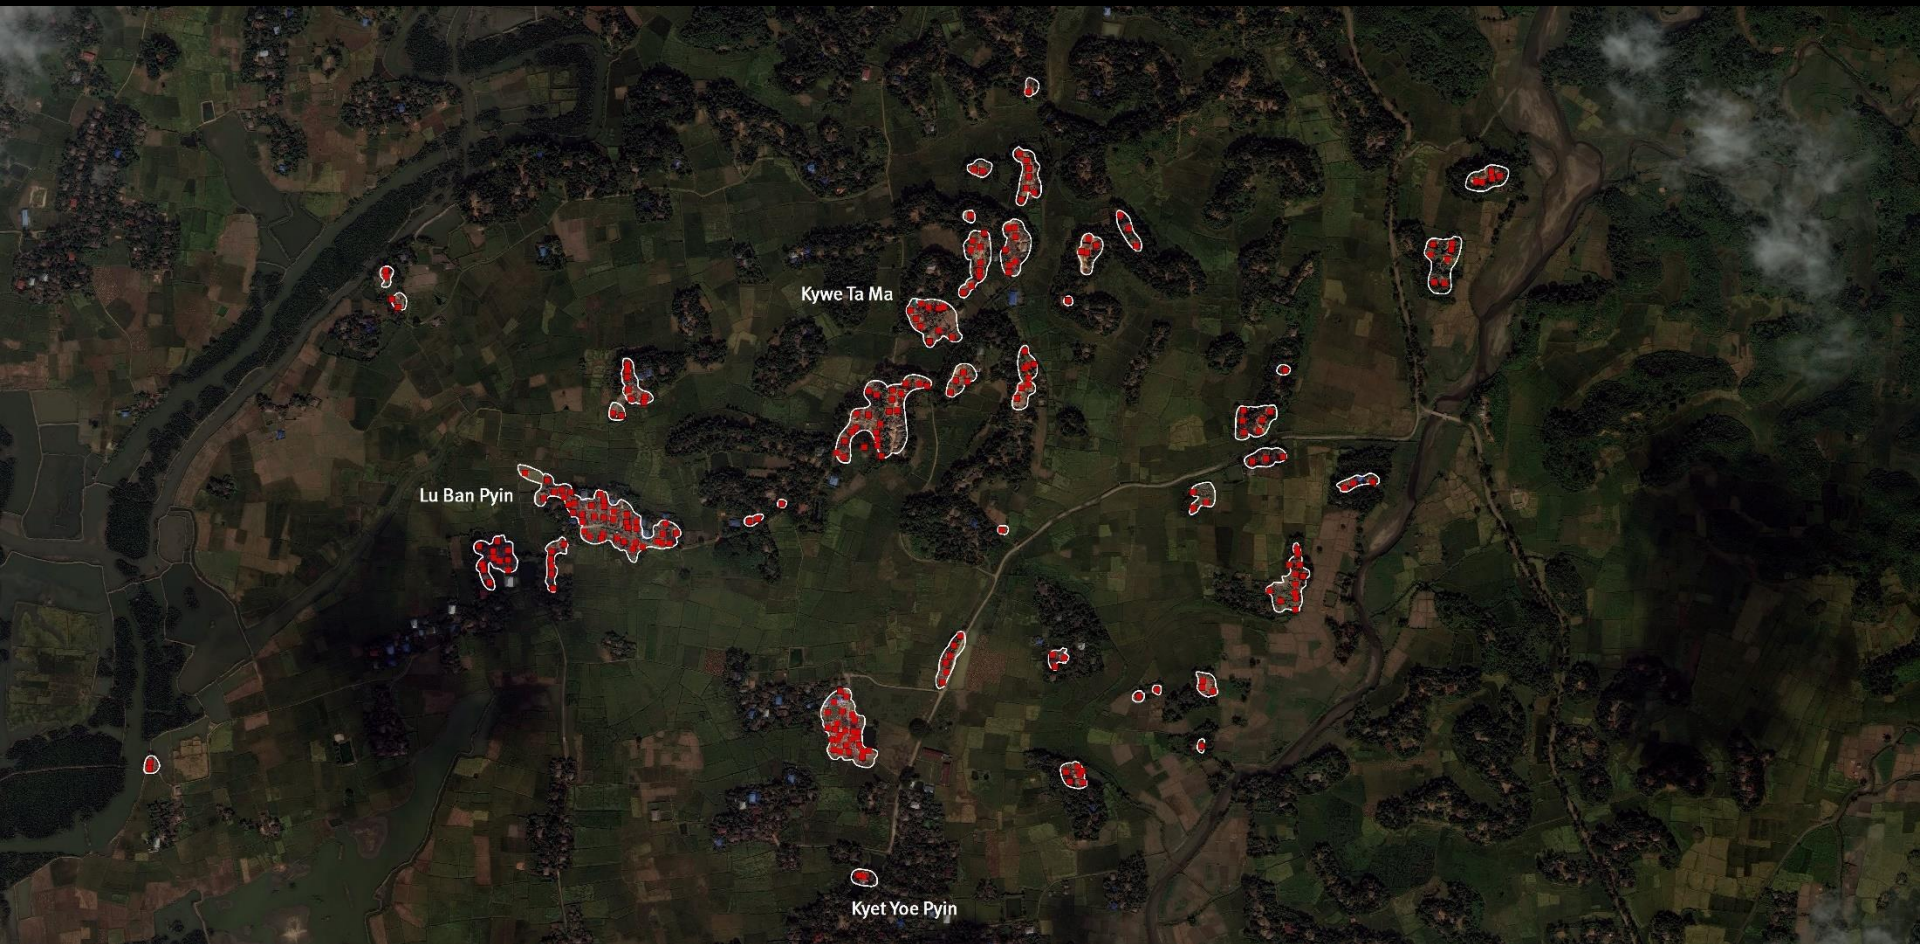
# Overview of Building destruction in the village of Kyet Yoe Pyin, Maungdaw District

A total of 245 buildings were destroyed in the village of Kyet Yoe Pyin (and the sub-villages of Lu Ban Pyin and Kywe Ta Ma) based on satellite imagery recorded on the mornings of 22 October and 10 November 2016. Active fires were detected in multiple locations in the village on 14 October by an environmental satellite sensor. The presence of extensive burn scars and active fires are consistent with arson.

Because of dense tree cover it is possible that a limited number of fire-affected buildings were not detected. The actual number of building destruction in Kyet Yoe Pyin could be higher.

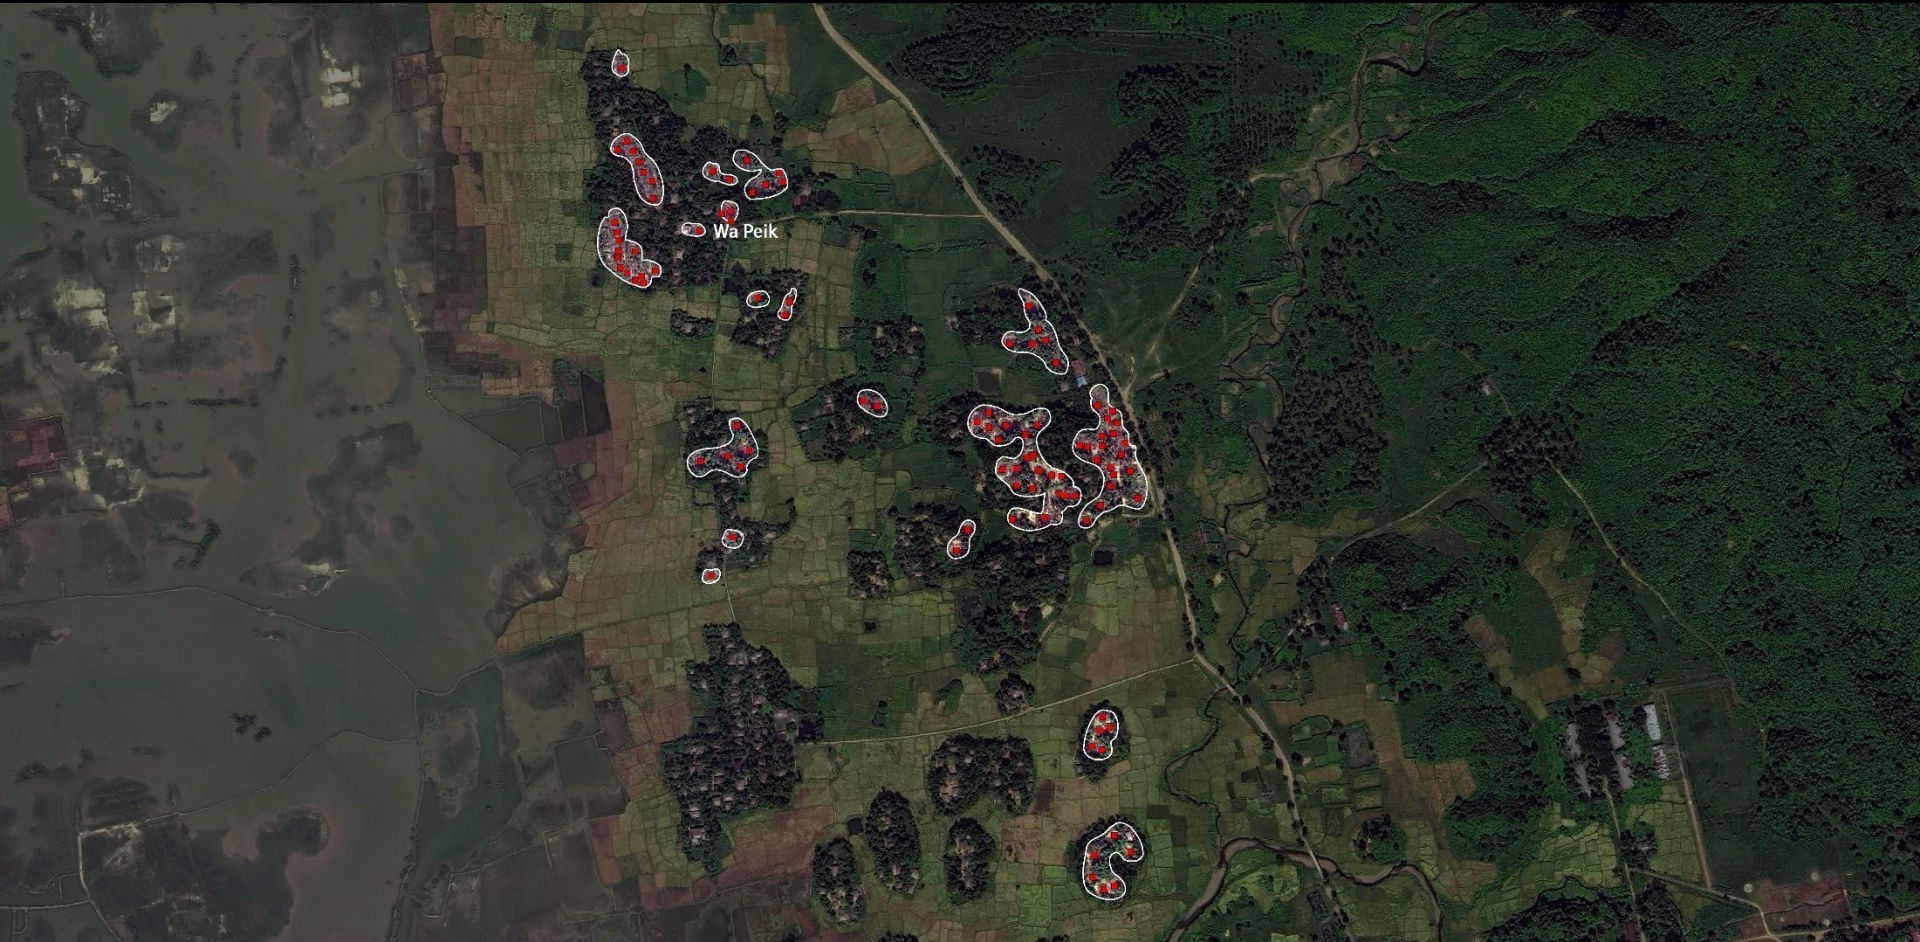
# Overview of Building destruction in the village of Wa Peik (Kye Kan Pyin), Maungdaw District

A total of 100 buildings were destroyed in the village of Wa Peik (Kye Kan Pyin) based on satellite imagery recorded on the mornings of 22 October, 3 and 10 November 2016. Active fires were detected in multiple locations in the village on 09 October by an environmental satellite sensor. The presence of extensive burn scars and active fires are consistent with arson.

Because of dense tree cover it is possible that a limited number of fire-affected buildings were not detected. The actual number of building destruction in Wa Peik (Kye Kan Pyin) could be higher.

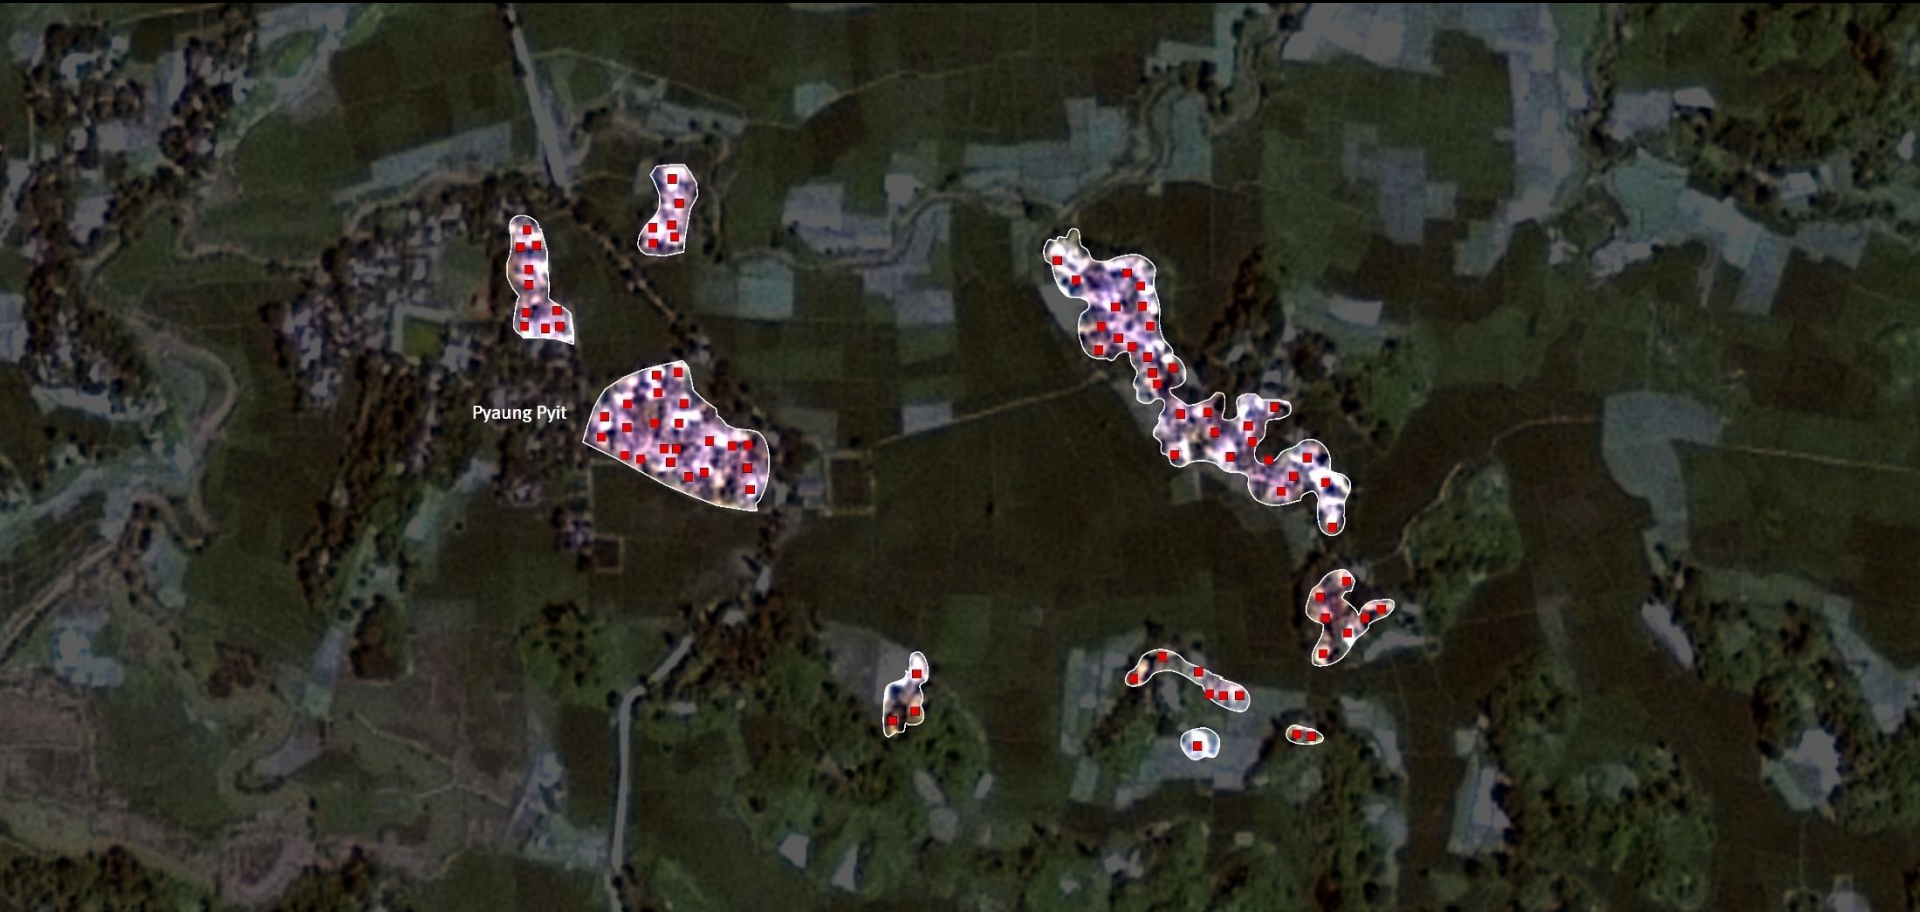
## Building destruction in the village of Pyaung Pyit (Ngar Sar Kyu), Maungdaw District

A total of 85 buildings were destroyed in the village of Pyaung Pyit (Ngar Sar Kyu) based on satellite imagery recorded on the mornings of 22 October and 10 November 2016. Damages are consistent with arson.

Because of dense tree cover it is possible that a limited number of fire-affected buildings were not detected. The actual number of building destruction in Pyaung Pyit could be higher.

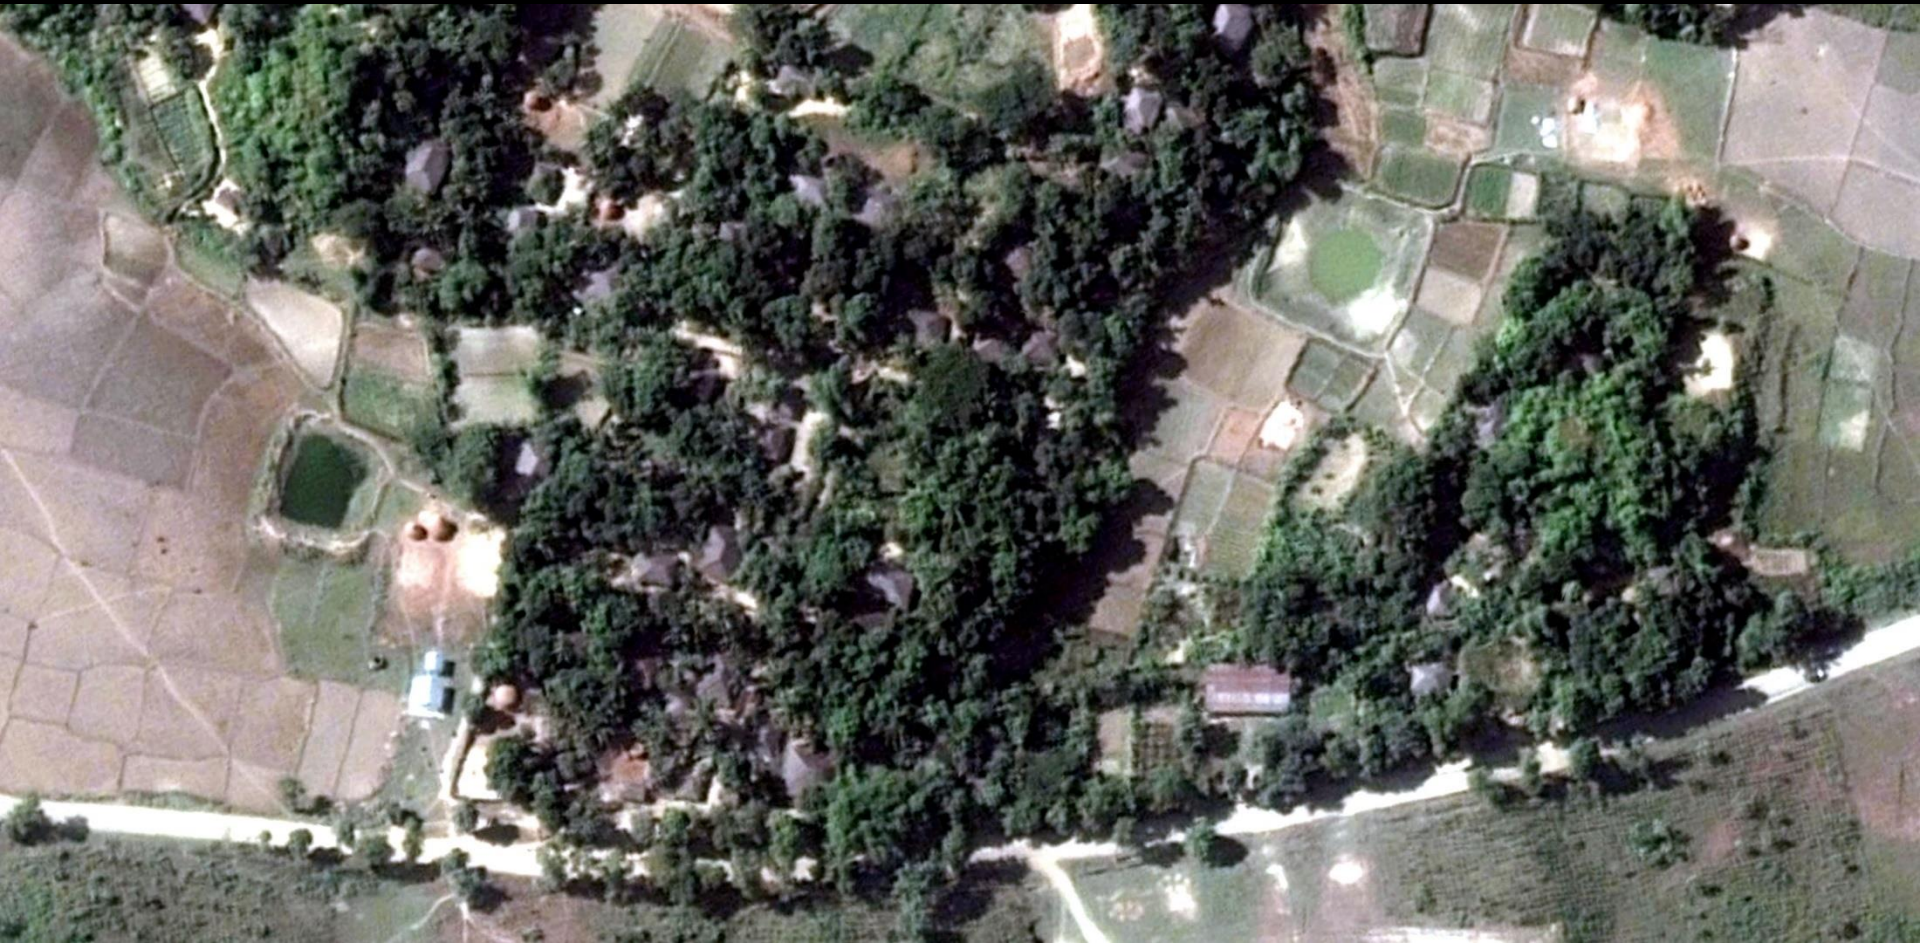
Building destruction in the village of Wa Peik (Kye Kan Pyin), Maungdaw District  
Pre-destruction satellite image recorded in 2014

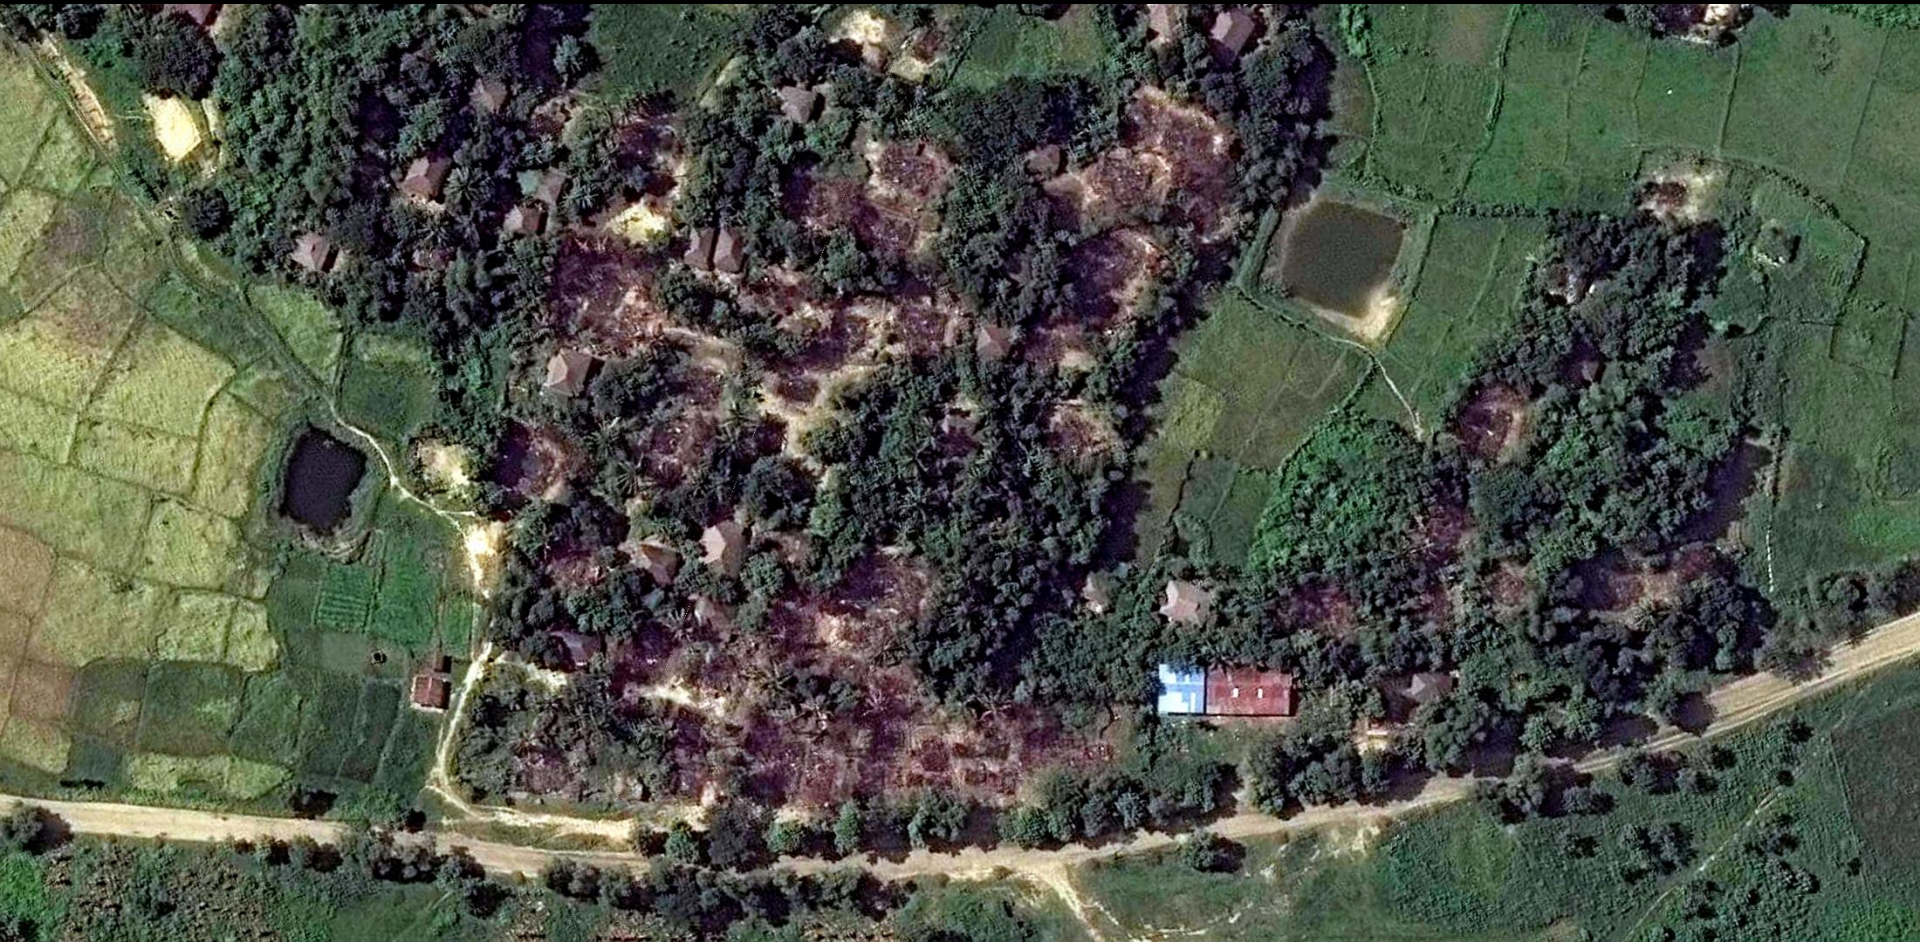
# Building destruction in the village of Wa Peik (Kye Kan Pyin), Maungdaw District

Post-destruction satellite image recorded on 10 November 2016

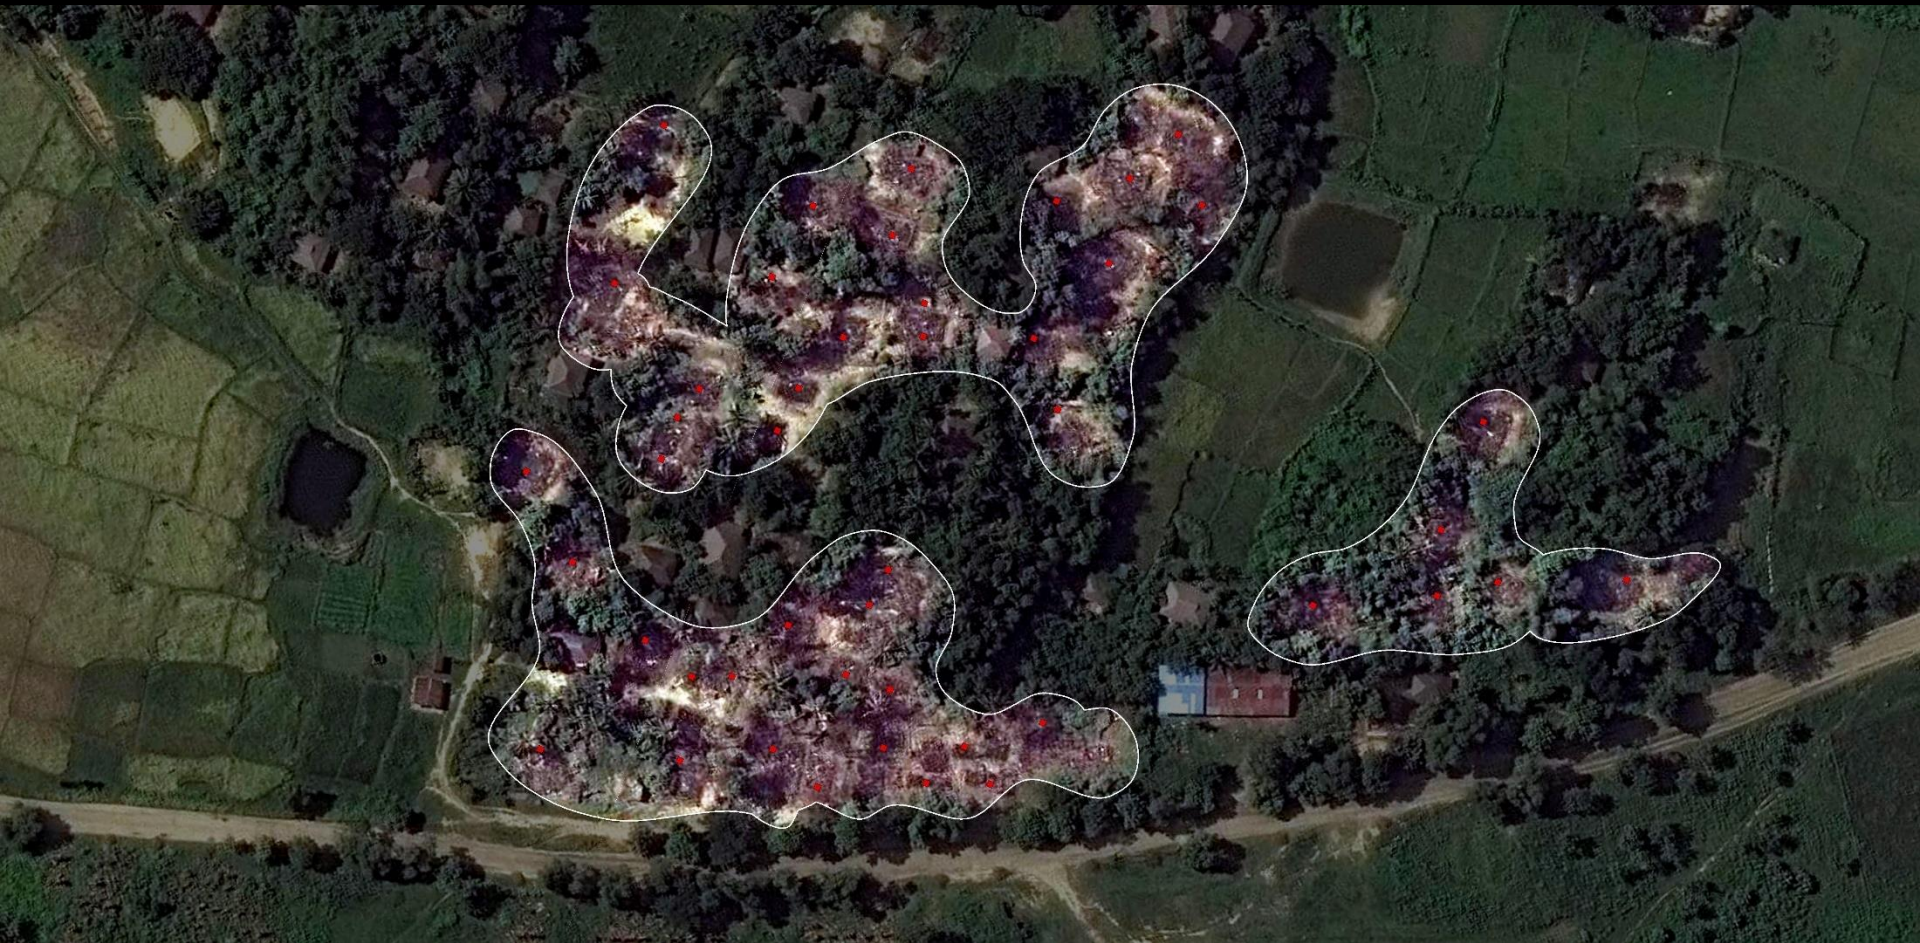
Building destruction in the village of Wa Peik (Kye Kan Pyin), Maungdaw District  
Post-destruction satellite image recorded on 10 November 2016 - Destroyed buildings annotated in red

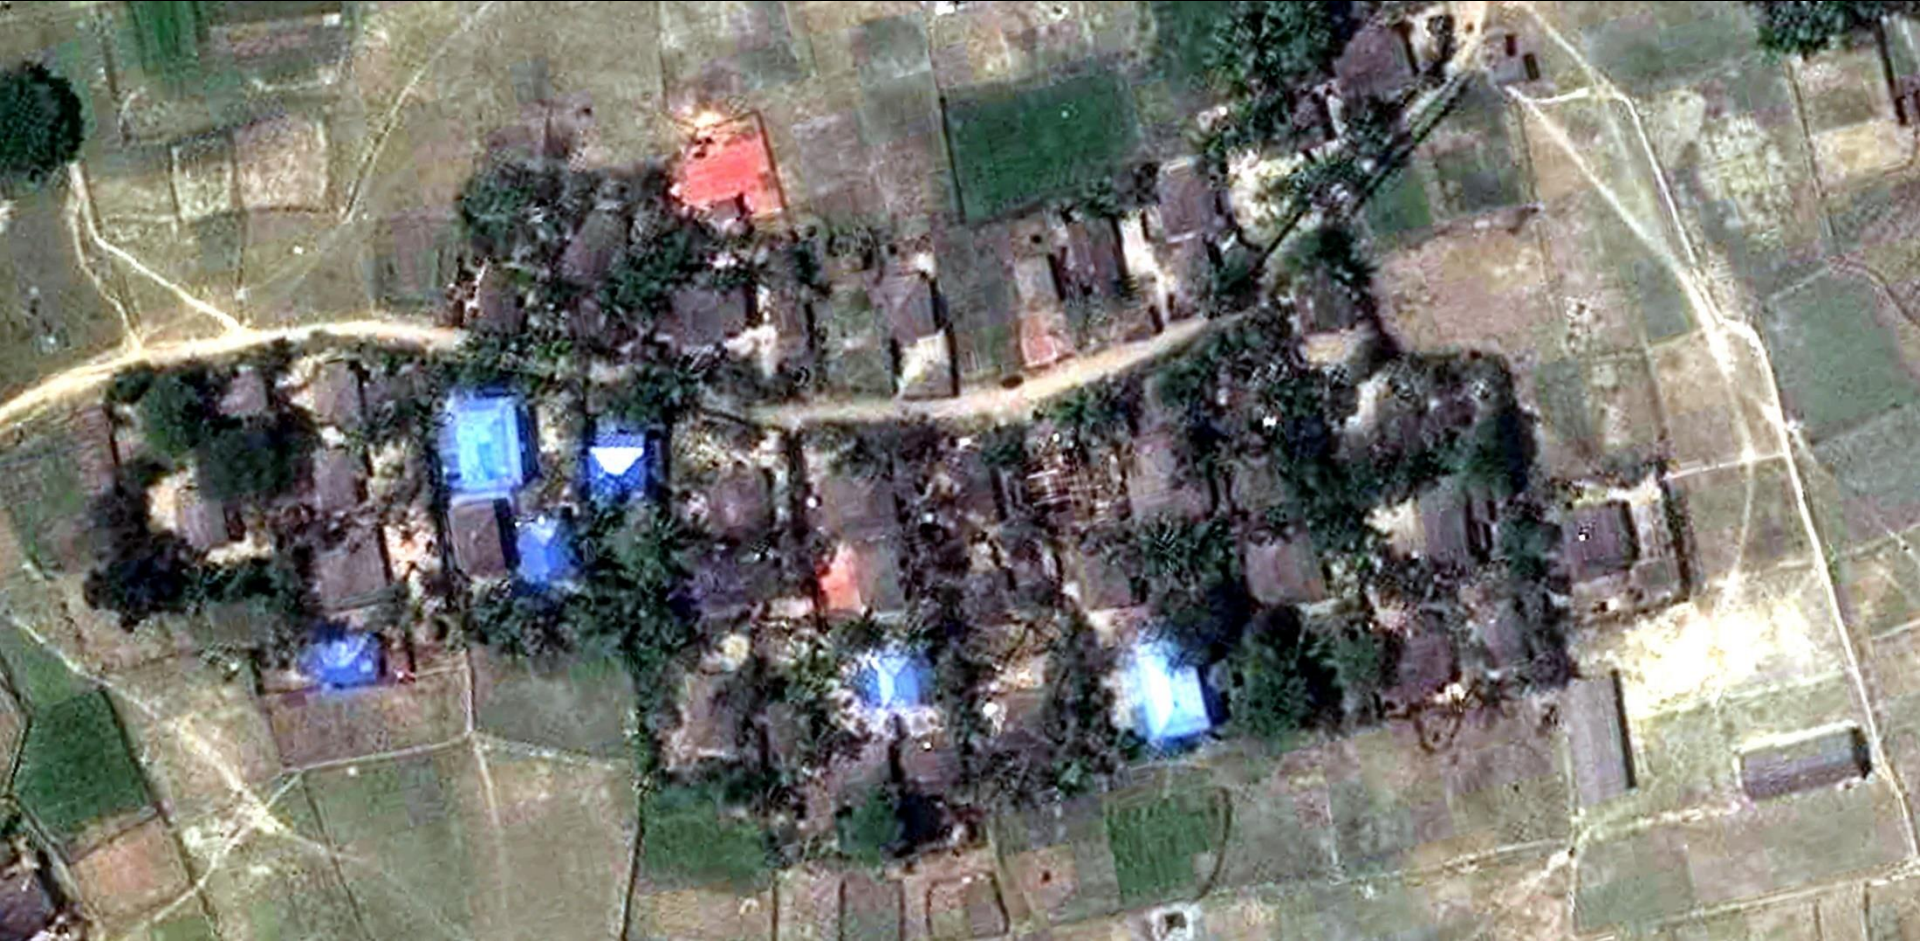
Building destruction in the village of Kyet Yoe Pyin, Maungdaw District  
Pre-destruction satellite image recorded on 30 March 2016

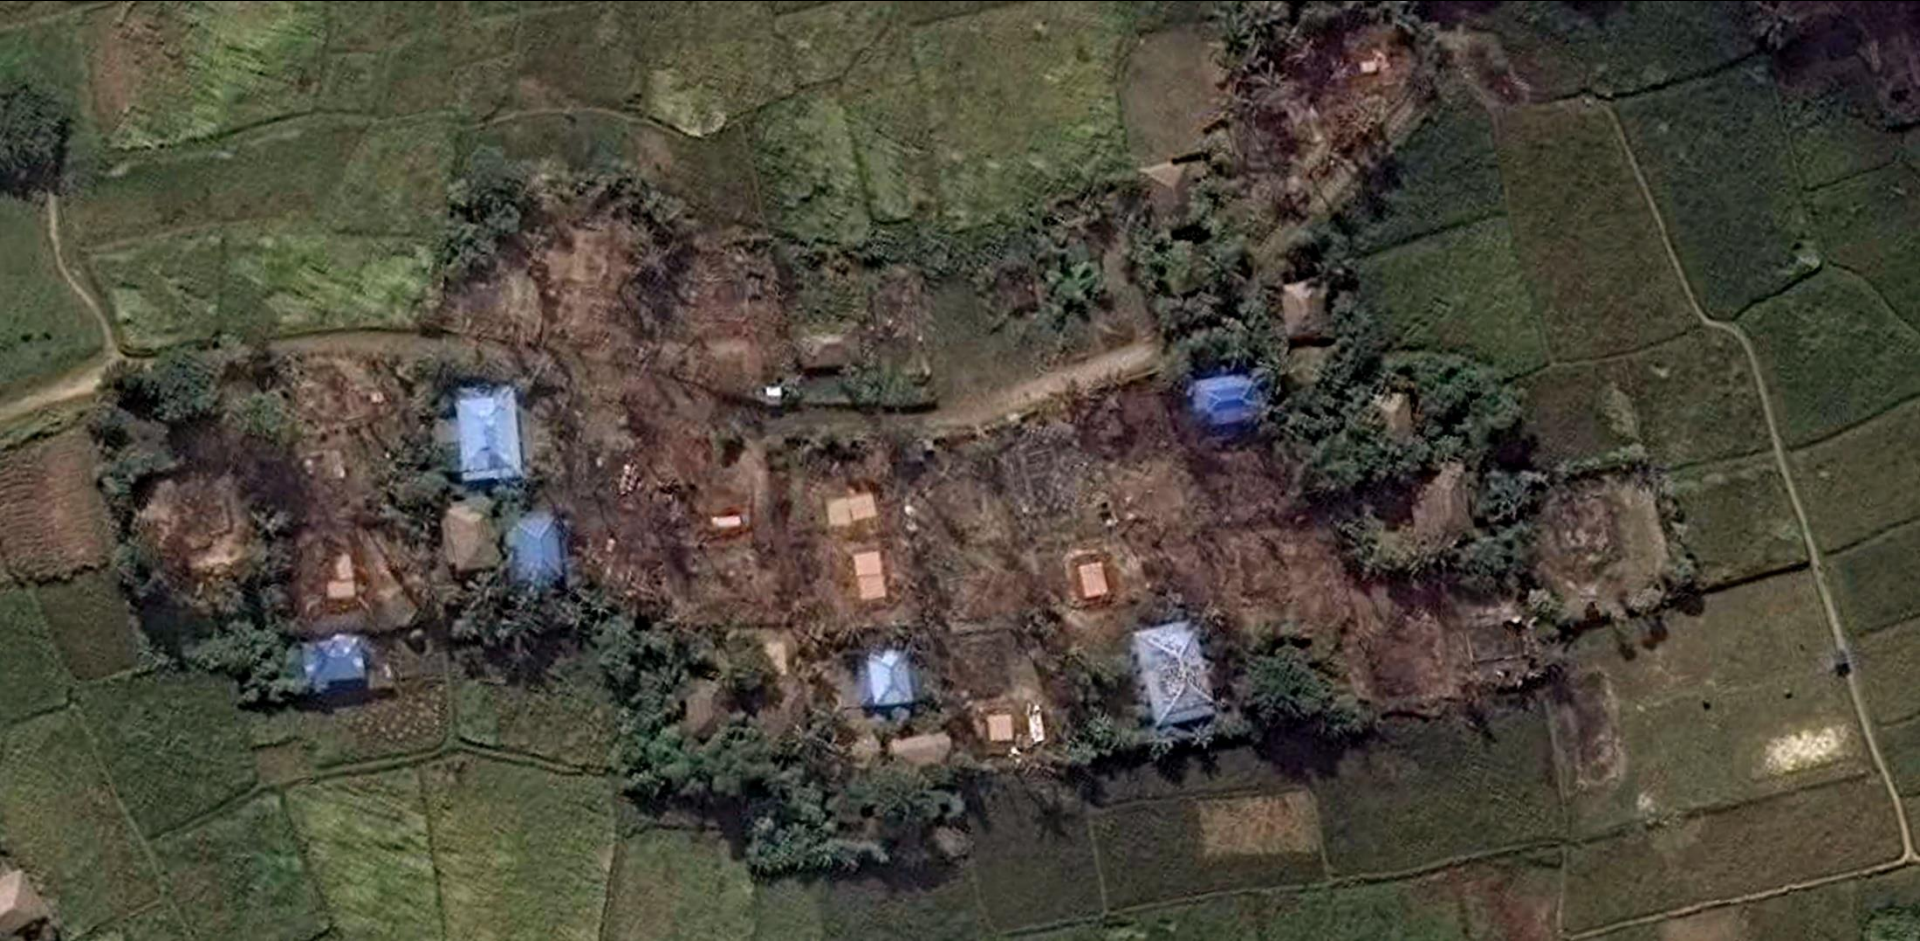
Building destruction in the village of Kyet Yoe Pyin, Maungdaw District  
Post-destruction satellite image recorded on 10 November 2016

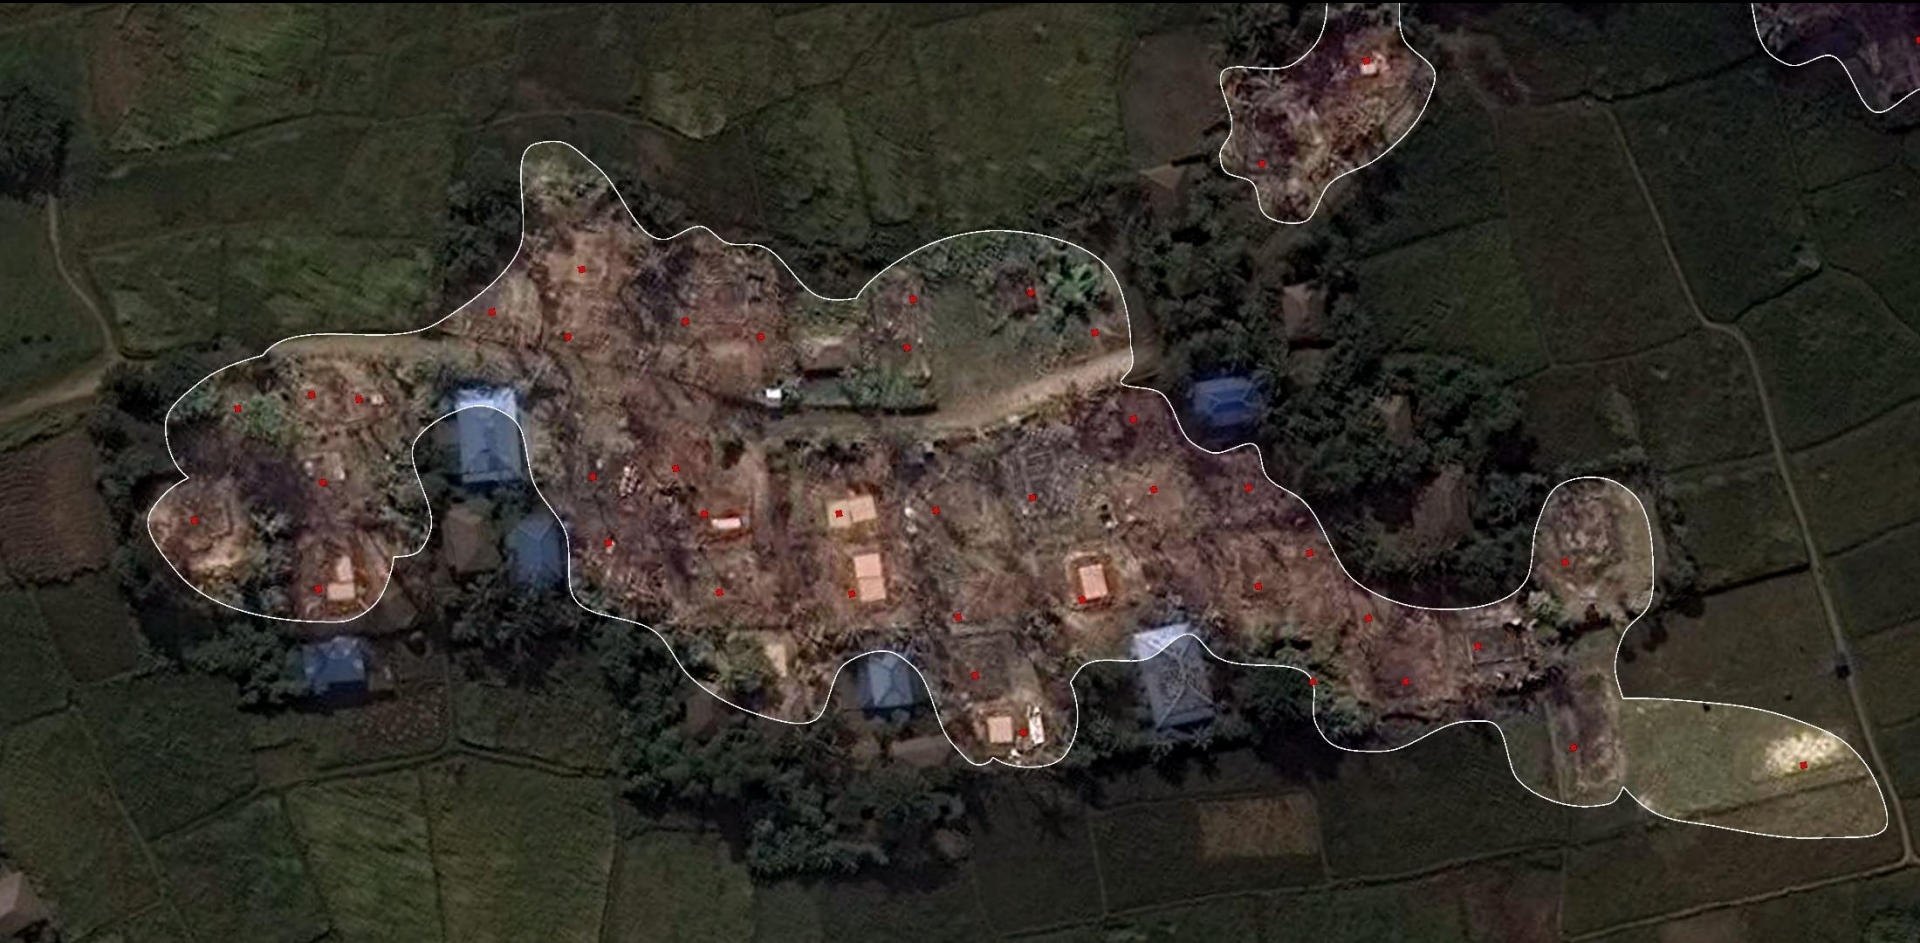
Building destruction in the village of Kyet Yoe Pyin, Maungdaw District  
Post-destruction satellite image recorded on 10 November 2016 - Destroyed buildings annotated in red
