### Overview - Village 3 & Village 6

### Village 3

### Village 6

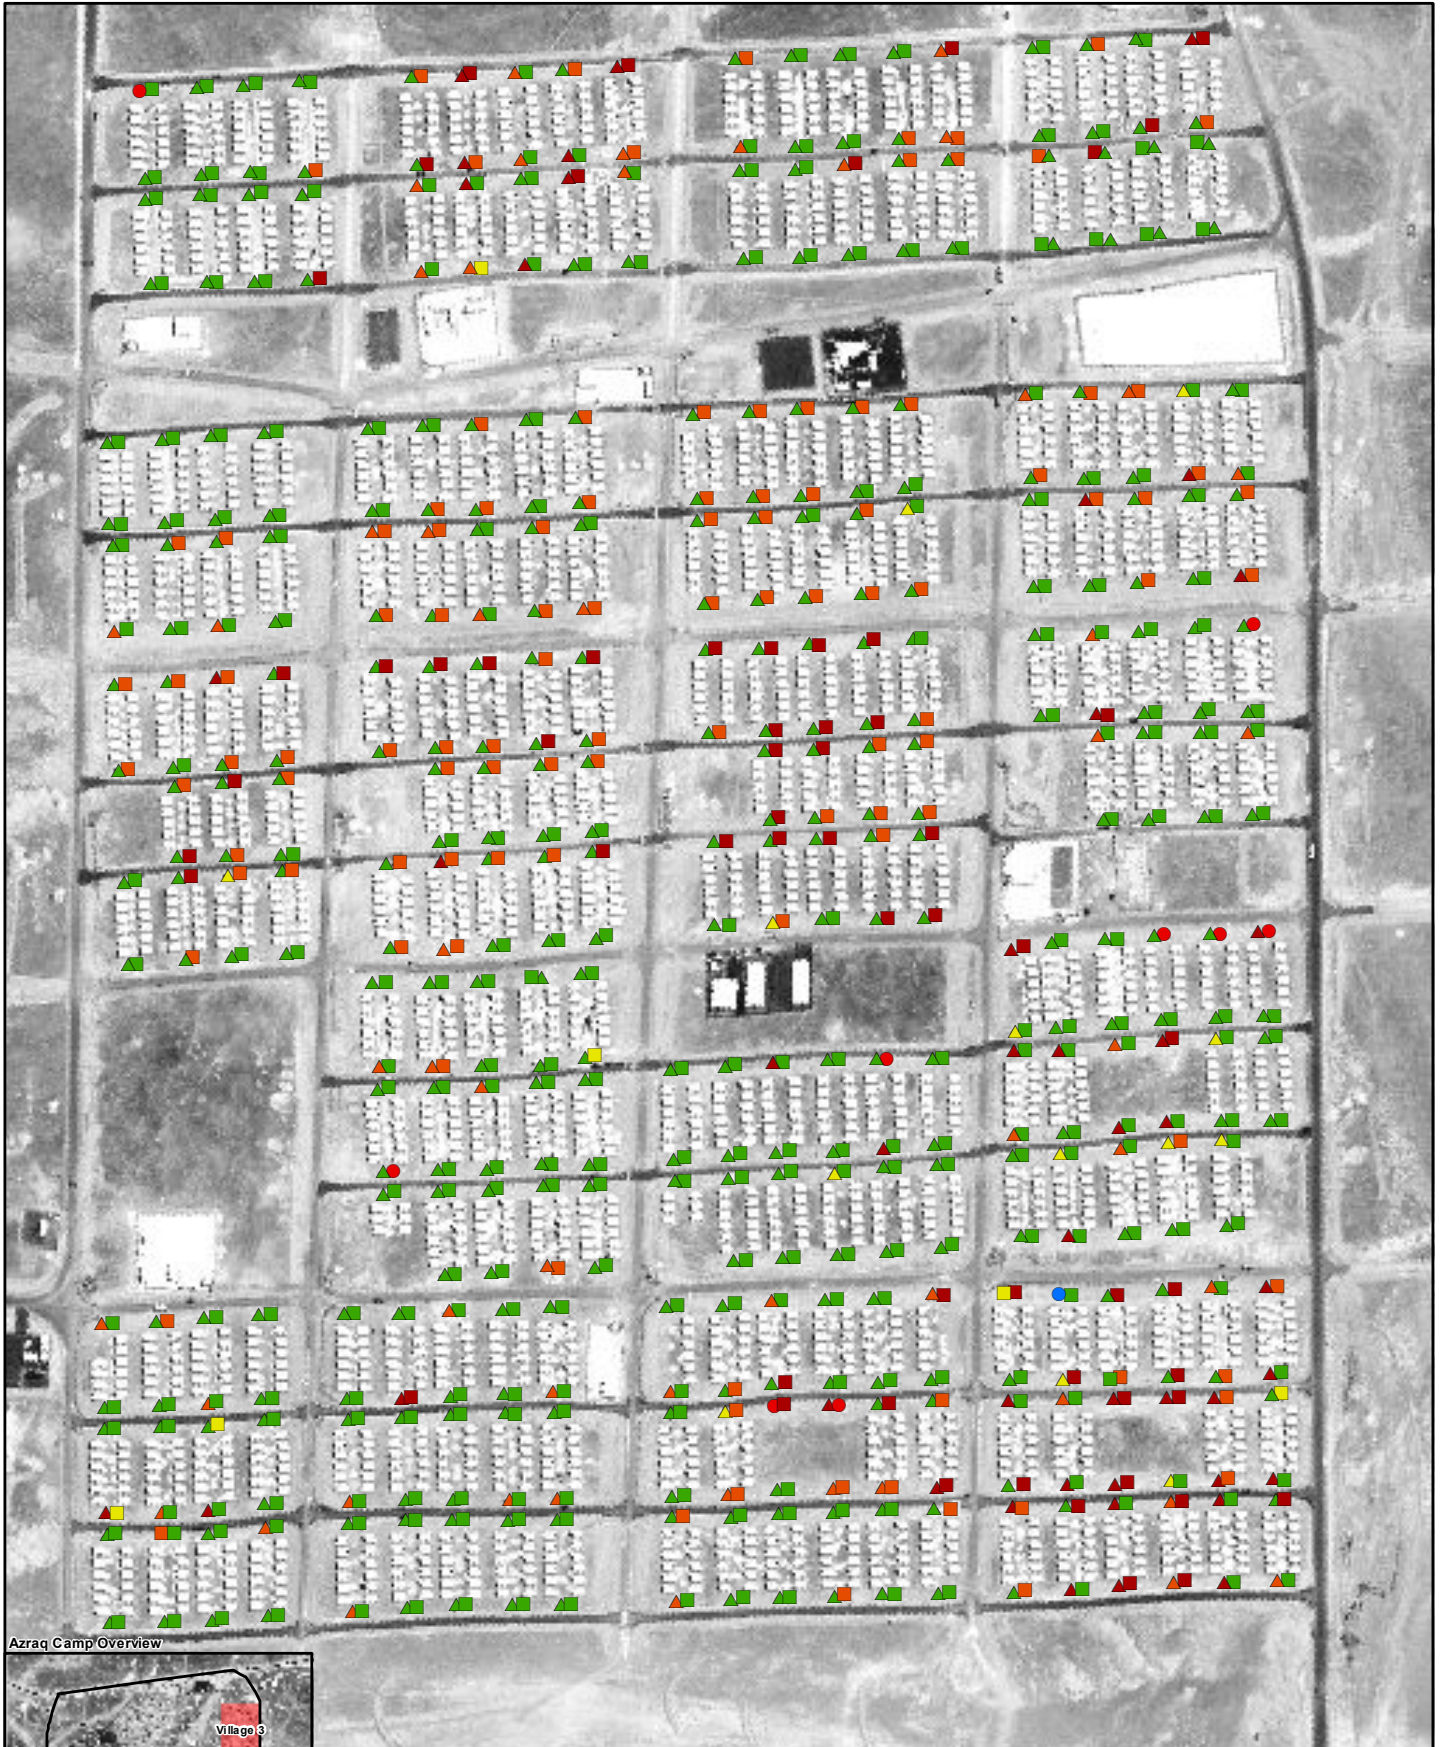
Map 1: Faeces found inside WASH centres in Village 3

This Week	2 weeks ago
There is no rubbish inside both stalls	1066 (66%)	938 (63%)
There is no faeces inside both stalls	1153 (72%) <span style="color: green;">&gt;5%</span>	946 (63%)
There is no faeces outside the structure within 5m	1146 (71%)	1026 (69%)
There is no standing water outside this structure within 5m	1588 (99%)	1480 (99%)

This Week	2 weeks ago
There is no rubbish inside both stalls	611 (67%)	535 (59%)
There is no faeces inside both stalls	617 (68%)	602 (66%)
There is no faeces outside the structure within 5m	633 (69%)	642 (71%)
There is no standing water outside this structure within 5m	906 (99%)	899 (99%)

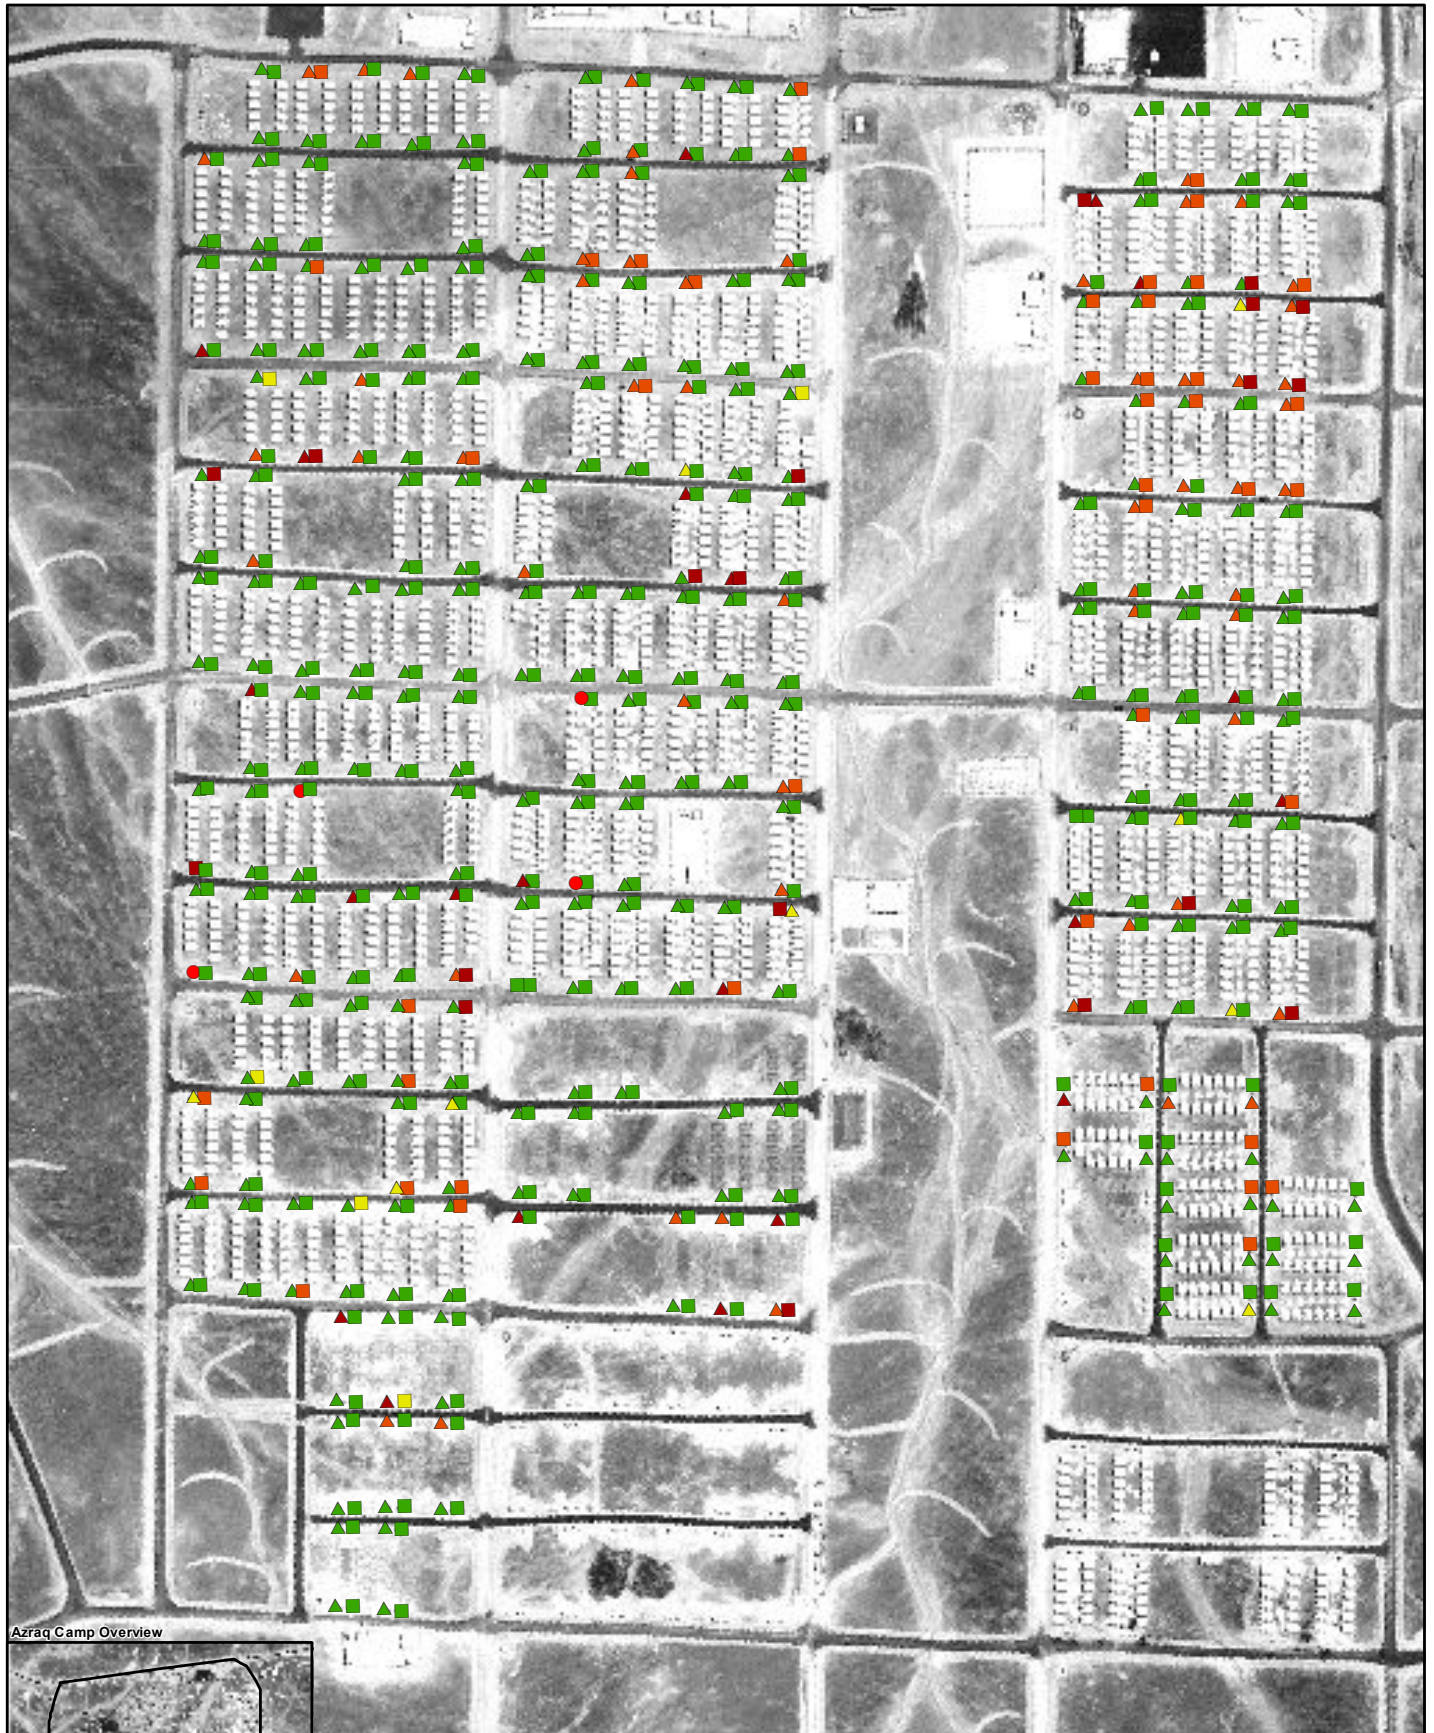
Map 2: Faeces found inside WASH centres in Village 6

This Week	2 weeks ago
There is no rubbish inside both stalls	455 (65%)	403 (69%)
There is no faeces inside both stalls	536 (77%)	344 (59%)
There is no faeces outside the structure within 5m	513 (74%)	384 (66%)
There is no standing water outside this structure within 5m	682 (98%)	581 (99%)

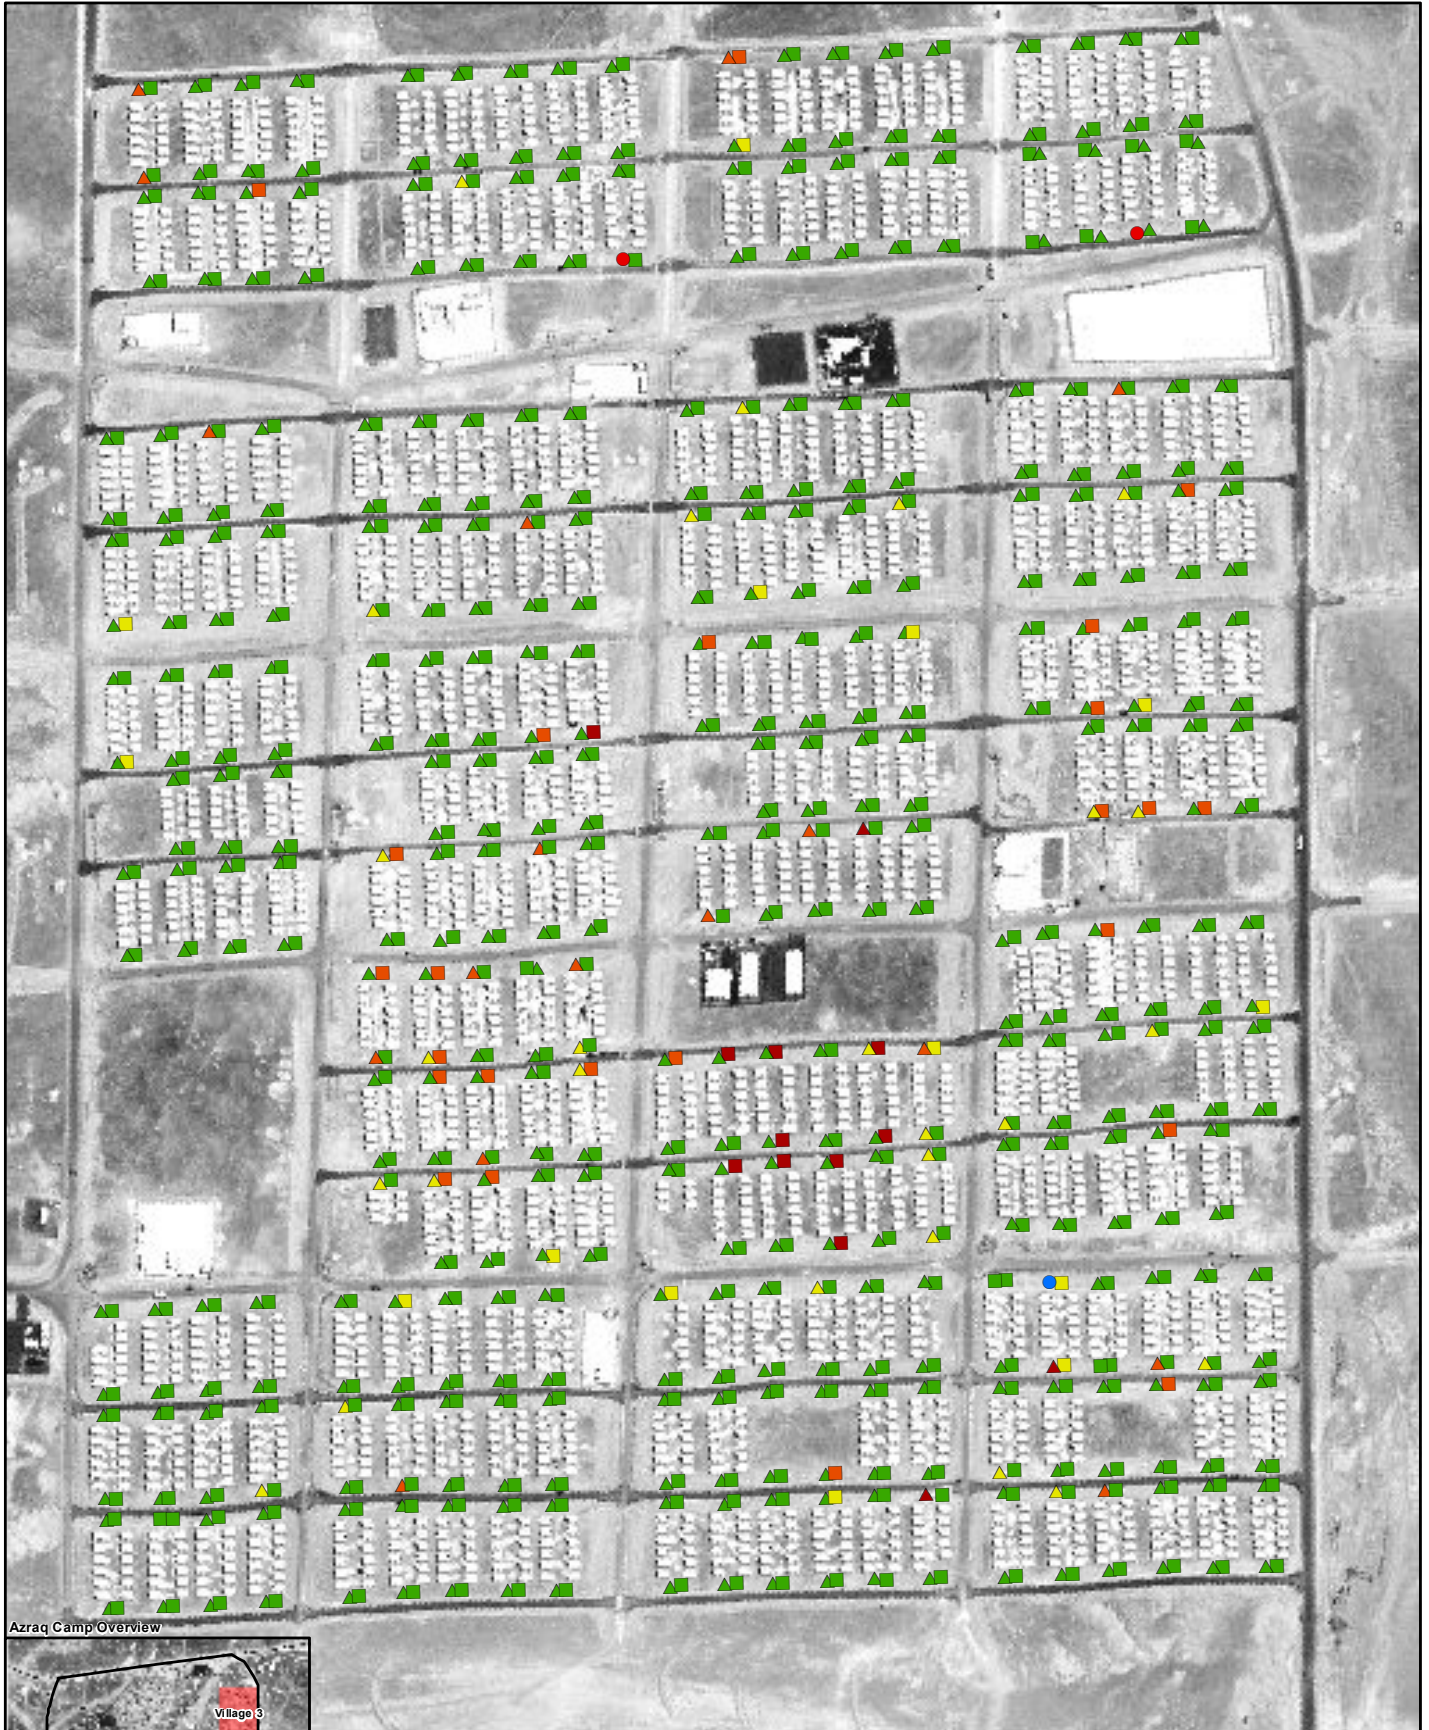
Map 5: Outside locks at the height of 1.2m from the ground or lower in Village 3

This Week	2 weeks ago
Door handles are at a child-friendly height of (≤1.2m)	88 (10%)	67 (7%)
Outside locks on both doors are at a child-friendly height (≤1.2m)	816 (89%)	833 (92%)
Inside locks on both doors are at a child-friendly height of (≤1.2m)	883 (97%)	890 (98%)
Both WASH centre doors are not privately locked	899 (99%)	901 (99%)
# of WASH centres dedicated to disabled persons	138 (15%)	134 (15%)
# of WASH centres with finished access ramp	137 (15%)	134 (15%)
Disabled toilet is still present in toilets for disabled persons	65 (47%)	58 (43%)

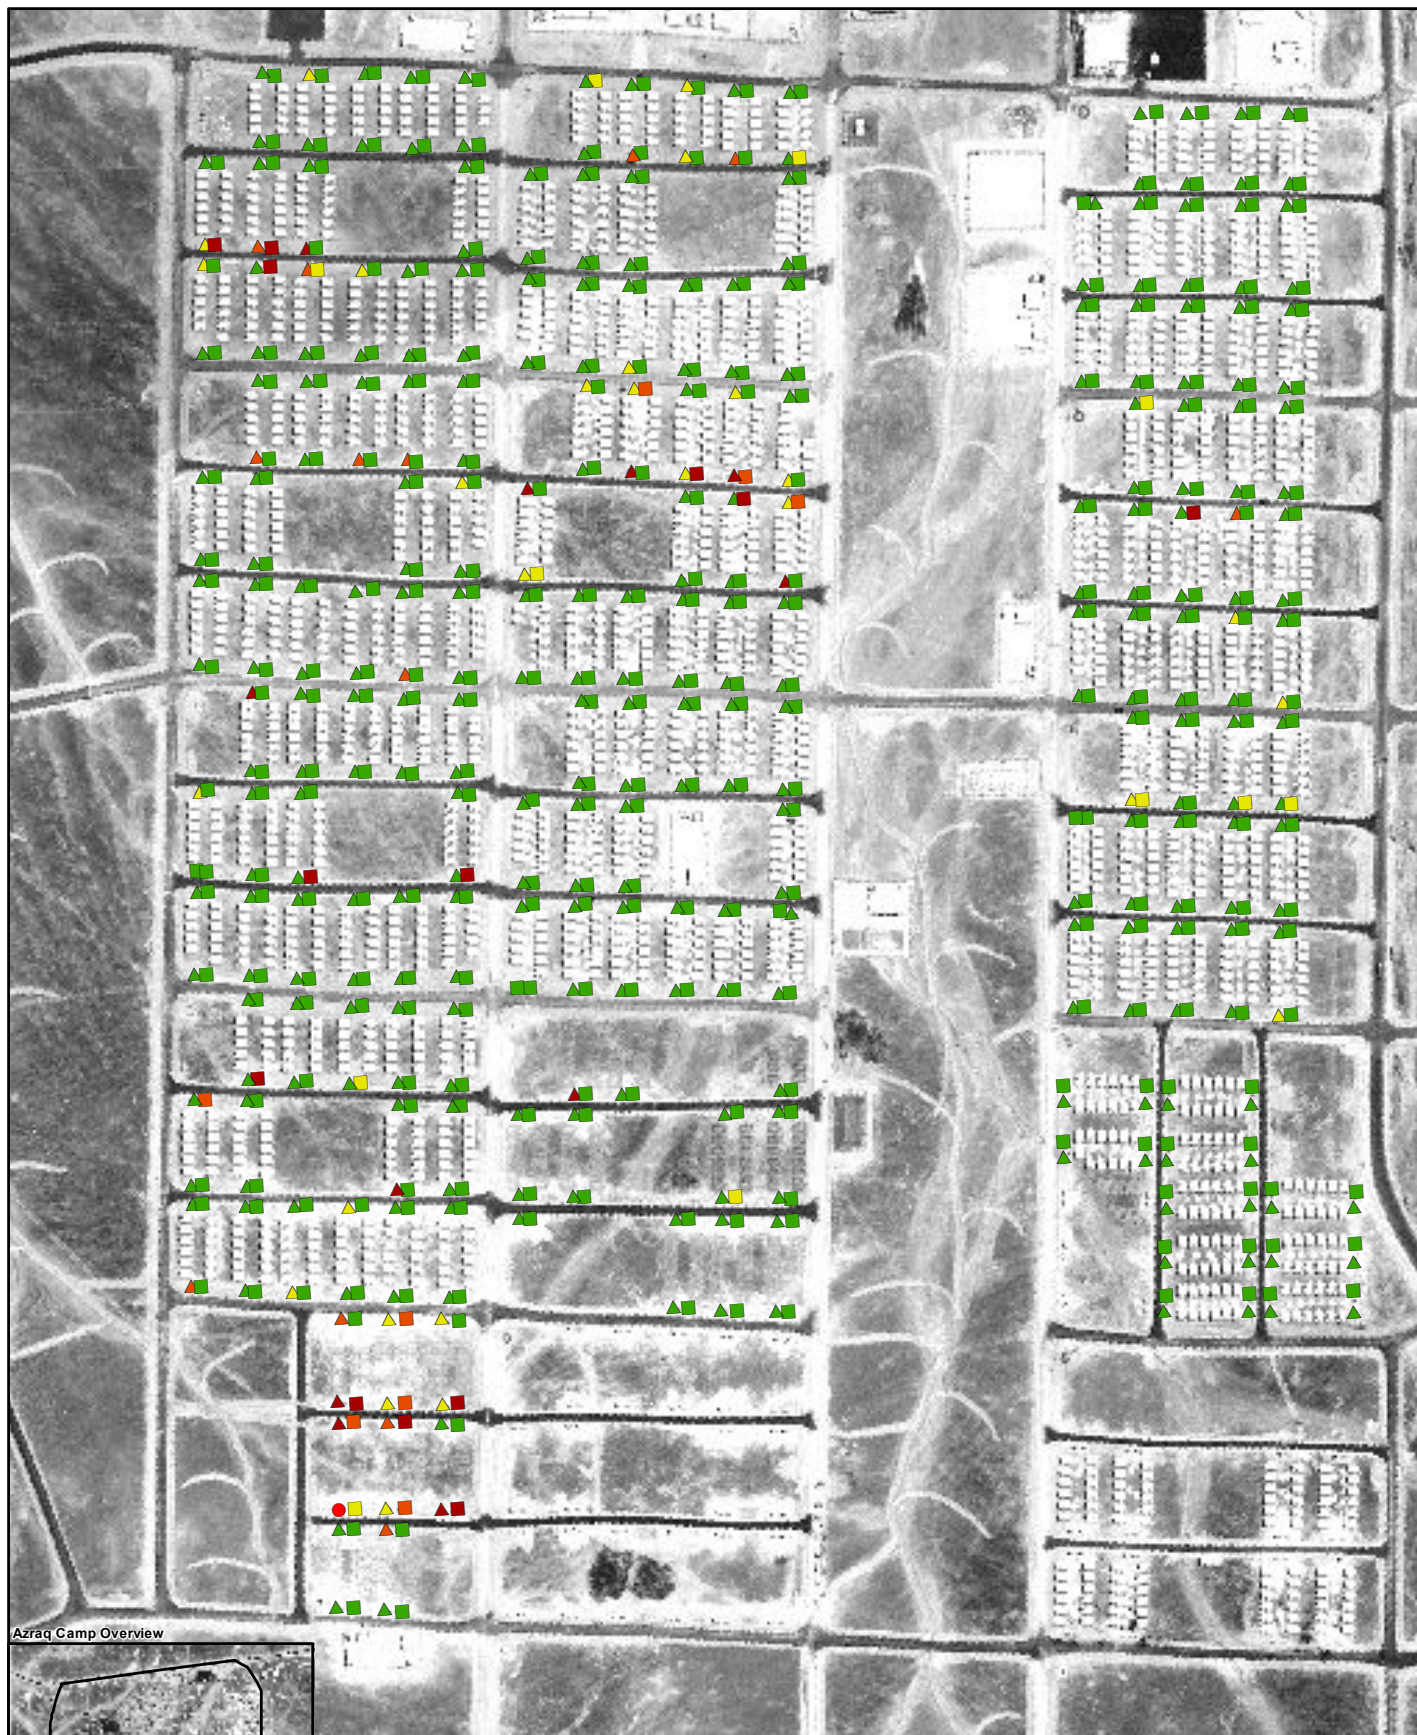
Map 6: Outside locks at the height of 1.2m from the ground or lower in Village 6

This Week	2 weeks ago
Door handles are at a child-friendly height of (≤1.2m)	38 (5%)	27 (5%)
Outside locks on both doors are at a child-friendly height (≤1.2m)	612 (88%)	522 (89%)
Inside locks on both doors are at a child-friendly height of (≤1.2m)	675 (97%)	575 (98%)
Both WASH centre doors are not privately locked	691 (99%)	583 (100%)
# of WASH centres dedicated to disabled persons	61 (9%)	62 (11%)
# of WASH centres with finished access ramp	53 (8%)	62 (11%)
Disabled toilet is still present in toilets for disabled persons	14 (23%)	21 (34%)

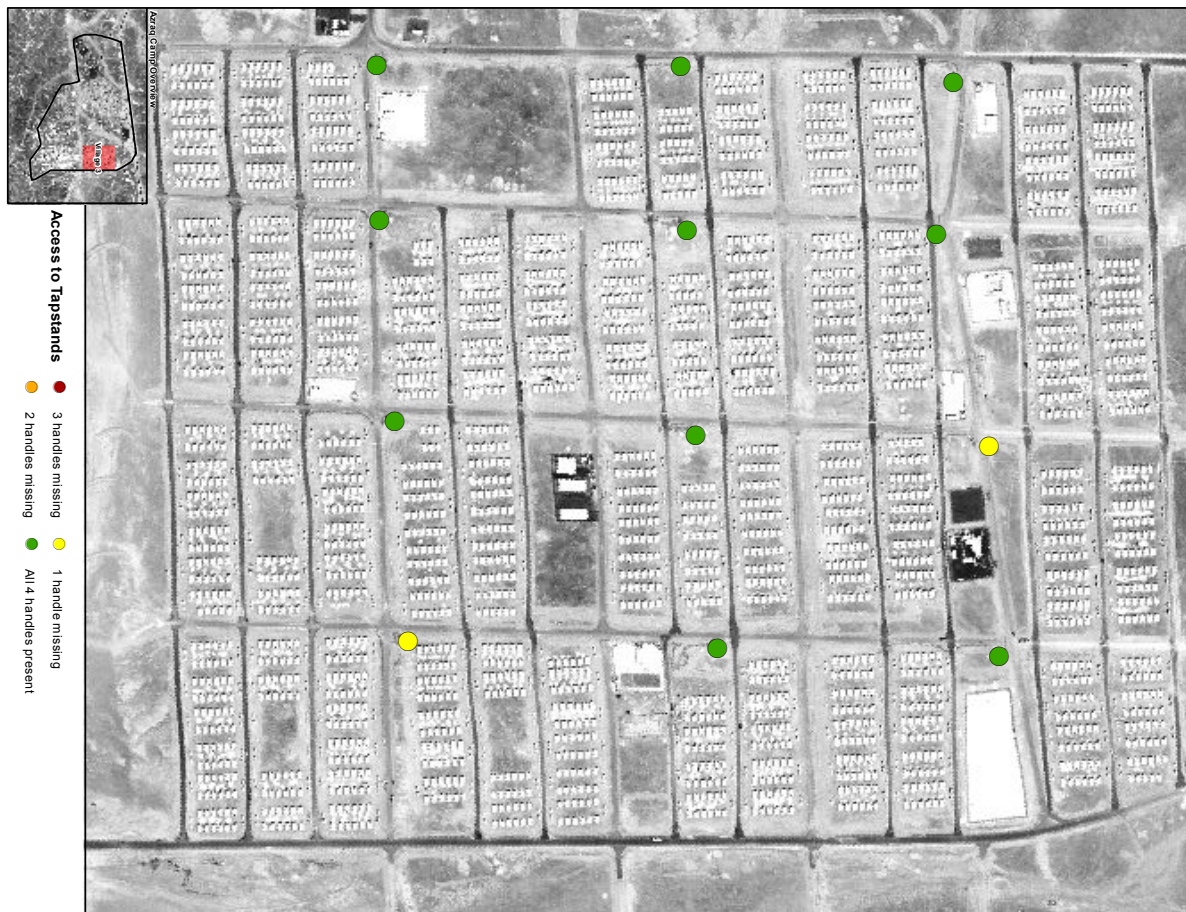
Map 7: Missing tapstand handles and private connections in Village 3

This Week	2 weeks ago
The tapstand provides water during its operational hours	12 (100%)	12 (100%)
The tapstand has all 4 taps attached	12 (100%)	12 (100%)
Tap handles are present on all remaining taps at the tapstand	10 (83%)	8 (67%)
All remaining taps on the tapstand provide water when turned on	12 (100%)	12 (100%)
All remaining taps at the tap stand are protected by tap guards	6 (50%)	12 (100%)
The concrete base of the tapstand is in decent shape*	12 (100%)	12 (100%)

This Week	2 weeks ago
There is no faeces on the ground within 10m of this tapstand	11 (92%)	12 (100%)
# of private hoses connected to individual taps	0	0
Average # of people queuing at the tapstand	1.41	2.8
Flow calculation based on # of seconds it takes to fill a 1L bottle	0.27	0.18

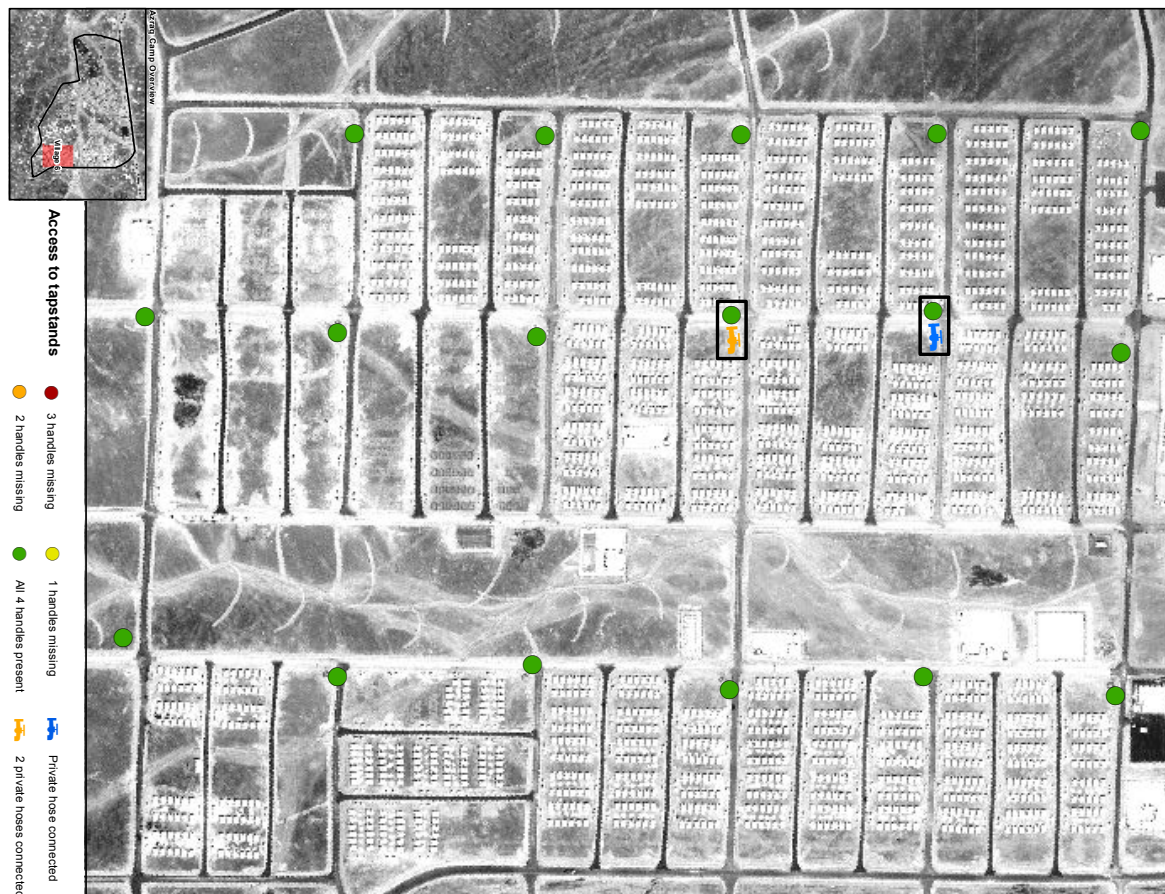
Map 8: Missing tapstand handles and private connections in Village 6

This Week	2 weeks ago
The tapstand provides water during its operational hours	17 (94%)	17 (94%)
The tapstand has all 4 taps attached	18 (100%)	18 (100%)
Tap handles are present on all remaining taps at the tapstand	18 (100%)	15 (83%)
All remaining taps on the tapstand provide water when turned on	17 (100%)	17 (100%)
All remaining taps at the tap stand are protected by tap guards	18 (100%)	18 (100%)
The concrete base of the tapstand is in decent shape*	18 (100%)	18 (100%)

This Week	2 weeks ago
There is no faeces on the ground within 10m of this tapstand	17 (94%)	18 (100%)
# of private hoses connected to individual taps	3	3
Average # of people queuing at the tapstand	0.28	2
Flow calculation based on # of seconds it takes to fill a 1L bottle	0.23	0.25
