Haiti Mission Report

20 January - 19 March 2010

MURALEE THUMMARUKUDY
PROGRAMME OFFICER, POST CONFLICT AND DISASTER MANAGEMENT BRANCH
UNITED NATIONS ENVIRONMENT PROGRAMME

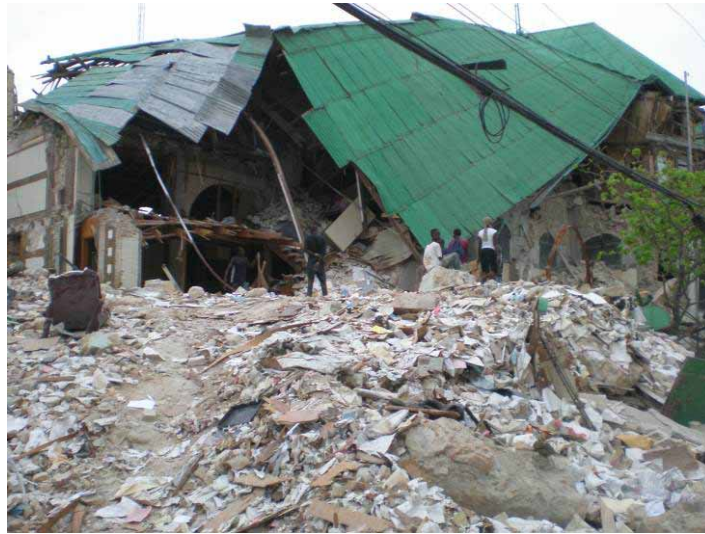
The Haitian Government infrastructure was seriously impacted by the earthquake; above, the remains of the Ministry of Environment.

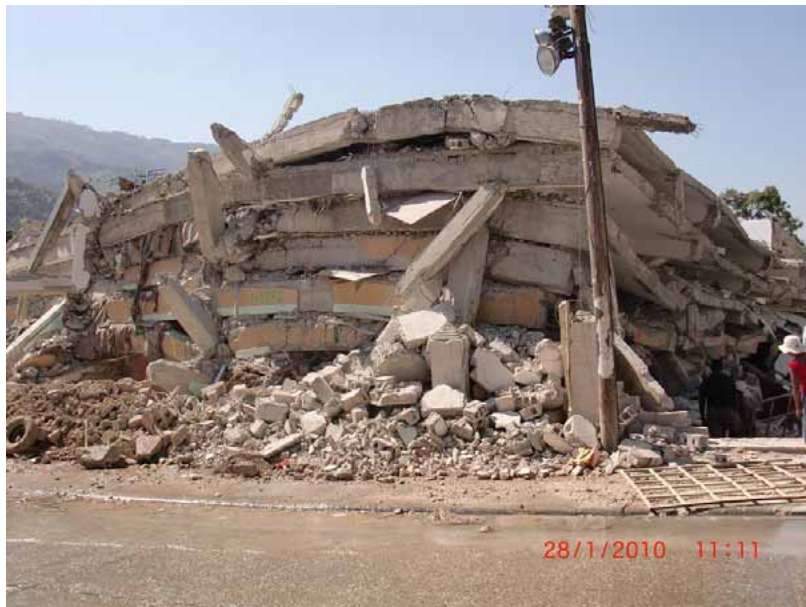
The earthquake caused multiple building storeys to crumble onto each other, compacting everything within.

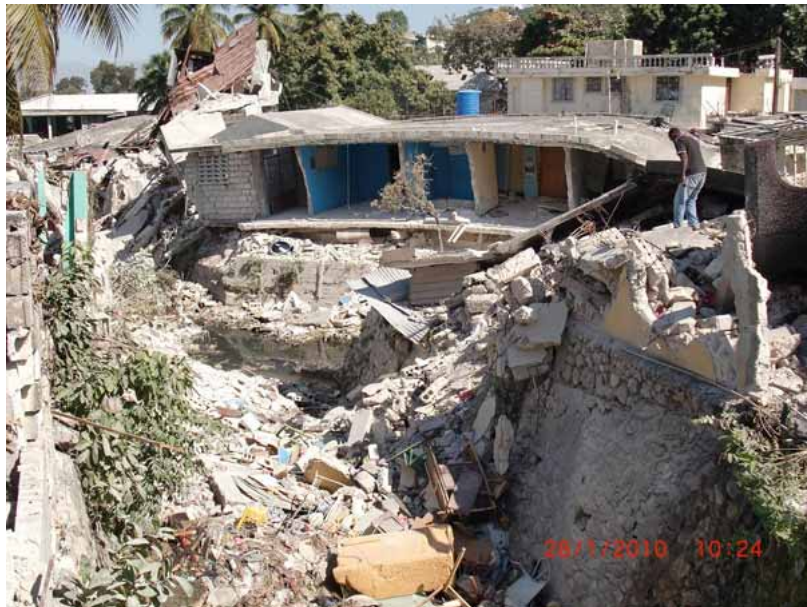
The collapse of municipal waste management services in the immediate aftermath of the earthquake led to the accumulation of everyday waste alongside disaster debris.

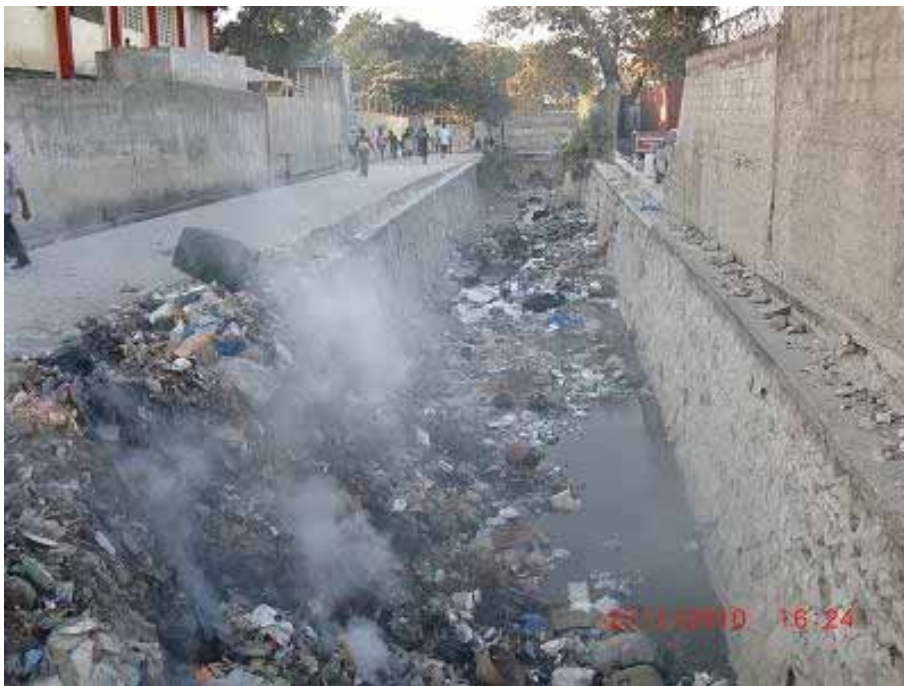
In many parts of Port-au-Prince, drainage channels are filled with solid waste. This causes localized flooding every time there is heavy rainfall.

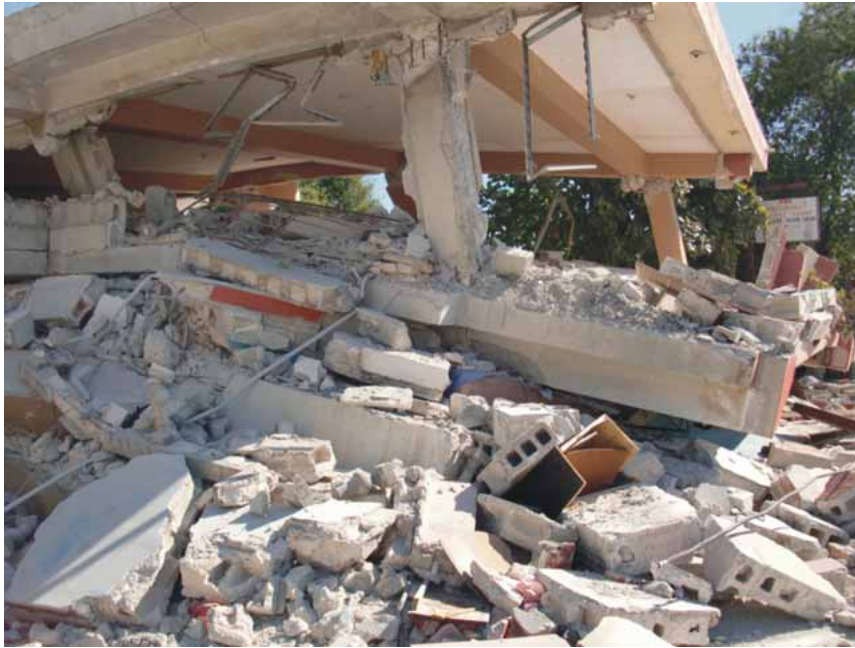
Concrete hollow bricks were often incorrectly used as load-carrying building material, and collapsed easily during the earthquake

First, limestone was used as a coarse and fine aggregate for making concrete for reinforced cement concrete structures. Unfortunately, limestone is not well suited for supporting heavy loads. Indeed it is clear from observations on the ground that a high proportion of lime in the concrete does not create adequate bonding to reinforcement bars. As a result, when the earthquake occurred, the concrete came off the reinforcement bars, making the columns and beams unstable and unable to behave as a single unit as designed, thereby failing the structure completely.

ensure better design factoring in all hazards, to decrease the dependence on limestone as the exclusive source of building construction material, and to develop and enforce building codes and quality control of building materials.

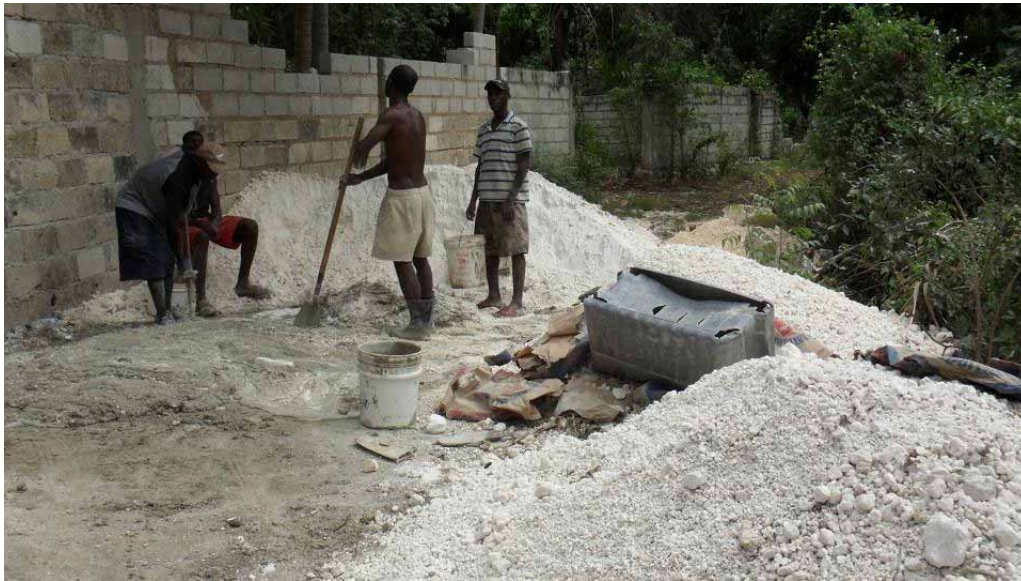
The use of existing approaches to making concrete will rebuild the same vulnerabilities into future construction.

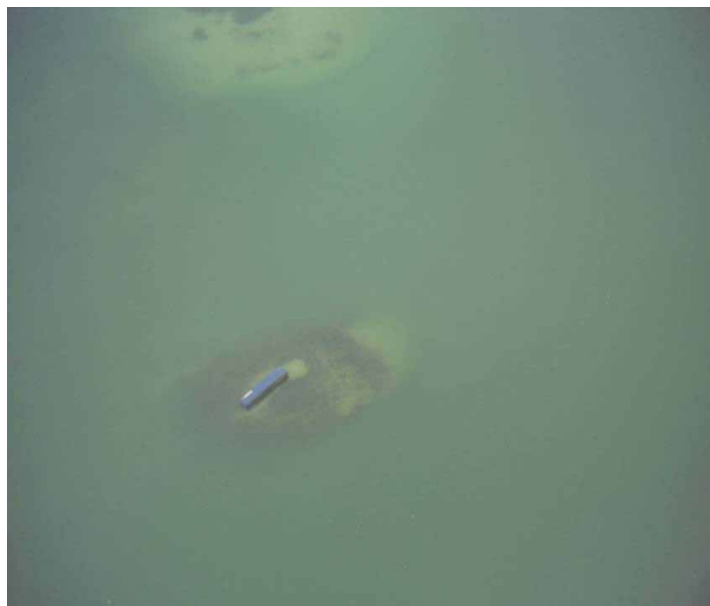
After the earthquake, a number of containers in the main port were washed out to sea, causing some concern for potential contamination.

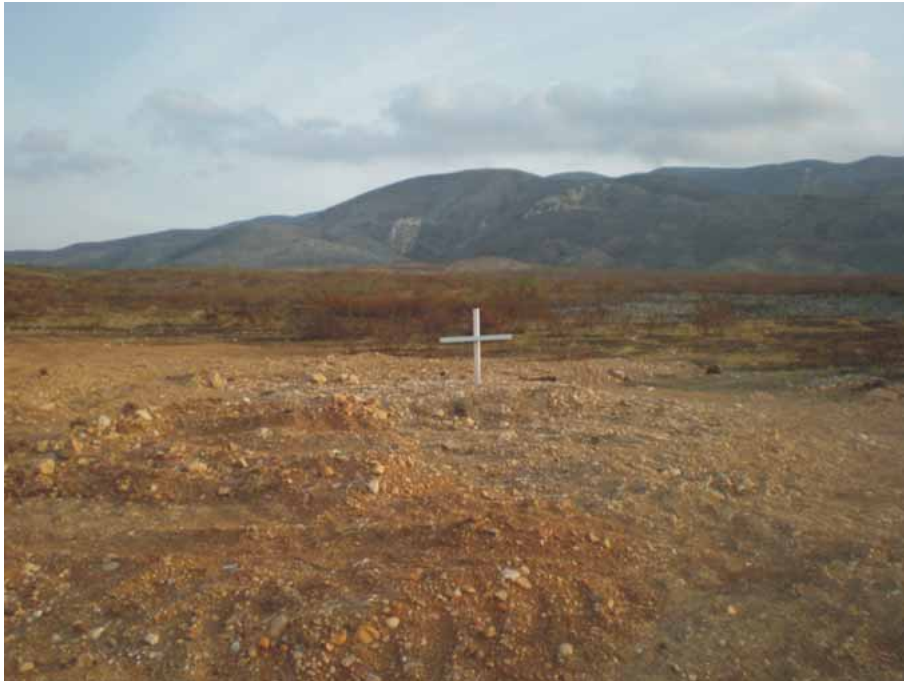
The remains of many victims were collected in trucks and disposed in hurriedly dug pits in Port-au-Prince and its environs.

In all the burial sites visited by the UNEP team, graves were found to be very shallow and it is likely that foul smells will start to emanate from these locations in the months to come. While some of the locations are far removed from places of habitation and may not lead to a public nuisance, in others they are adjacent to settled communities and may cause significant difficulties.

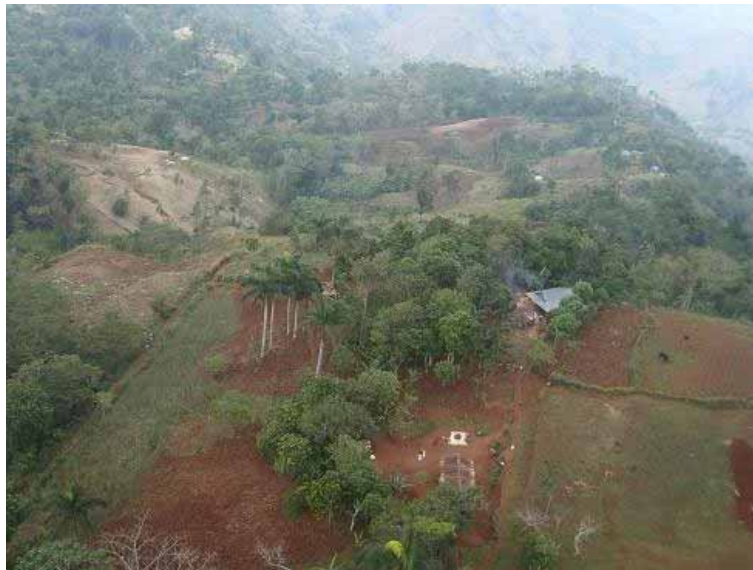
Significant soil erosion caused by deforestation reduces the ability of top soil to support vegetation.

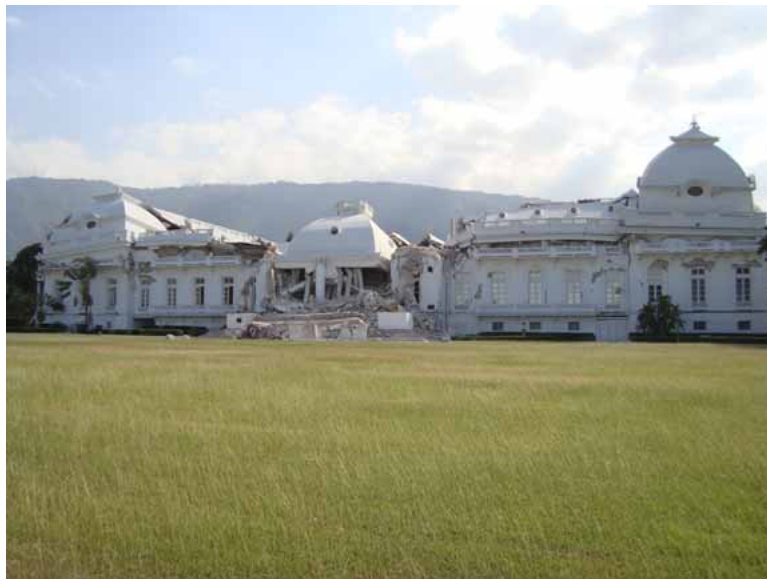
The presidential palace in Port-au-Prince was extensively damaged by the earthquake and will need to be demolished.

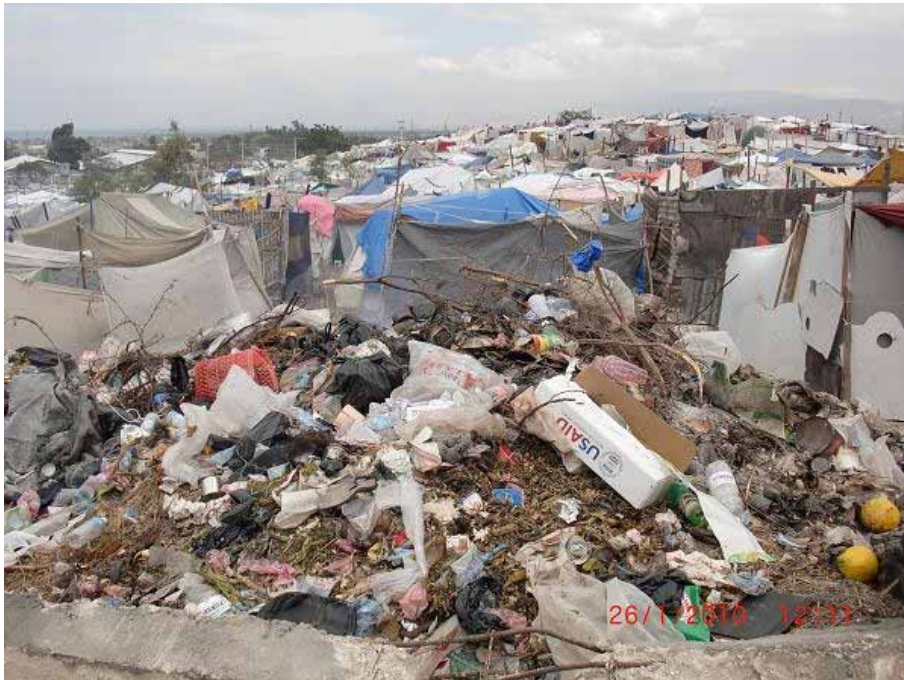
The lack of solid waste management in IDP camps creates many health risks for residents.

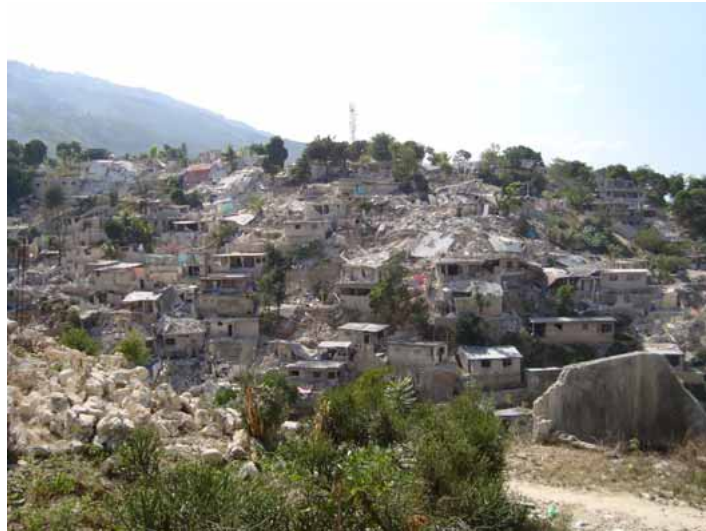
The presence of a fault line beneath the hills of Pétionville makes the area unsuitable for resettling impacted populations.
