Overview - Village 3 & Village 6

Azraq Camp

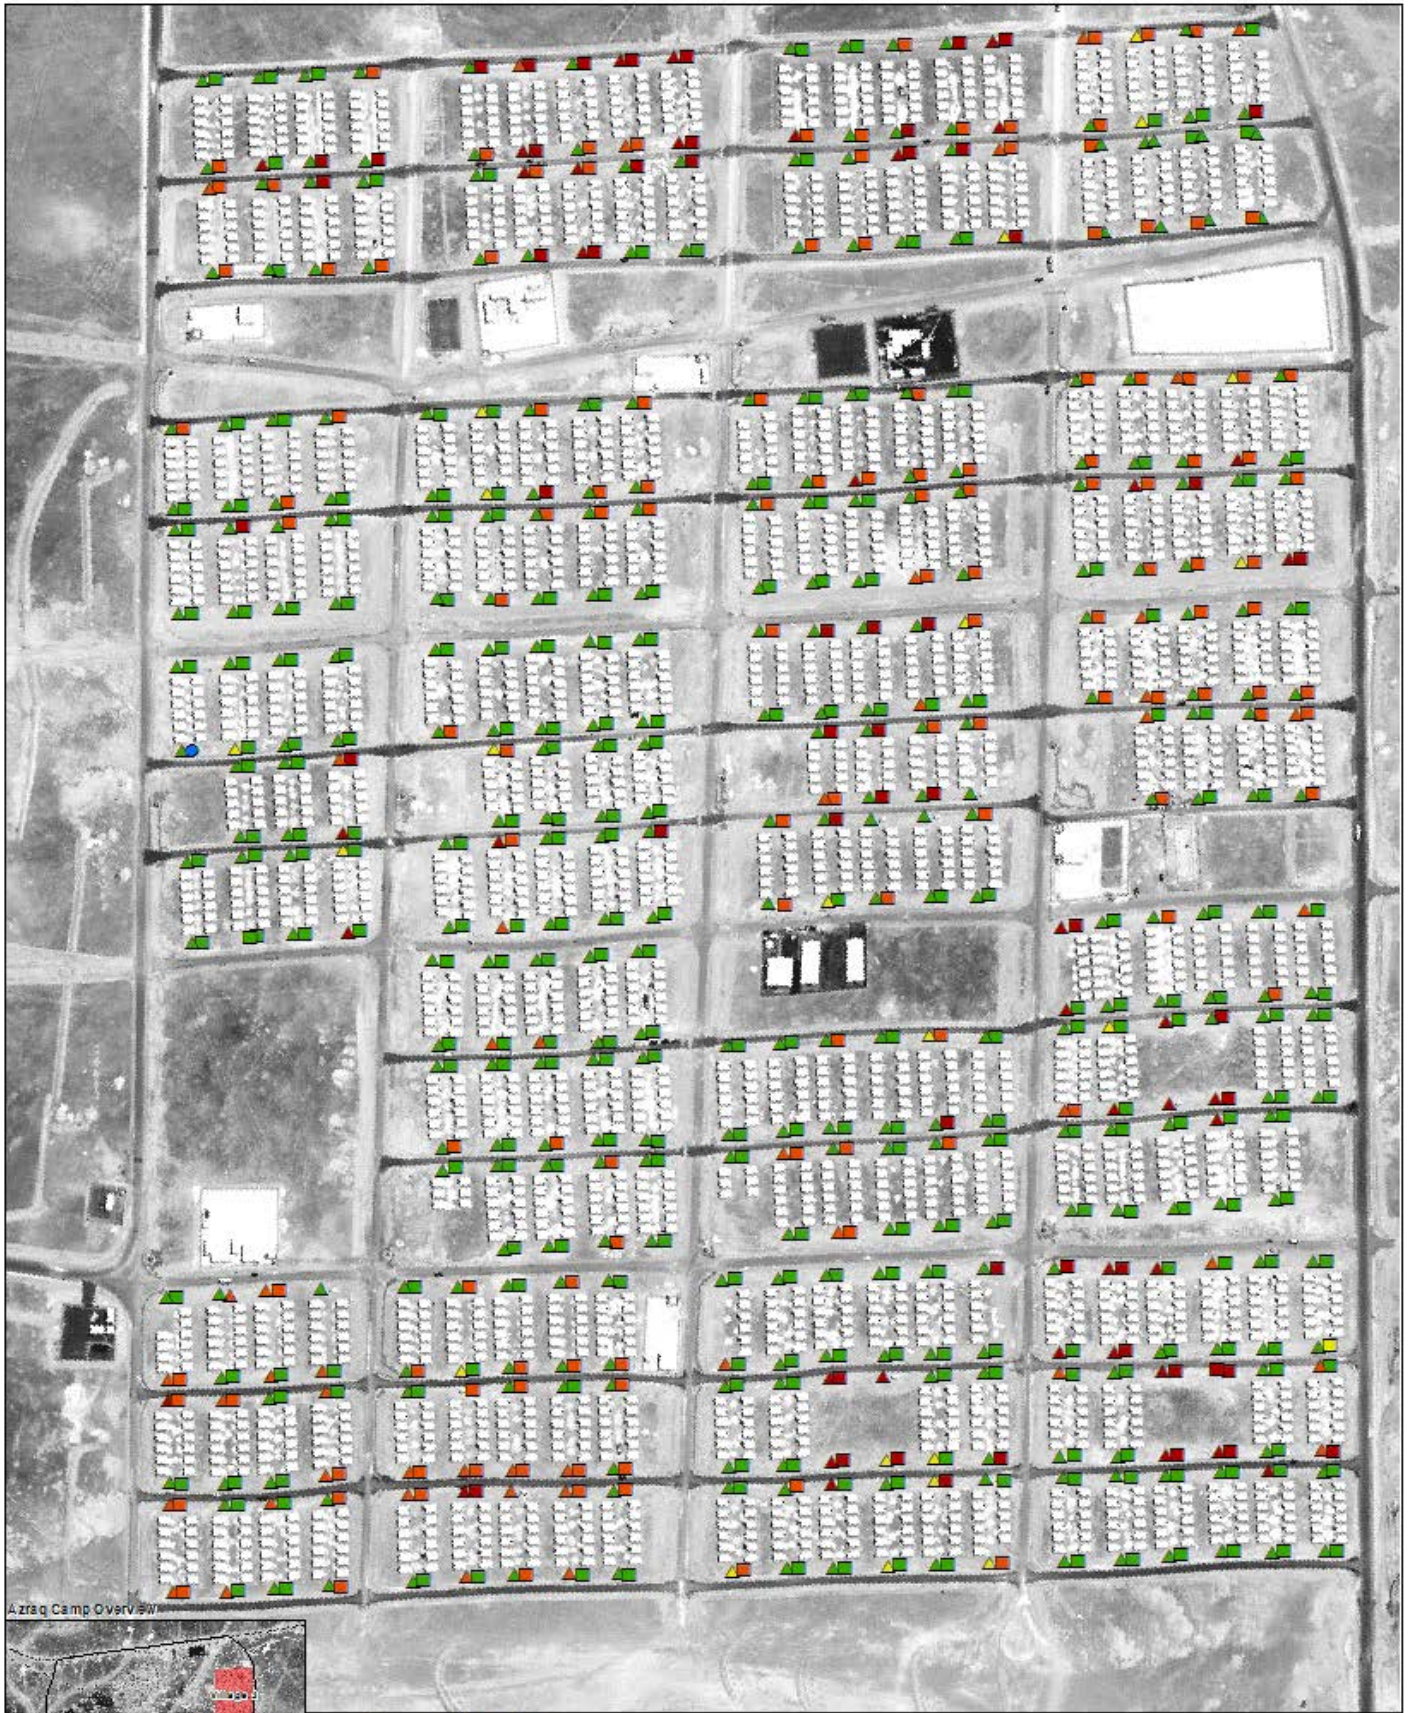
Map 1: Faeces found inside WASH centres in Village 3

There is no rubbish inside both stalls	938 (63%)	1010 (67%)
There is no faeces inside both stalls	946 (63%)	1130 (75%)
There is no faeces outside the structure within 5m	1026 (69%)	1253 (83%)
There is no standing water outside this structure within 5m	1480 (99%)	1484 (99%)

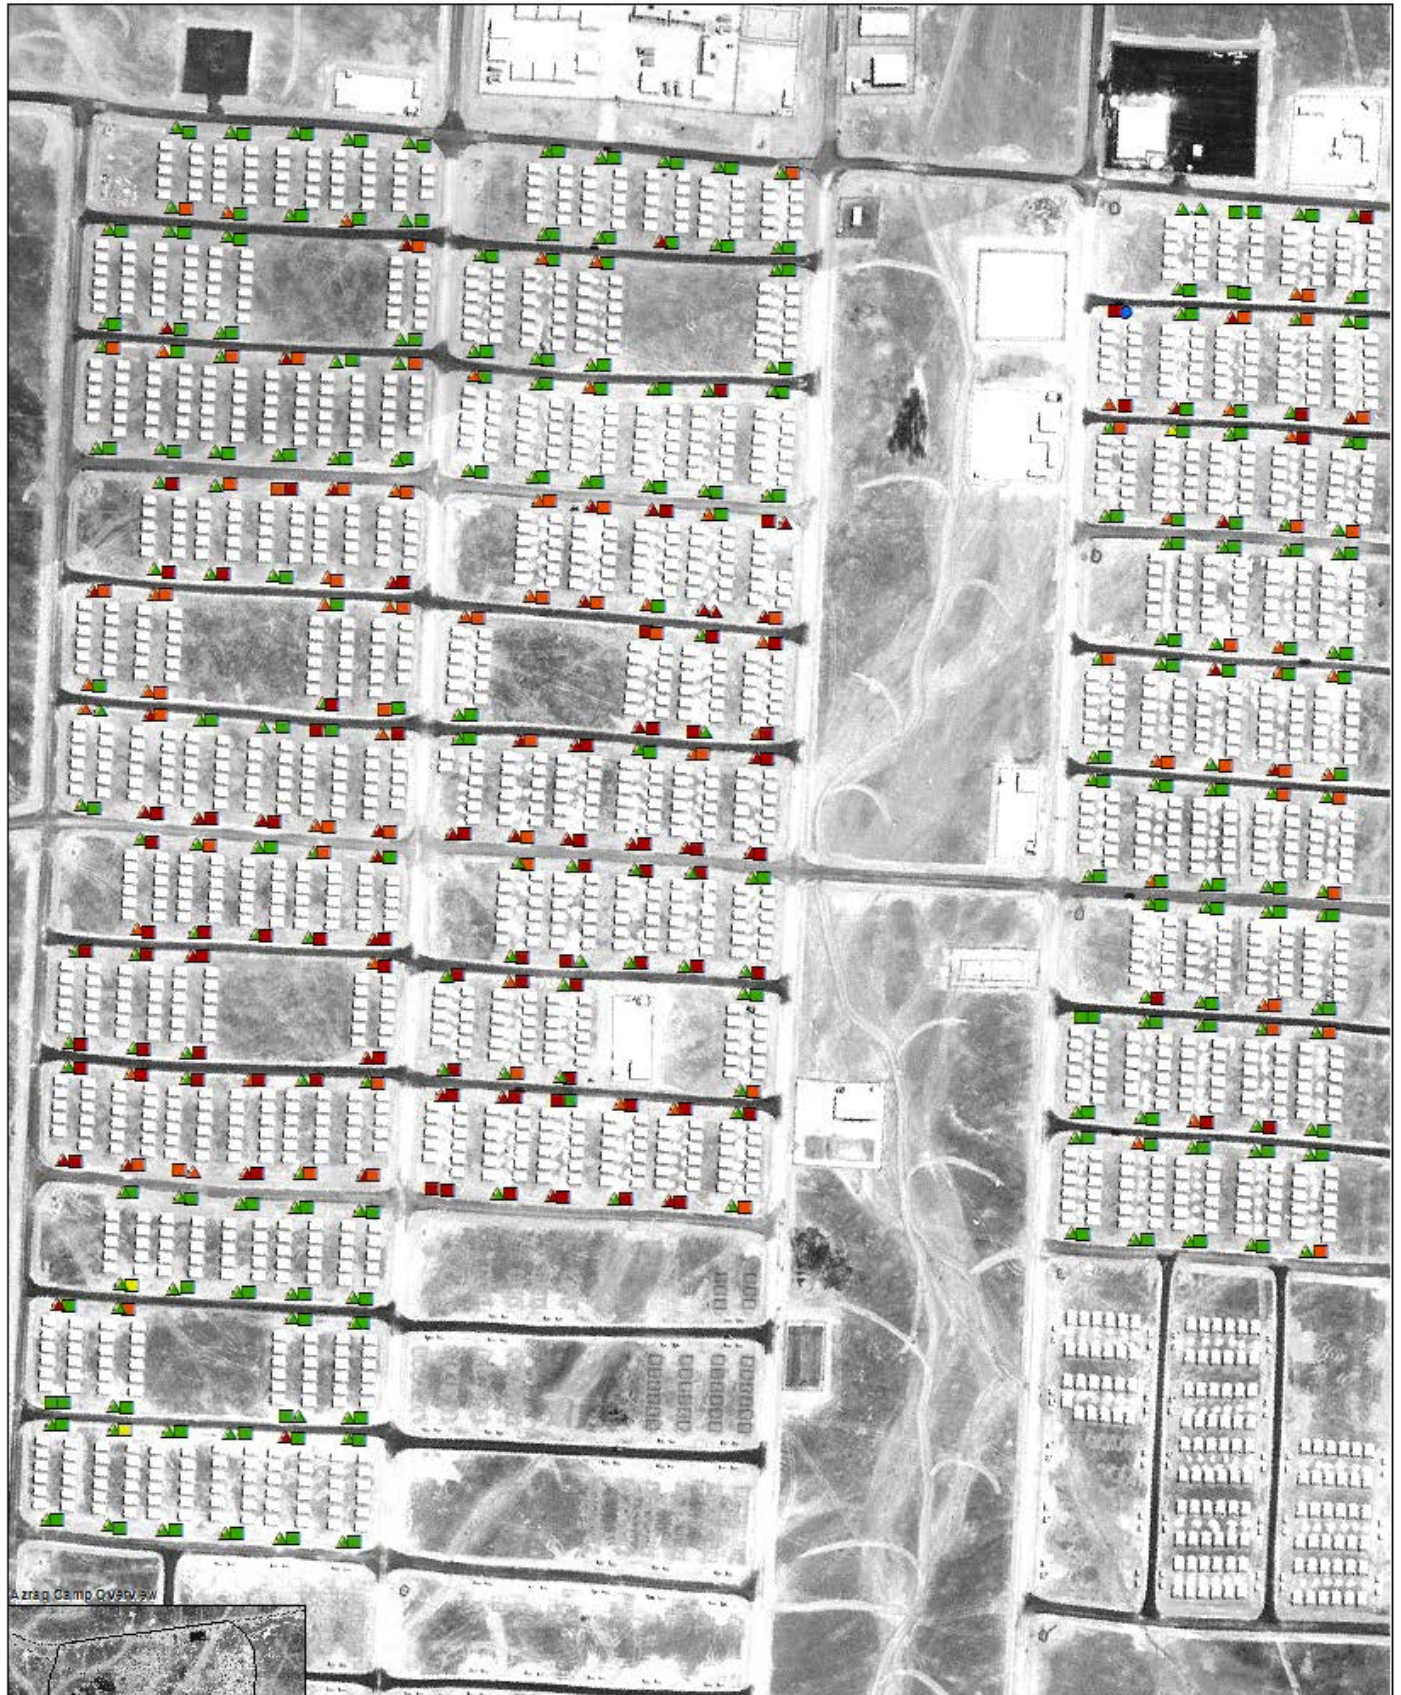
Map 2: Faeces found inside WASH centres in Village 6

This Week	2 weeks ago
There is no rubbish inside both stalls	403 (69%) ^{>5%}	353 (60%)
There is no faeces inside both stalls	344 (59%) ^{>5%}	407 (69%)
There is no faeces outside the structure within 5m	384 (66%) ^{>5%}	453 (77%)
There is no standing water outside this structure within 5m	581 (99%)	576 (98%)

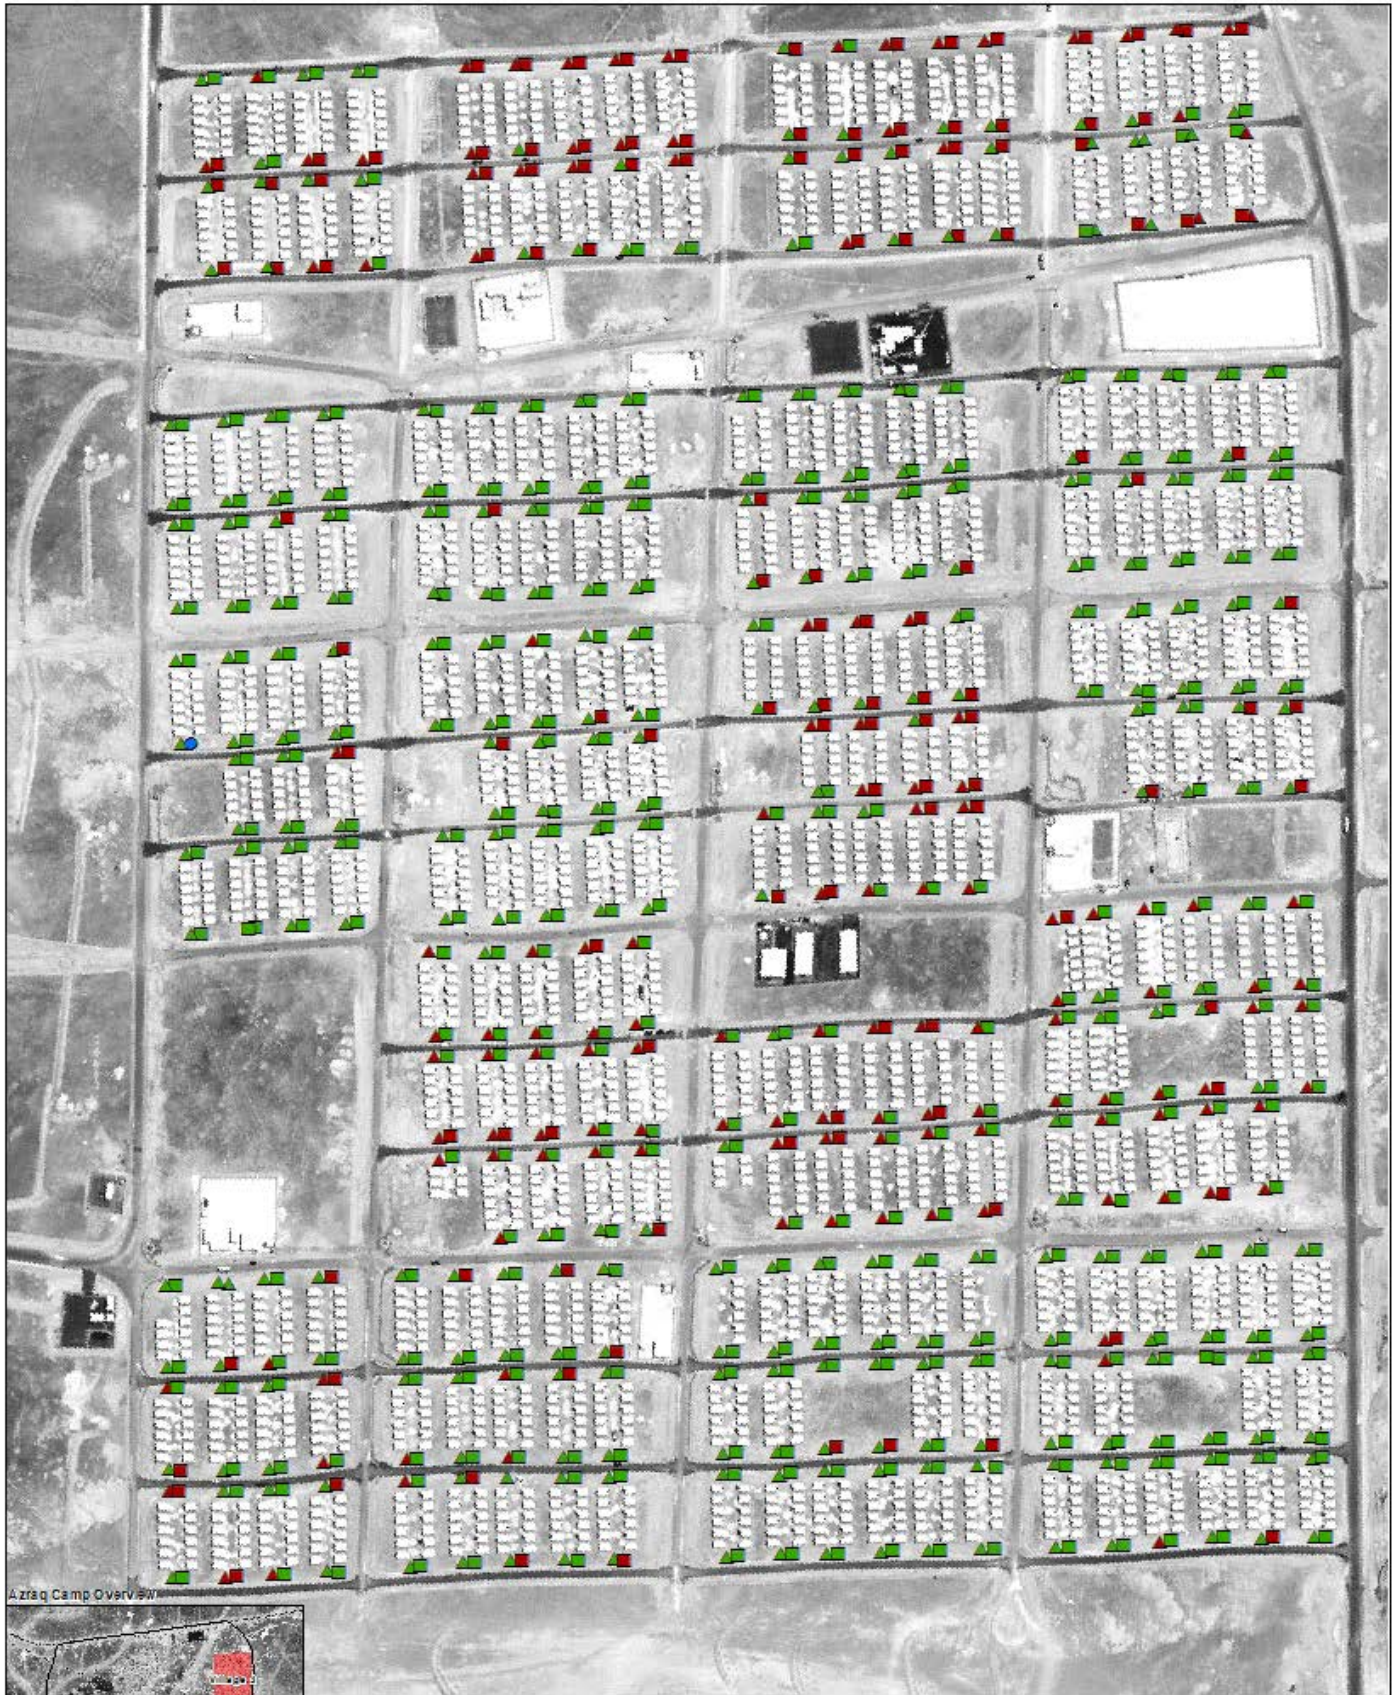
Map 3: Faeces found outside WASH centres in Village 3

Faeces found outside (within 5m radius)

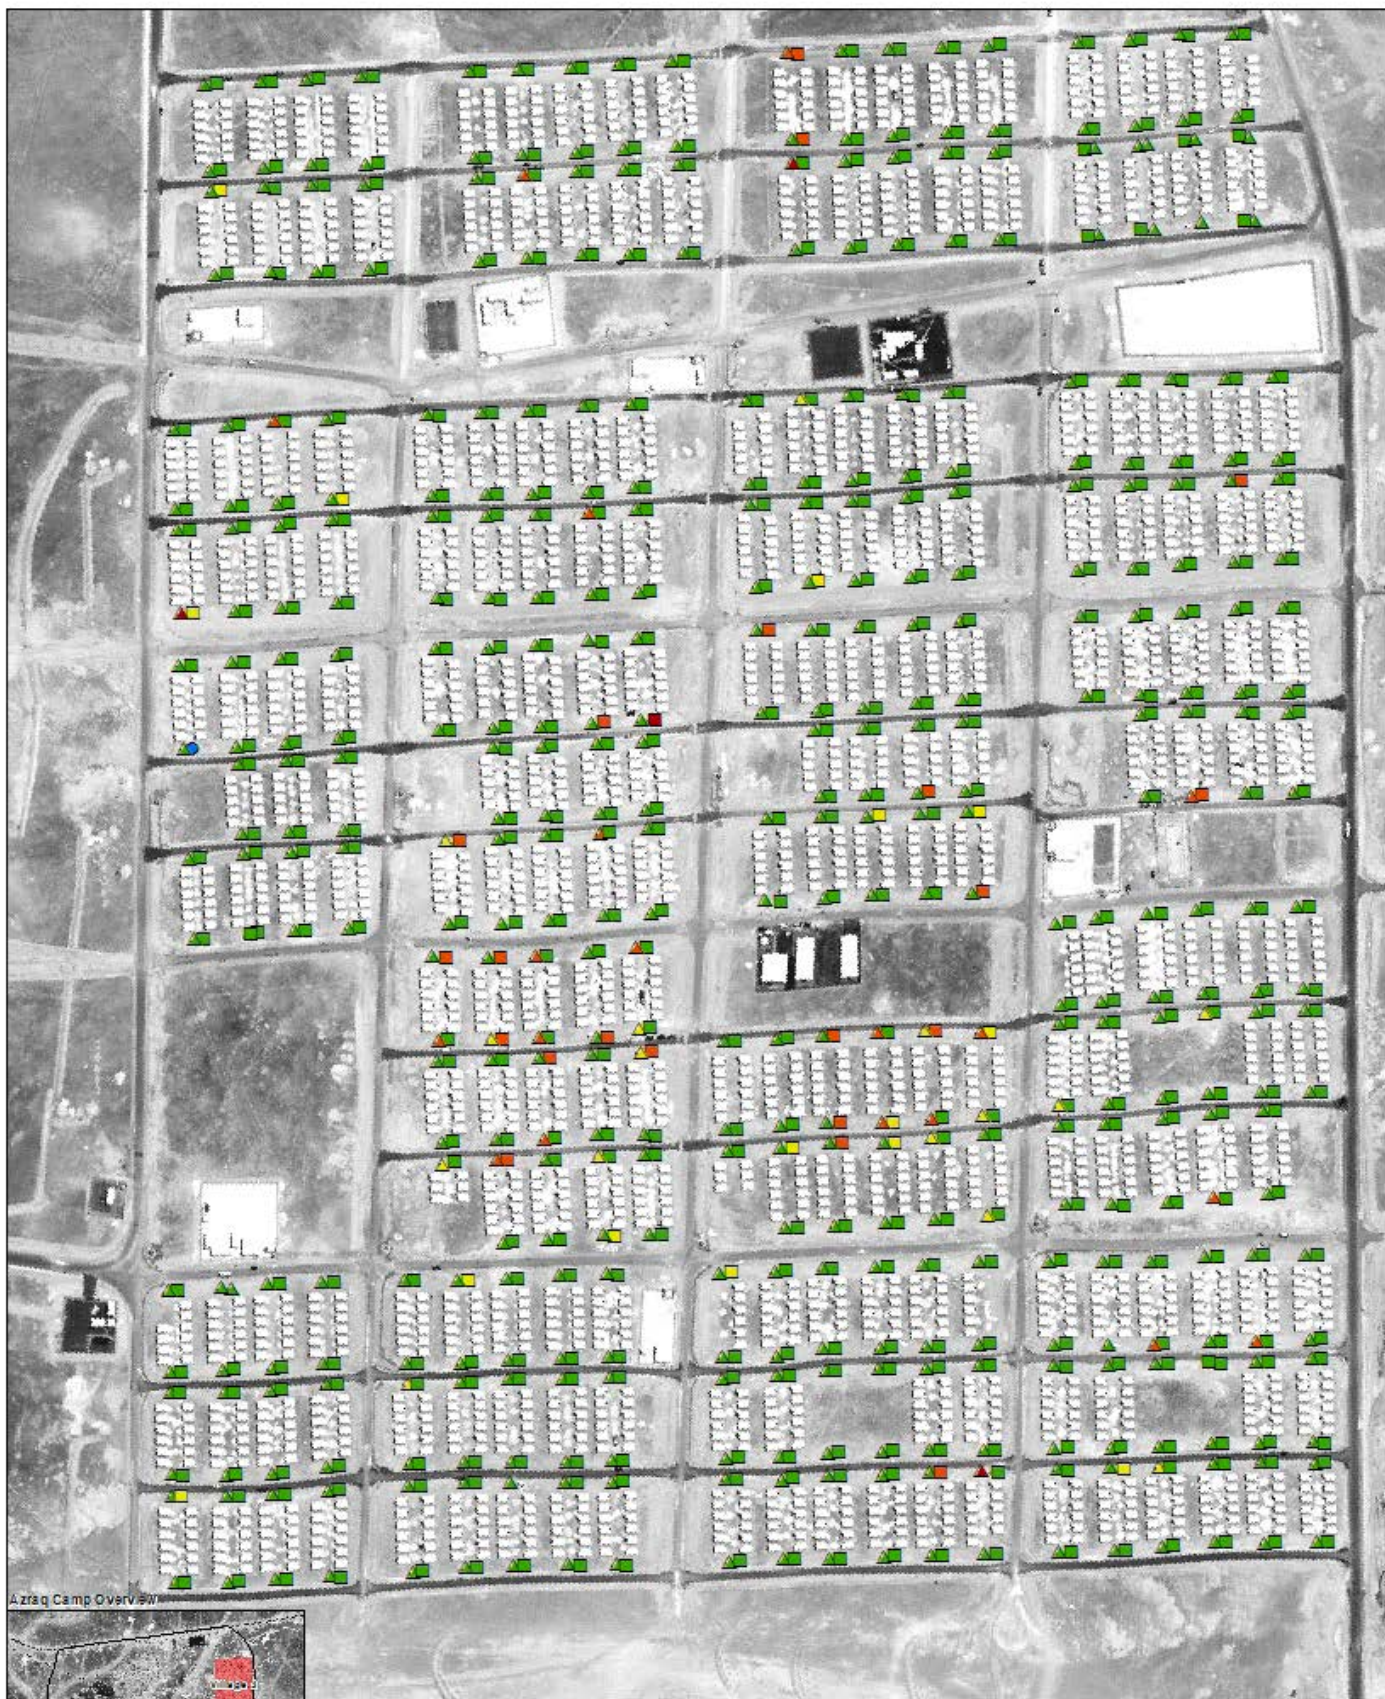
Map 5: Outside locks at the height of 1.2m from the ground or lower in Village 3

Outside locks at 1.2m or lower

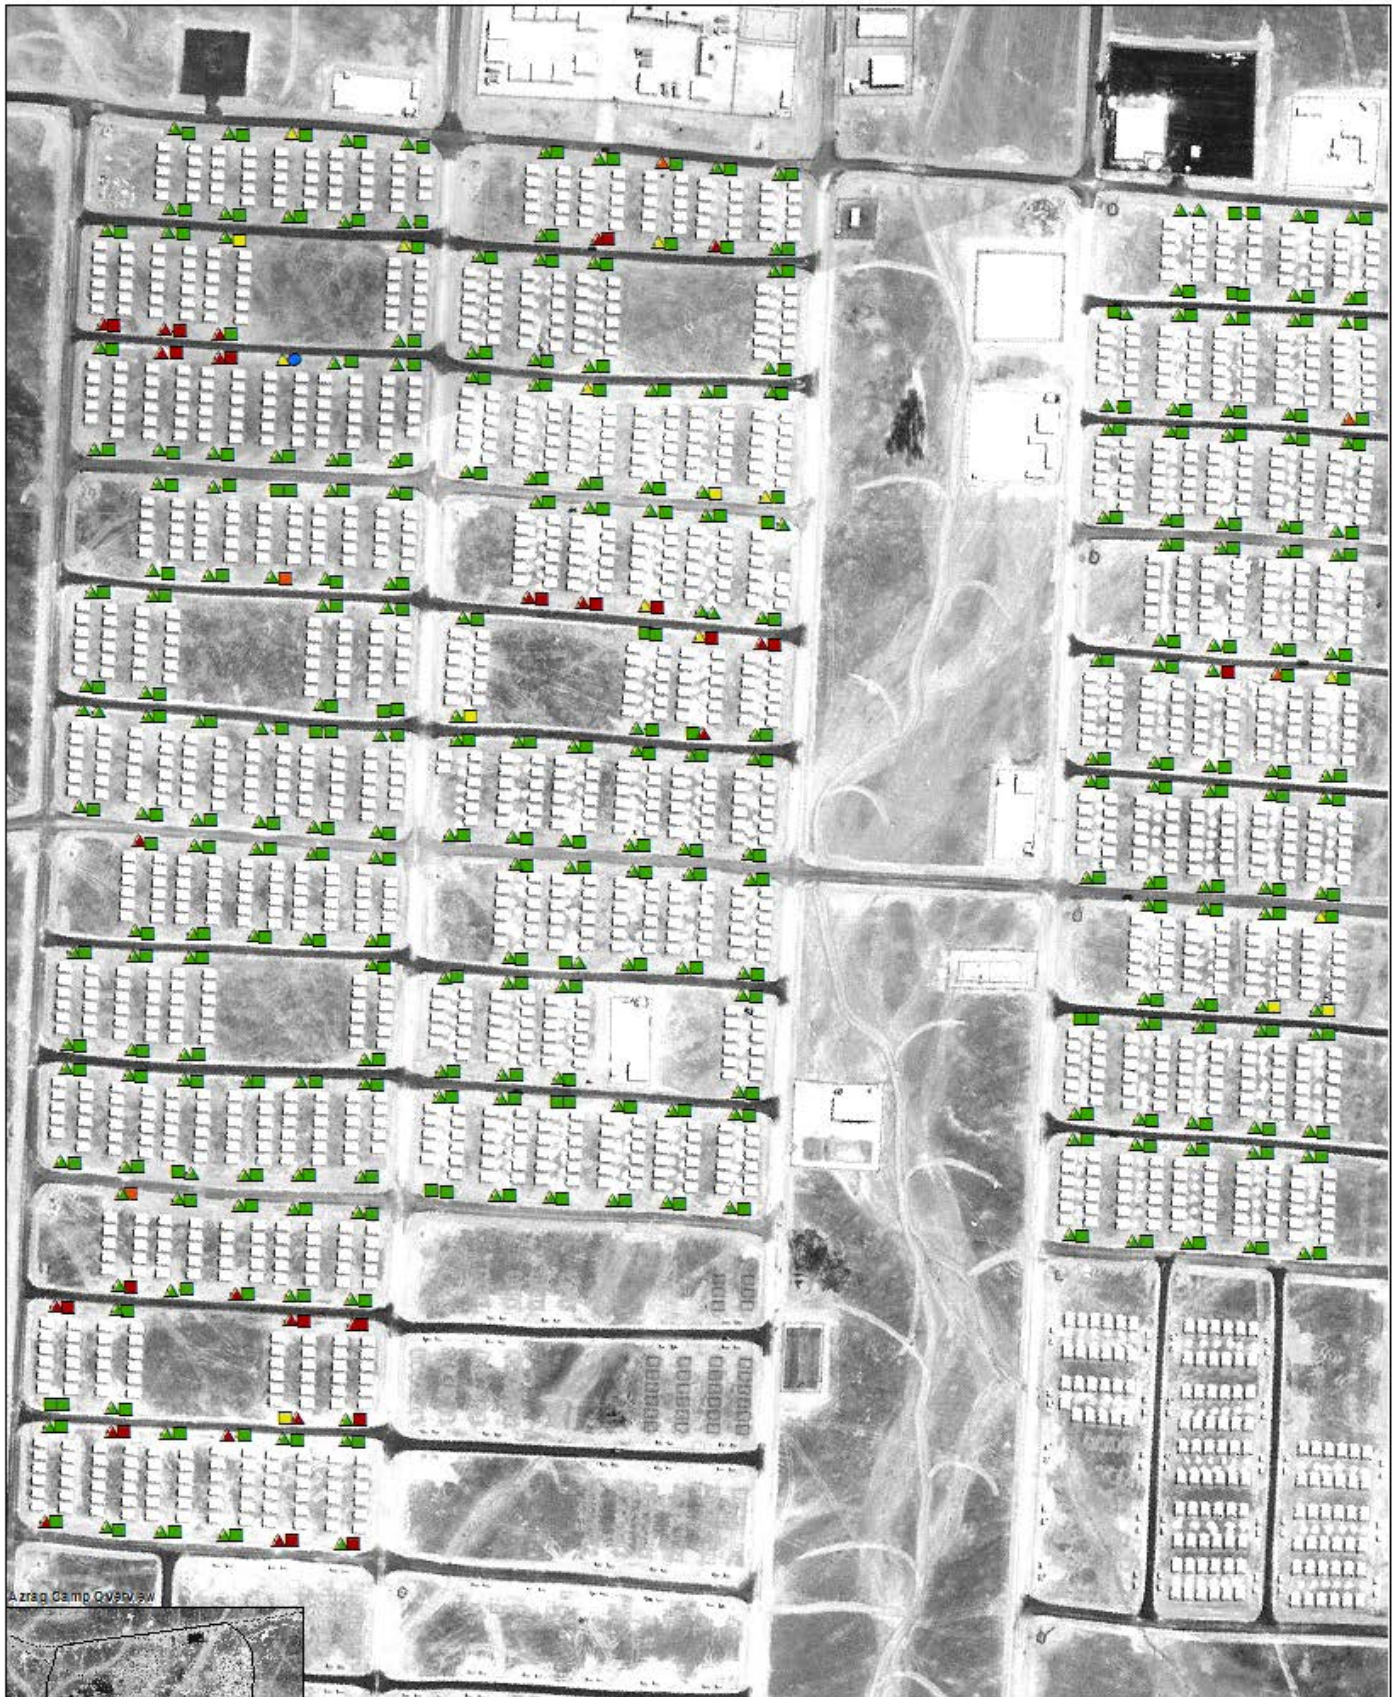
Map 6: Outside locks at the height of 1.2m from the ground or lower in Village 6

Outside locks at 1.2m or lower

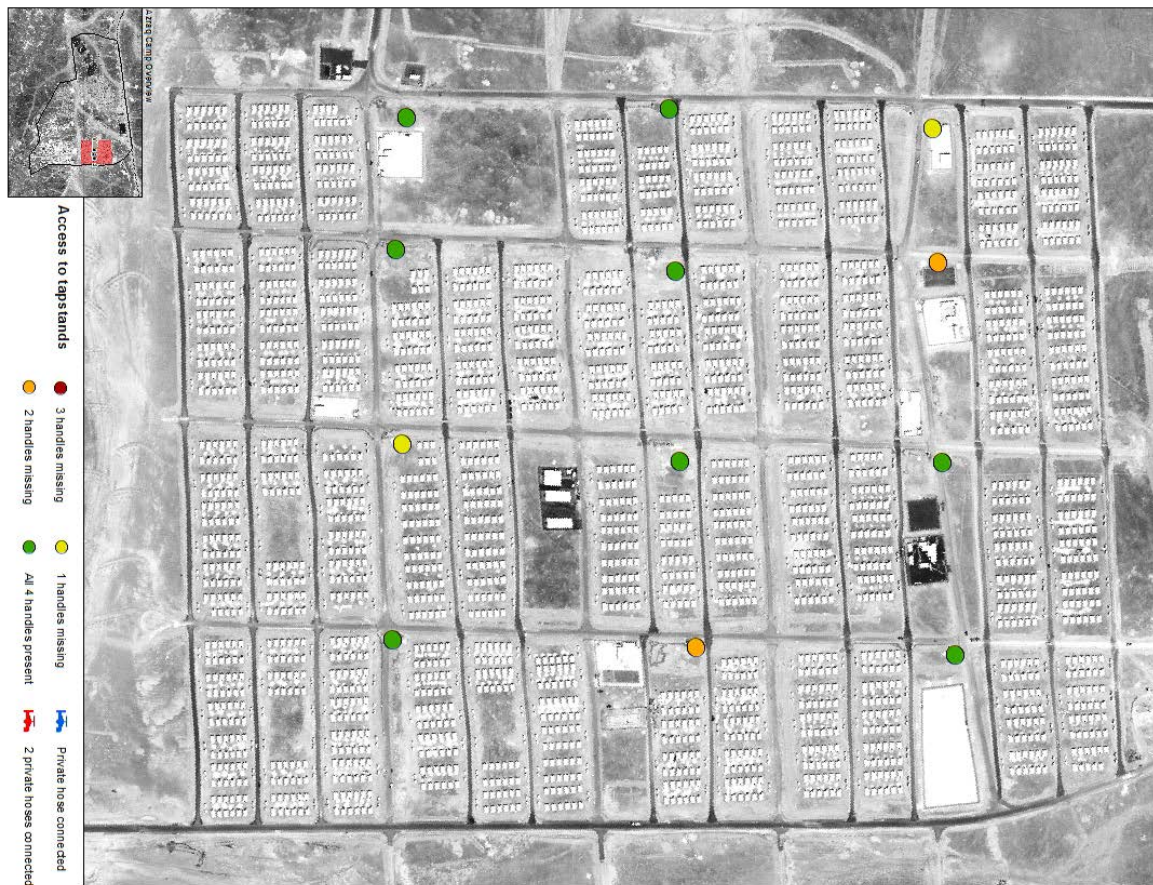
Map 7: Missing tapstand handles and private connections in Village 3

This Week	2 weeks ago
The tapstand provides water during its operational hours	12 (100%)	12 (100%)
The tapstand has all 4 taps attached	12 (100%)	12 (100%)
Tap handles are present on all remaining taps at the tapstand	8 (67%) ^{>10%}	11 (92%)
All remaining taps on the tapstand provide water when turned on	12 (100%)	12 (100%)
All remaining taps at the tap stand are protected by tap guards	12 (100%) ^{>10%}	10 (83%)
The concrete base of the tapstand is in decent shape*	12 (100%)	12 (100%)

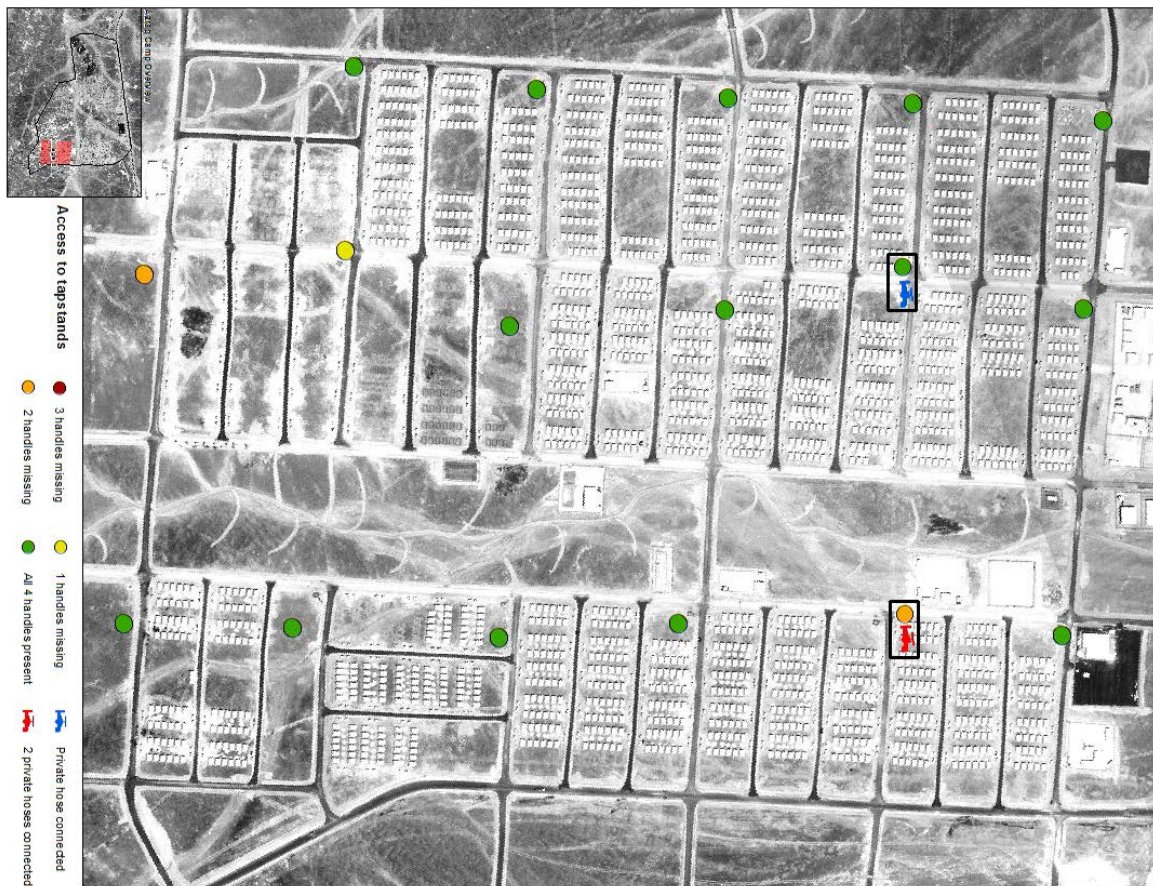
Map 8: Missing tapstand handles and private connections in Village 6

This Week	2 weeks ago
The tapstand provides water during its operational hours	17 (94%)	18 (100%)
The tapstand has all 4 taps attached	18 (100%)	18 (100%)
Tap handles are present on all remaining taps at the tapstand	15 (83%)	16 (89%)
All remaining taps on the tapstand provide water when turned on	17 (100%) ^{>10%}	15 (83%)
All remaining taps at the tap stand are protected by tap guards	18 (100%)	18 (100%)
The concrete base of the tapstand is in decent shape*	18 (100%)	18 (100%)
