Production Date: 12/11/2014

SITUATION UPDATE FOR ALEPPO CITY, ALEPPO GOVERNORATE, SYRIAN ARAB REPUBLIC

Based on Satellite Imagery Acquired 6 November 2014

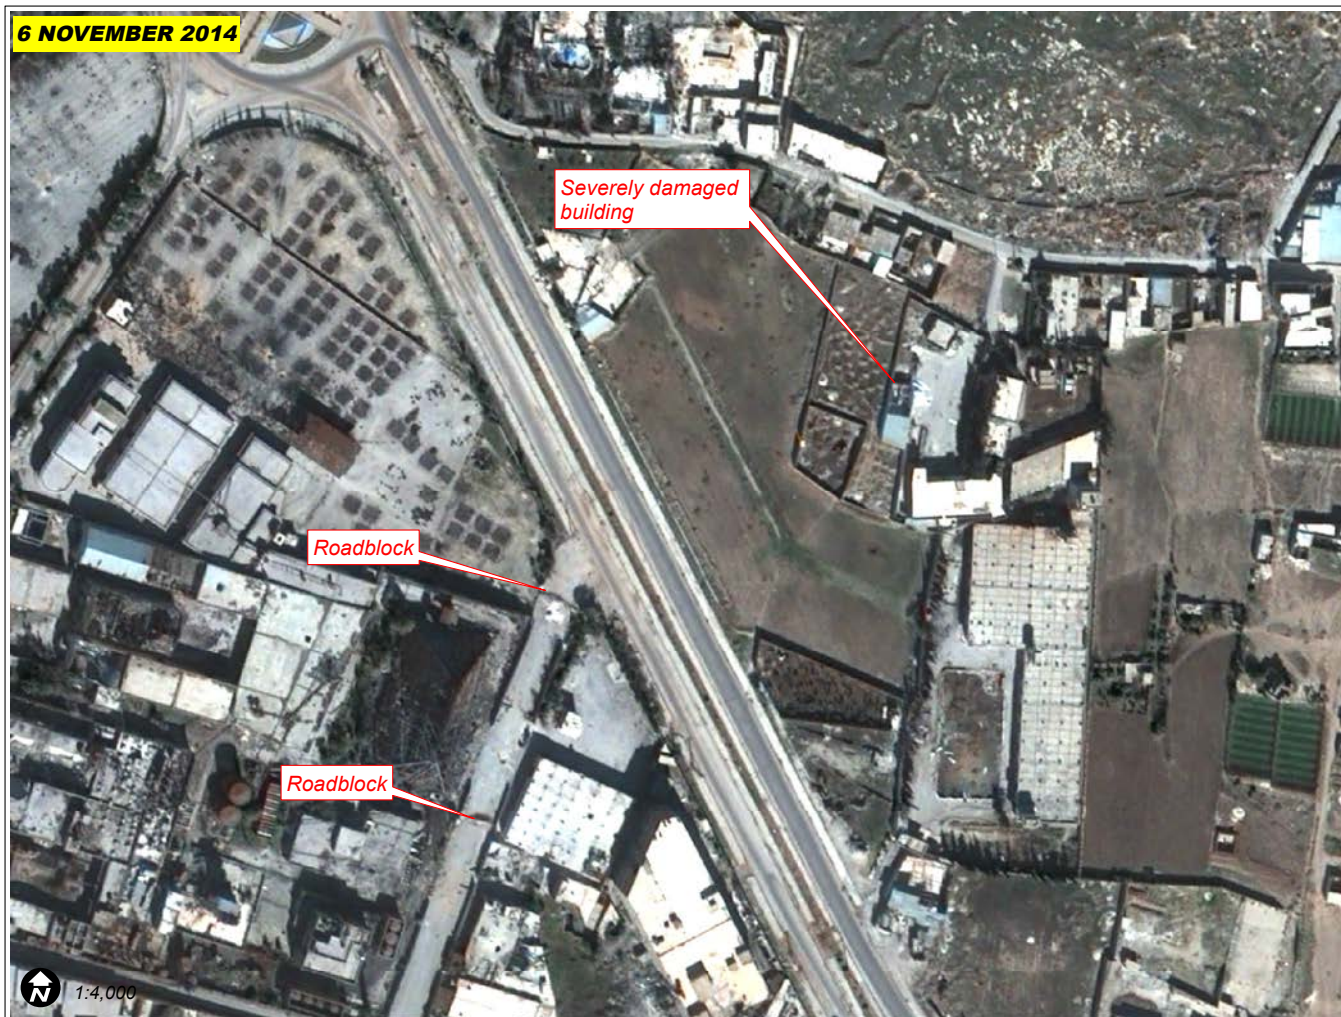
Center Coordinates:
37°10'30.75"E 36°14'46.35"N

The image shows a severely damaged building at Owaija neighborhood. Roadblocks are also visible in the area indicating that the area is affected by access constraints.

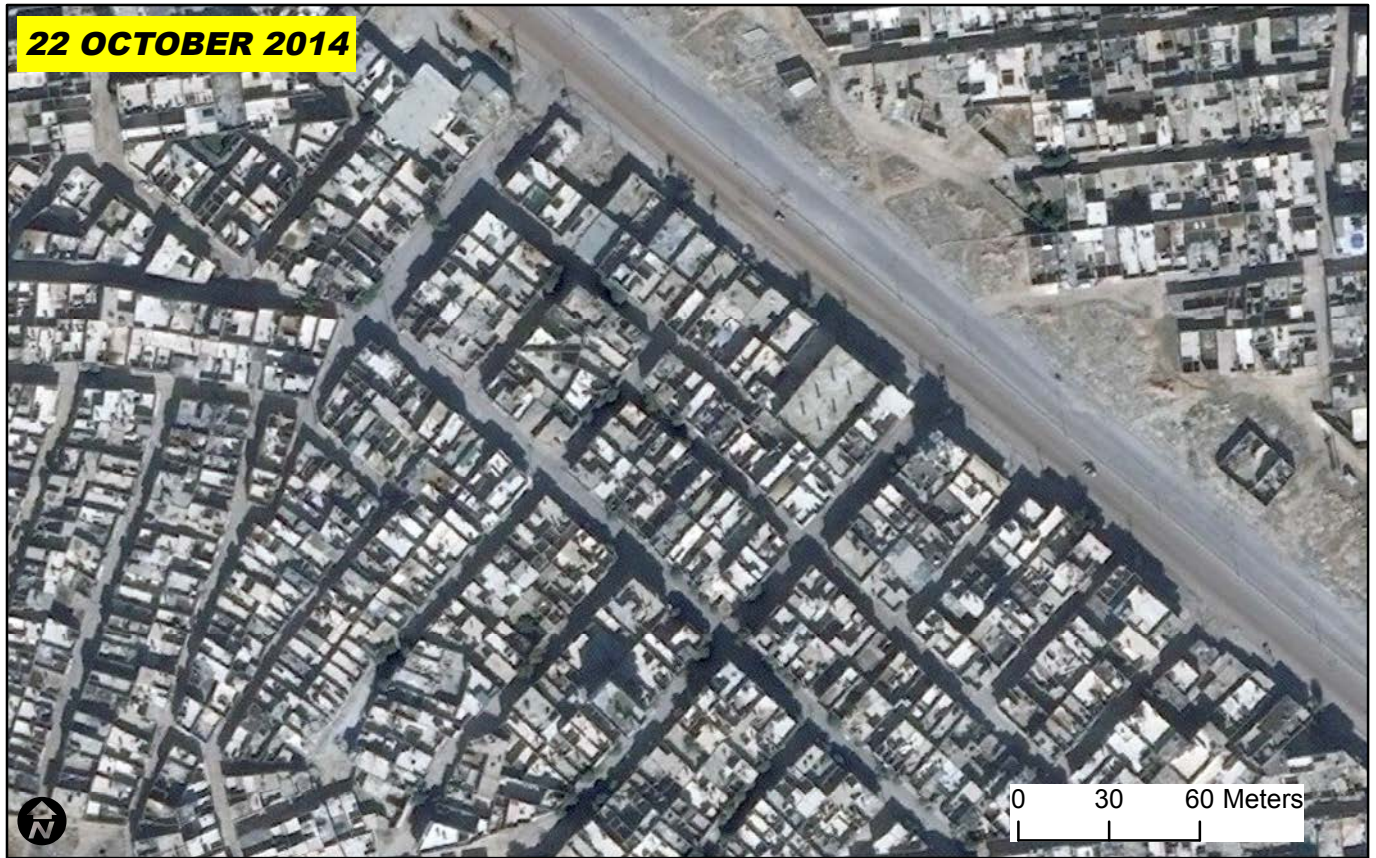
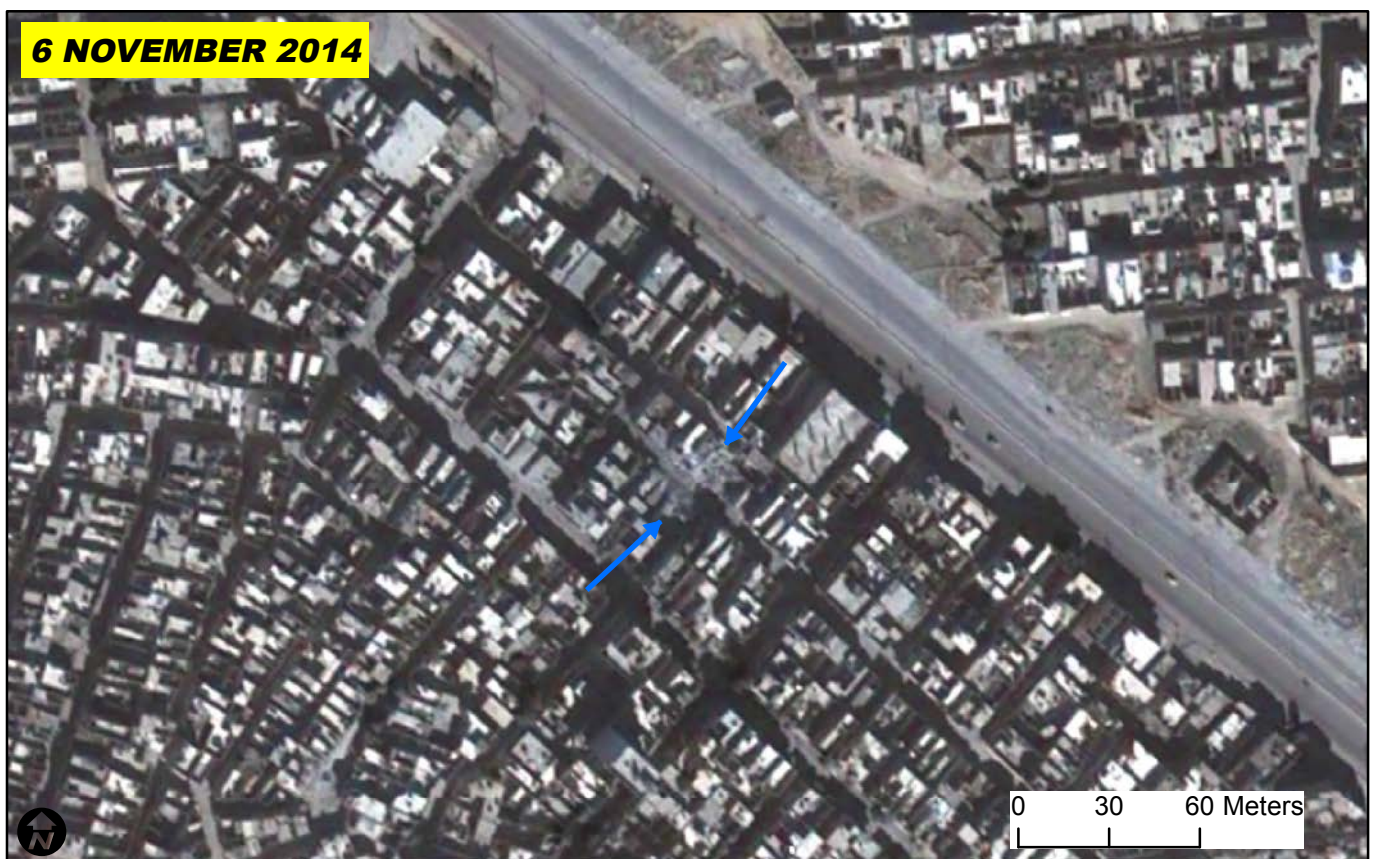
Figure 1: Destroyed structures in Aleppo

The figure shows a portion of Ba'aiedin neighborhood, Aleppo where several buildings appear destroyed or severely damaged (blue arrows). This damage is similar to that observed from air strikes or barrel bombing. Images copyright 2014 Airbus Defence and Space and DigitalGlobe Inc.

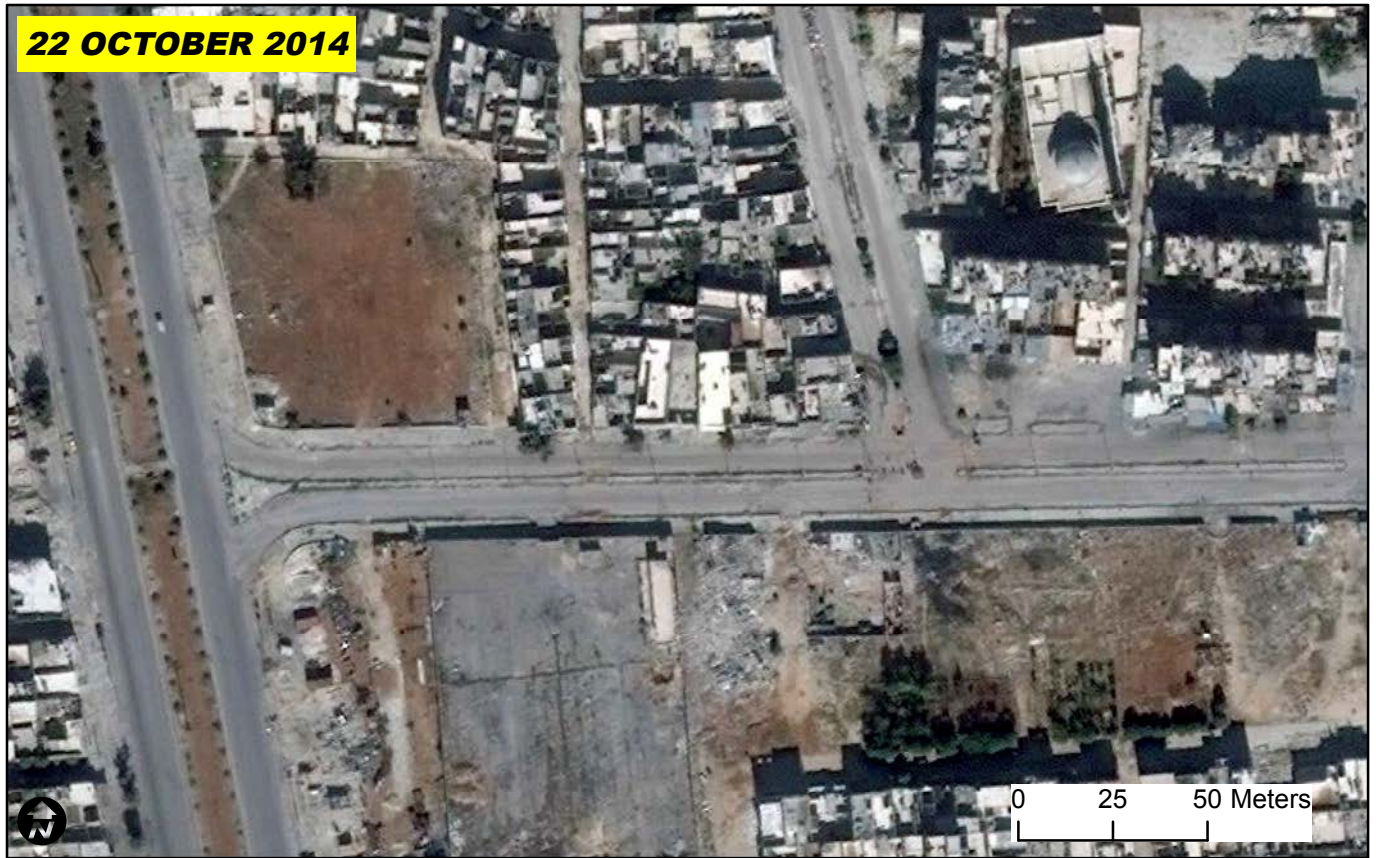
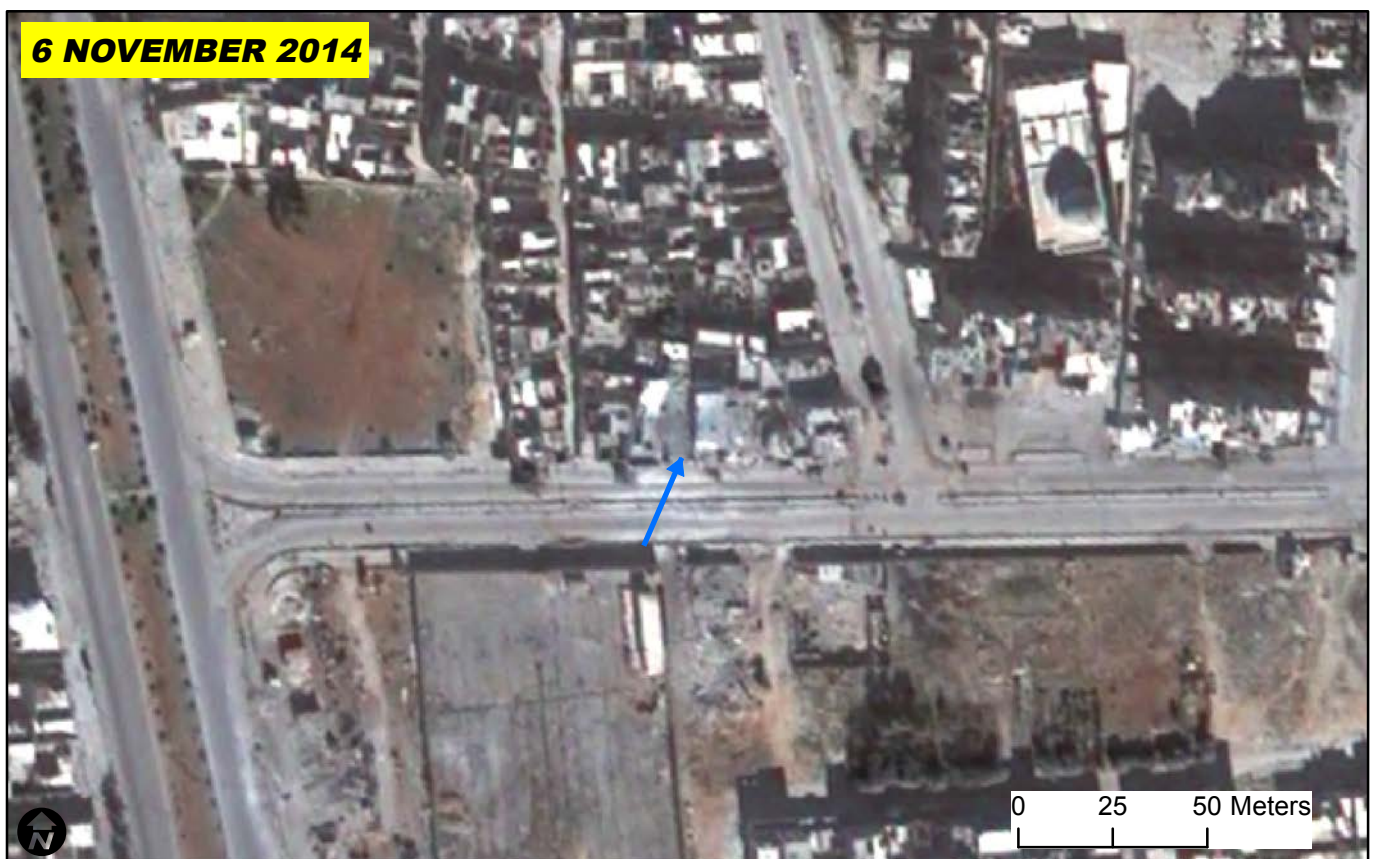
Figure 2: Severely damaged structures in Aleppo

The figure shows a portion of Hanano neighborhood, Aleppo where a few buildings appear severely damaged (blue arrow). This damage can be caused by artillery and direct fire from tanks and other armored vehicles. Images copyright 2014 Airbus Defence and Space and DigitalGlobe Inc.

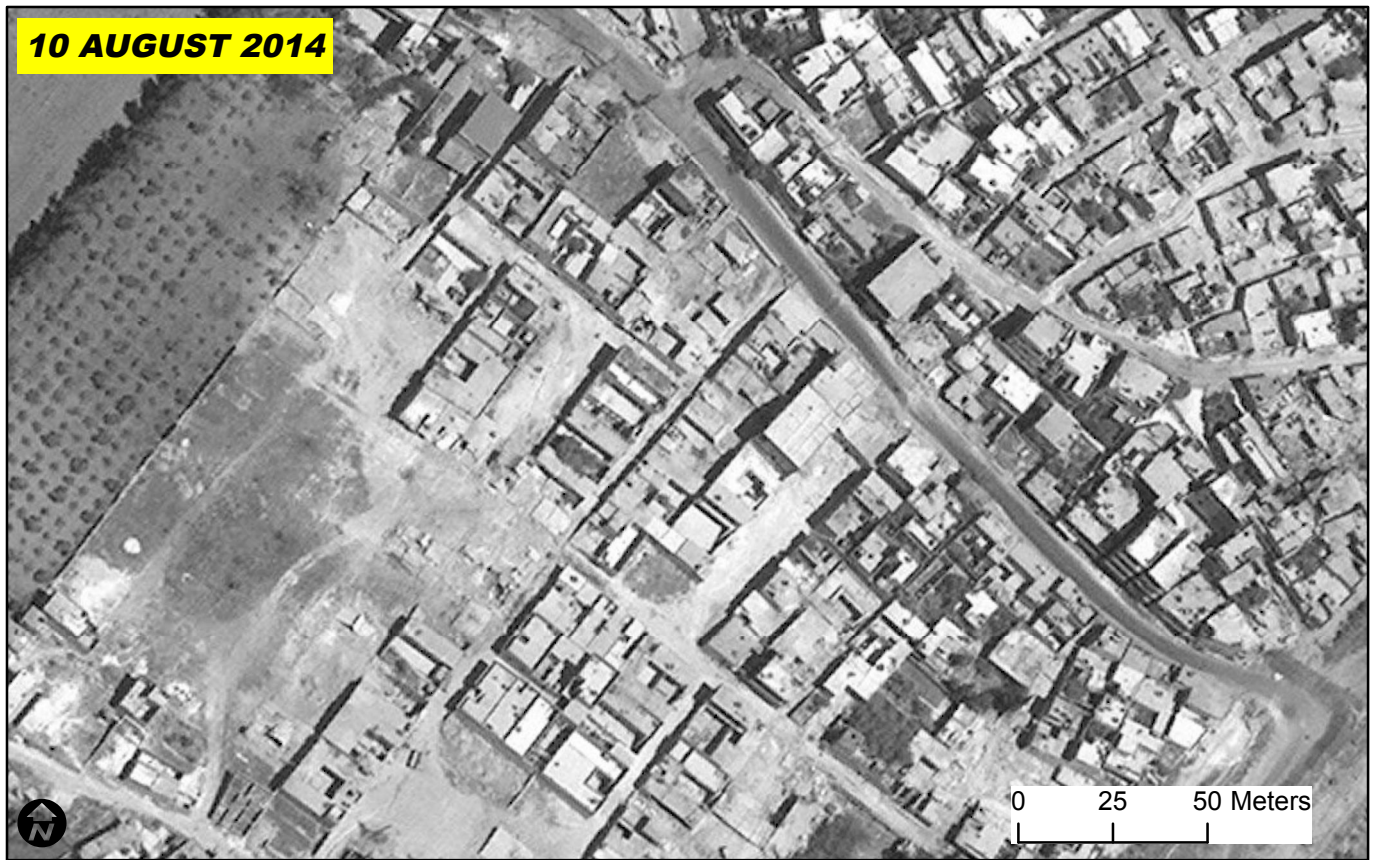
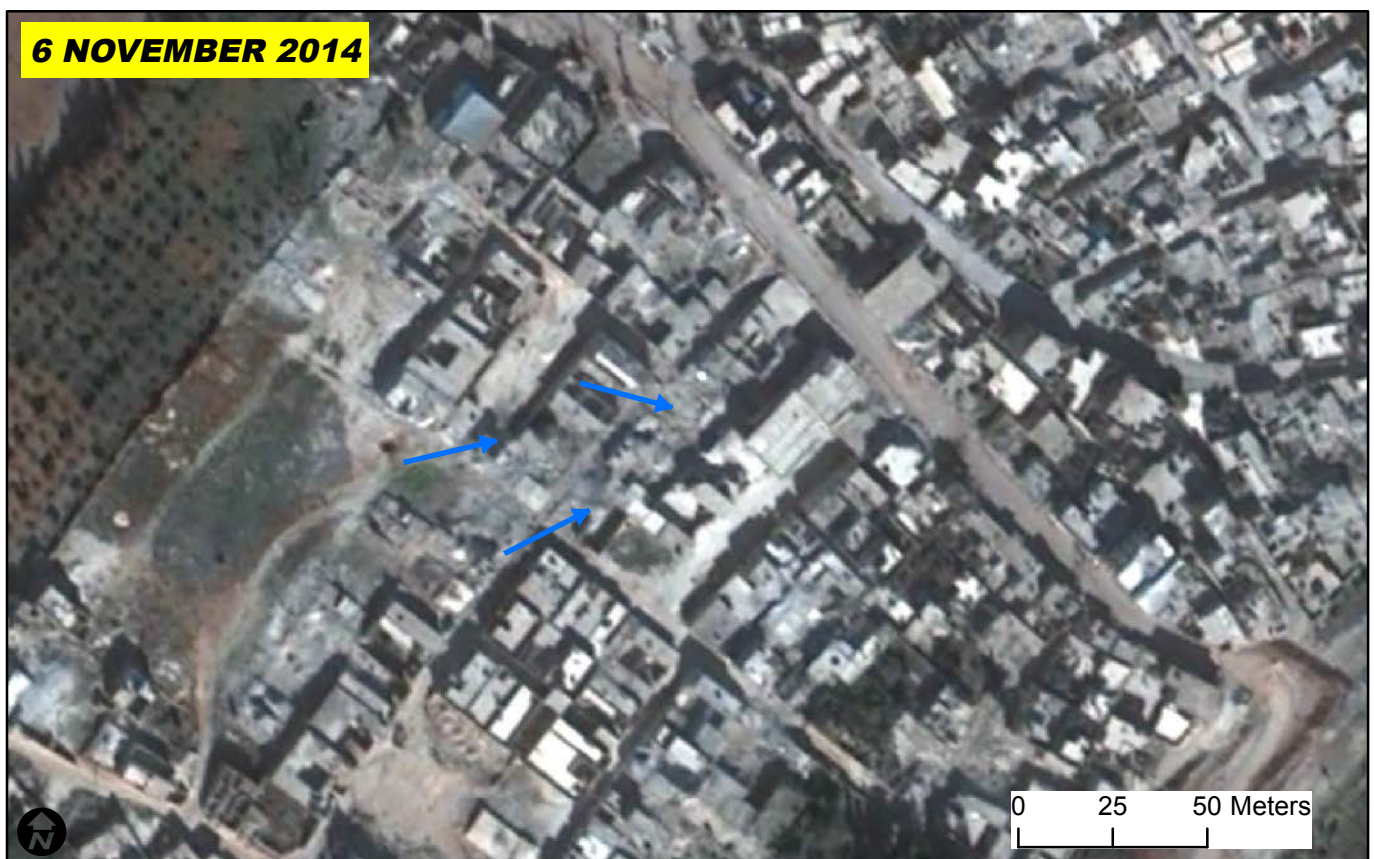
Figure 3: Destroyed structures in Aleppo

The figure shows a portion of Handarat District, north of Aleppo. Imagery shows several destroyed or severely damaged buildings in the area (blue arrows). Numerous impact craters on the fields surrounding the area are also visible. Images copyright 2014 Airbus Defence and Space and DigitalGlobe Inc.

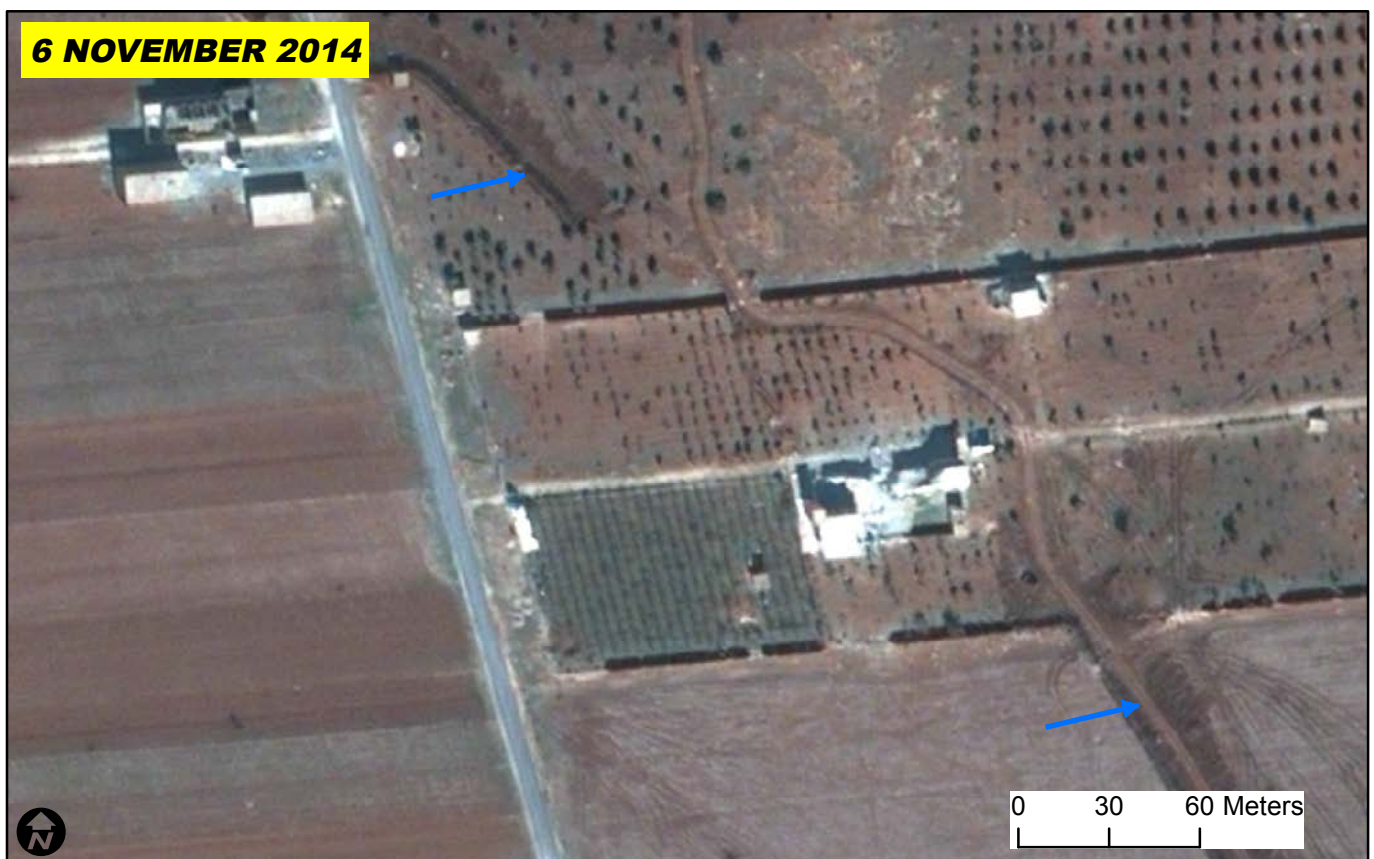
Figure 4: Fighting positions and access constraints

The figure shows new fortified fighting positions visible north of Handarat. Roadblocks and fighting positions on the roads of North Aleppo have not changed in recent months, though new fighting positions are visible north of Handarat and Mazra'a Halabi. There is some vehicle traffic visible in northern Aleppo city but the main road that connects Handarat and Aleppo has no traffic. Images copyright 2014 Airbus Defence and Space and DigitalGlobe Inc.
