# Four Years of Human Suffering

The Syria conflict as observed  
through satellite imagery

United Nations Institute for Training and Research

UNOSAT

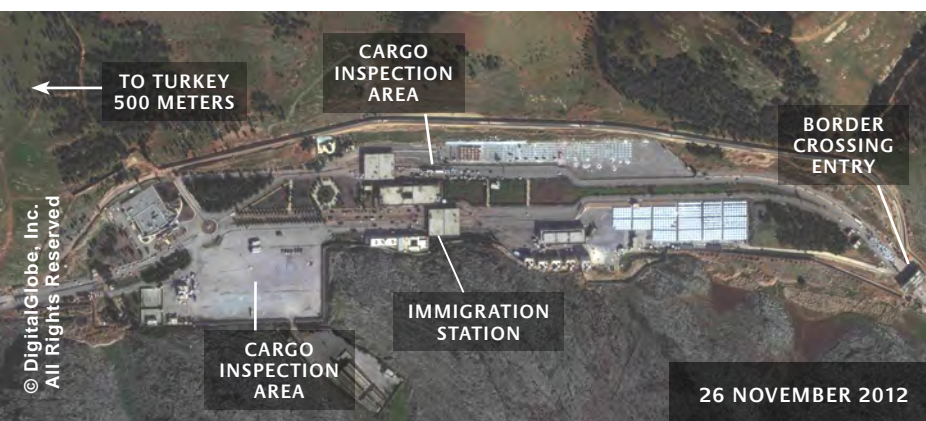
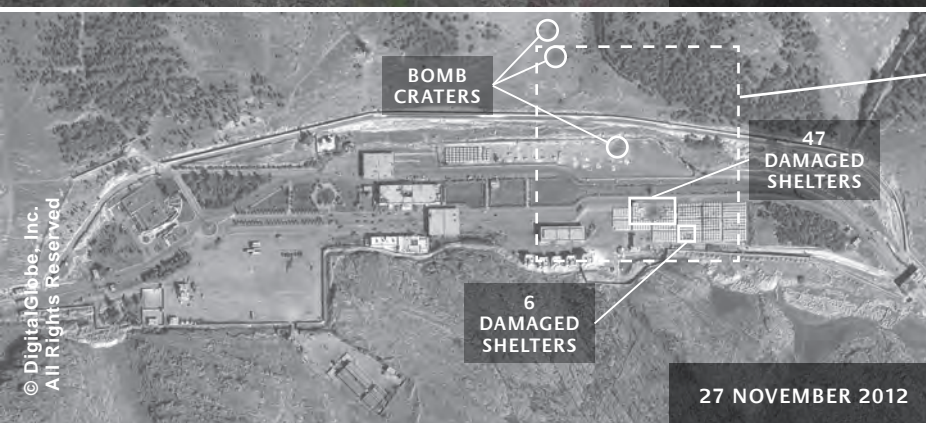
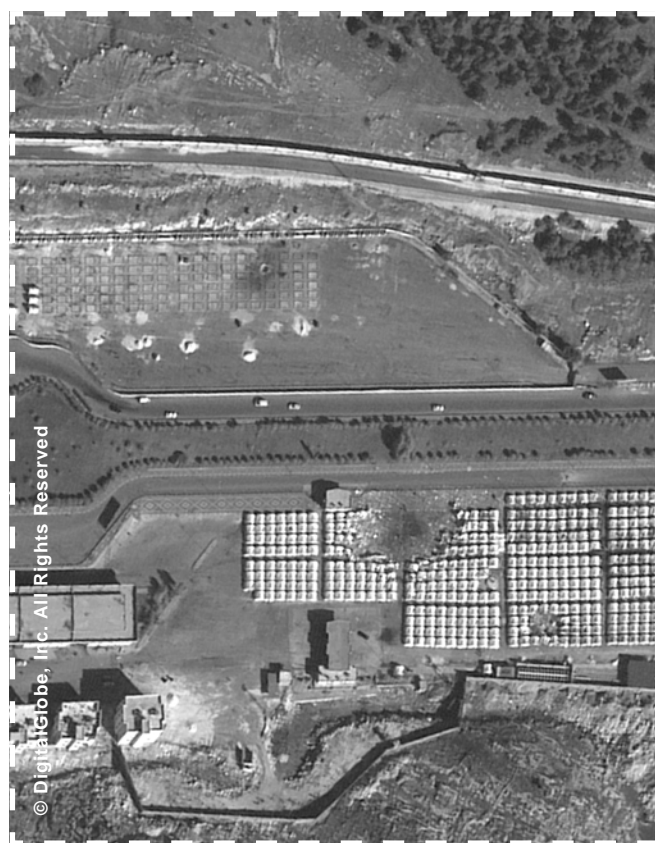
**FIGURE 6**

The Bab-al Hawa border crossing was bombed on 26 November 2012. A temporary settlement for internally displaced persons (IDPs) at that location houses people waiting to cross into Turkey as refugees. A total of 596 shelters for the IDPs are visible in the satellite image acquired on 26 November 2012, prior to the reported bombing. In an image acquired the next day, on 27 November, a crater and blast area, measuring approximately 40 meters across, is visible on the northwest portion of the settlement, with a second crater located 127 meters northwest and outside the IDP settlement area, see Figure 6. A total of 47 shelters are seen to be damaged or destroyed on 27 November within the IDP settlement and an additional six shelters located 70 meters southeast of the crater are likewise damaged or destroyed. The source of the damage and destruction for these latter six shelters is unclear but almost certainly related to the bombing and perhaps due to debris or shrapnel. Most likely, surrounding tent shelters are damaged as well. Additional possible munitions impacts are visible elsewhere in the image.

The Bab al Hawa IDP camp with craters and blast area visible as of 27 November 2012, a consequence of a reported airstrike.

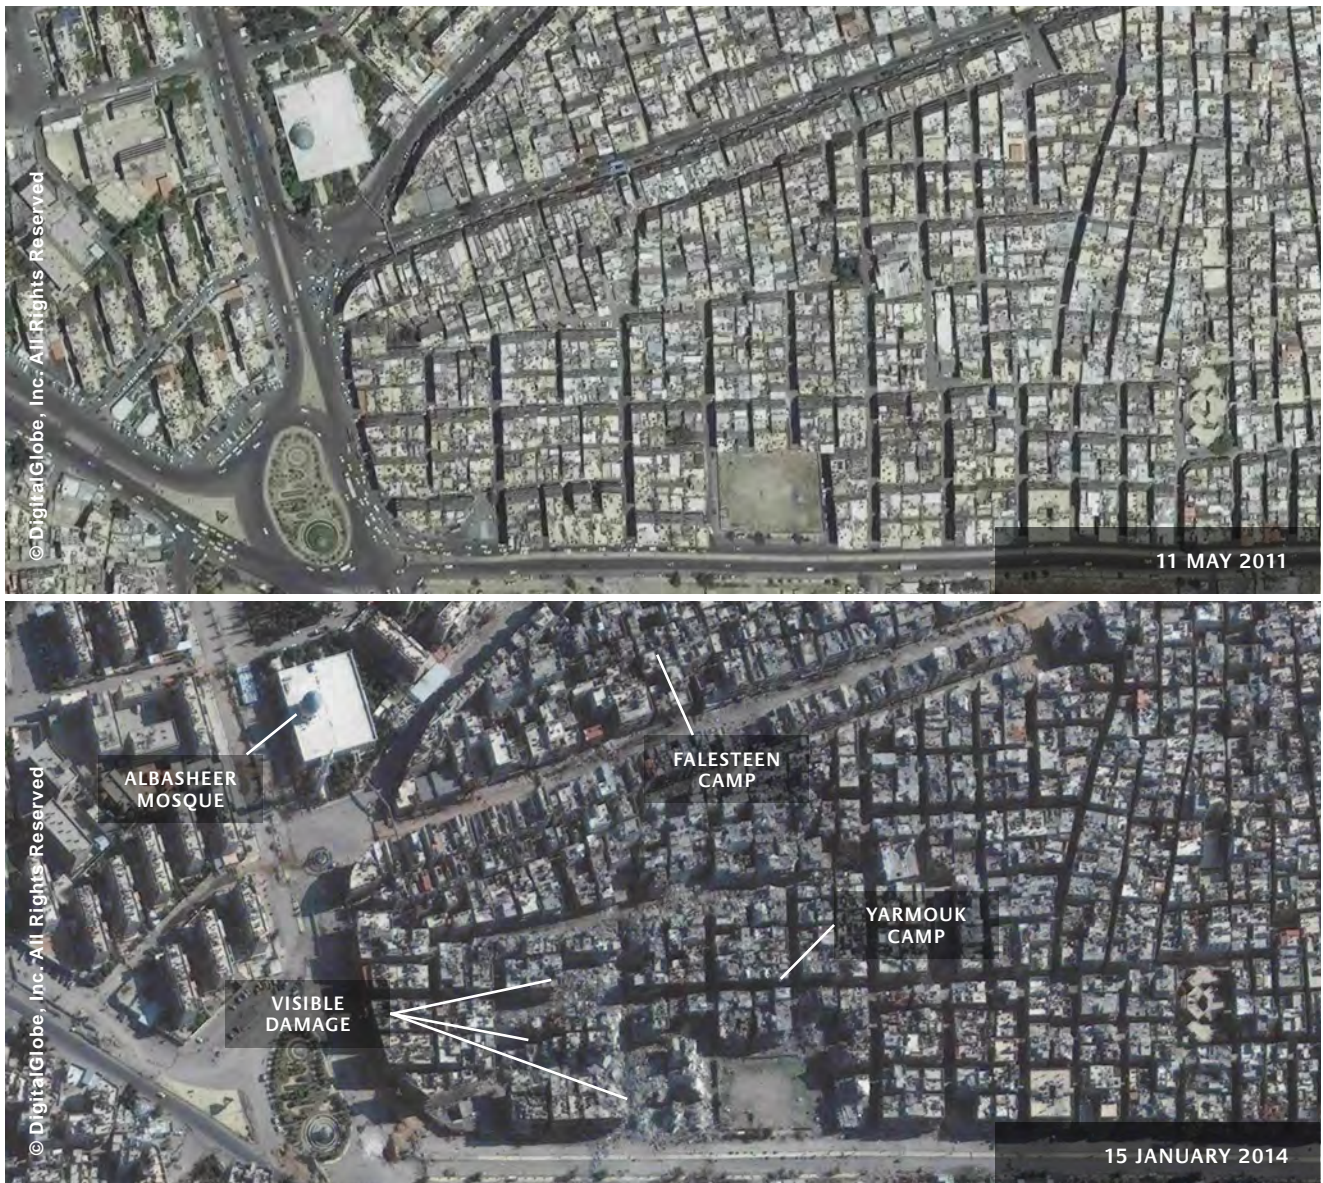
**FIGURE 7**  
Destruction in Yarmouk  
refugee settlement, Damascus.

Yarmouk Camp is a district of Damascus and is considered as an unofficial refugee camp that shelters more than 18,000 Palestinian refugees. As requested by UN OCHA and in support to Security Council resolution 2139, UNOSAT has performed multiple security analyses to monitor the situation in Yarmouk, and specifically whether it is accessible for humanitarian assistance. As seen in Figure 7, imagery from 15 January 2014 clearly show Yarmouk as besieged, with numerous roadblocks and security controls along strategic roads and controlling access to the district. Such roadblocks and checkpoints were used to restrict all traffic into the area, including humanitarian resupply, leading to deplorable conditions within Yarmouk including shortages of food, medicines, and other essential items. Due to conflict between the Syrian government and opposition forces inside Yarmouk damage was also heavy in specific areas. Damage from bombing and shelling has reduced multiple buildings in Yarmouk to rubble, with damage along its primary road to Damascus observed as extreme.

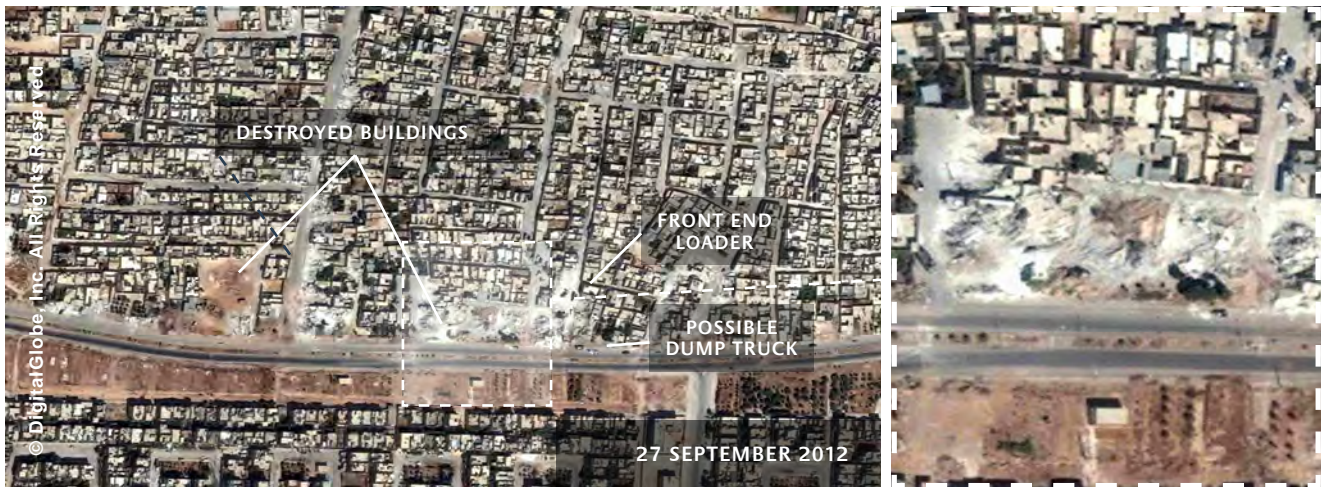
**FIGURE 8**  
The presence of heavy vehicles on 27 September 2012 as they began to raze the neighbourhood of Masaa Al Arbaeen.

The images seen in Figures 8 and 9, depict the results of the demolitions that occurred in Masaa Al Arbaeen Hama's district between 27 September and 23 October 2012. Imagery collected on 27 September 2012 shows heavy vehicles, including dump trucks and heavy equipment such as bulldozers and front-end loaders, as they began to raze the neighborhood. Residents living in this area were perceived as sympathizing with the opposition.

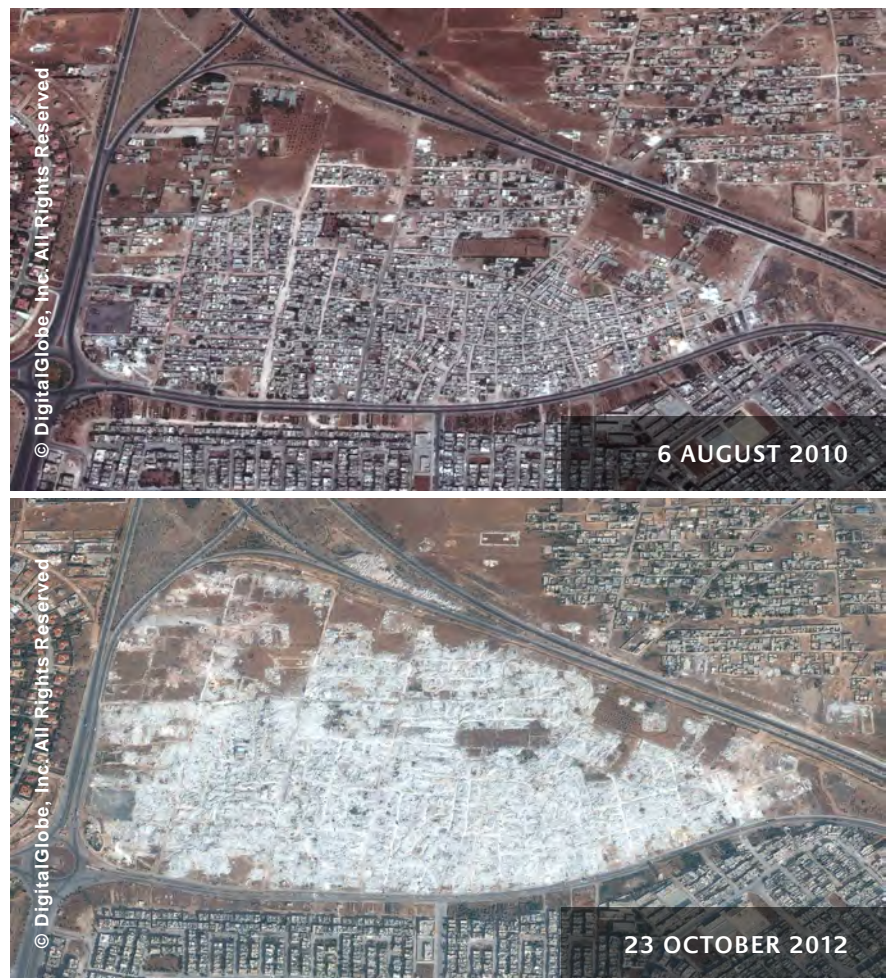
**FIGURE 9**  
The Masaa Al Arbaeen neighborhood of Hama was razed between 27 September and 23 October 2012, affecting a total of 3,256 buildings.

The Masaa Al Arbaeen Hama's district was then systematically razed over the following month. As of 23 October 2012 the whole of the district is demolished, affecting a total of 3,256 buildings that were reduced to rubble.

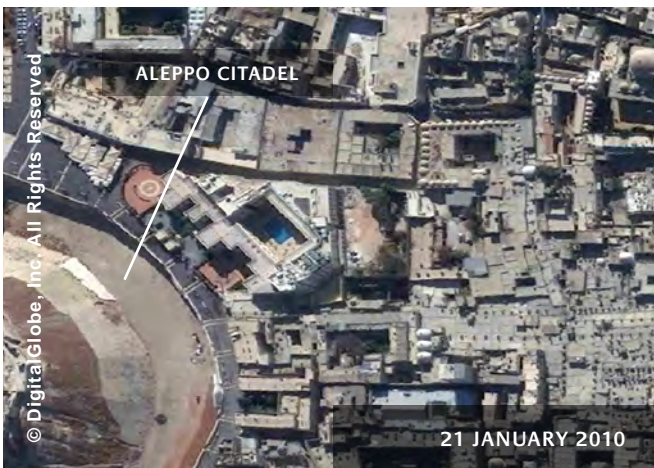
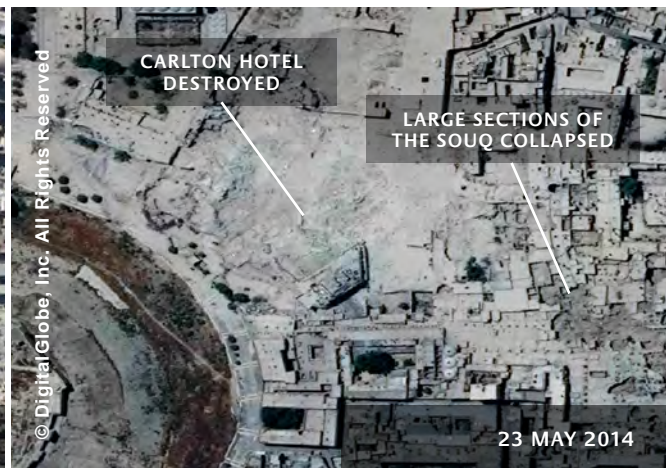
Overview of damage over a portion of Aleppo close to the Old Citadel with large craters visible. Several structures and a large section of The Souq appear collapsed.

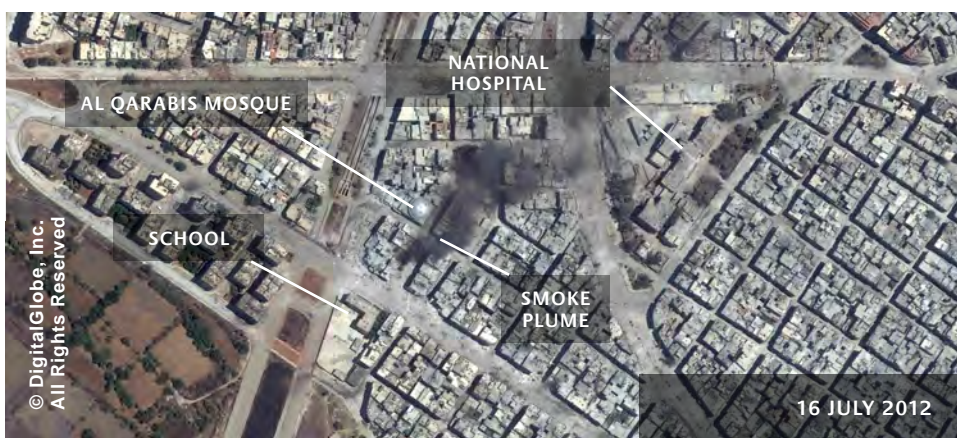
**FIGURE 15**

Imagery from 16 July 2012 collected at 14:17 local time in Homs shows a smoke plume in a residential area, near Al Qarabis Mosque, in the Al Qarabis neighbourhood of Homs, see Figure 15. Inside a military base southeast of Homs city artillery pieces are visible. The approximate fire bearing of the individual artillery pieces in that base were calculated and subsequent preliminary fire cones were generated, see Figure 17. The trajectory described for the artillery bearing intersects with the smoke plume next to the Al Qarabis Mosque, located about 18 km away from the artillery batteries. A subsequent image collected on 14 September 2012 shows repositioning of several artillery pieces, a possible indicator that the artillery unit inside the military base was active and targeting other areas of the city as well. Additionally, military resupply activity was visible in the area as well. Two ammunition resupply trucks were visible on 16 July 2012 but not in the subsequent image, see Figure 16. Multiple other military sites are placed around the city of Homs, especially in the south eastern part of the city, as well as missile sites and other types of armament such as mortar batteries.

A smoke plume in the Al Qarabis neighborhood of Homs as of 16 July 2012.

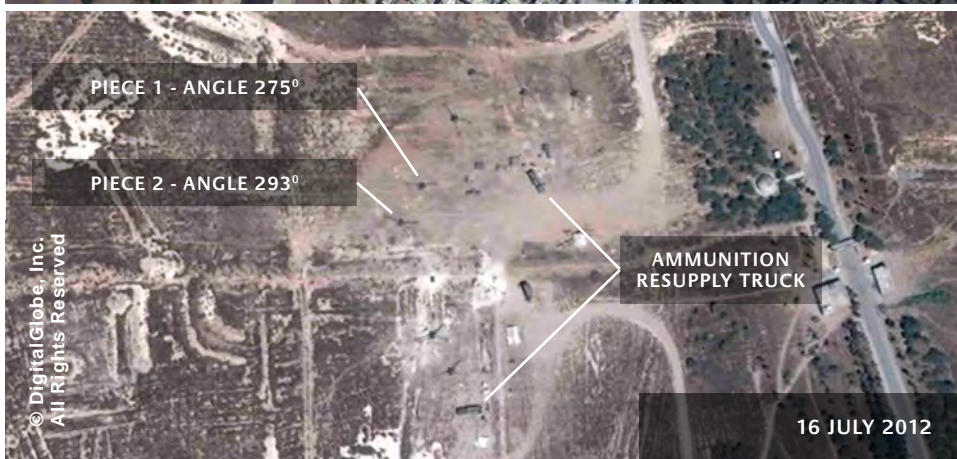
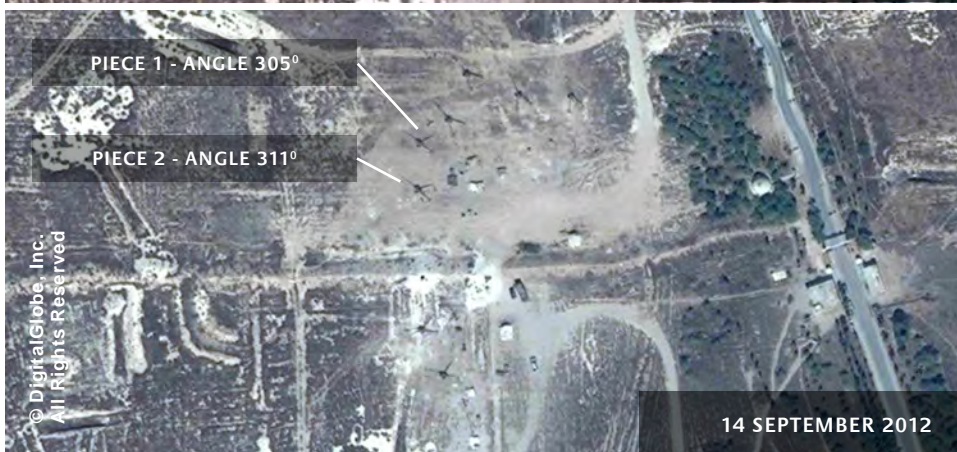
**FIGURE 16**

Two artillery pieces from an artillery battery adjusted their firing angle between 16 July 2012 and 14 September 2012.

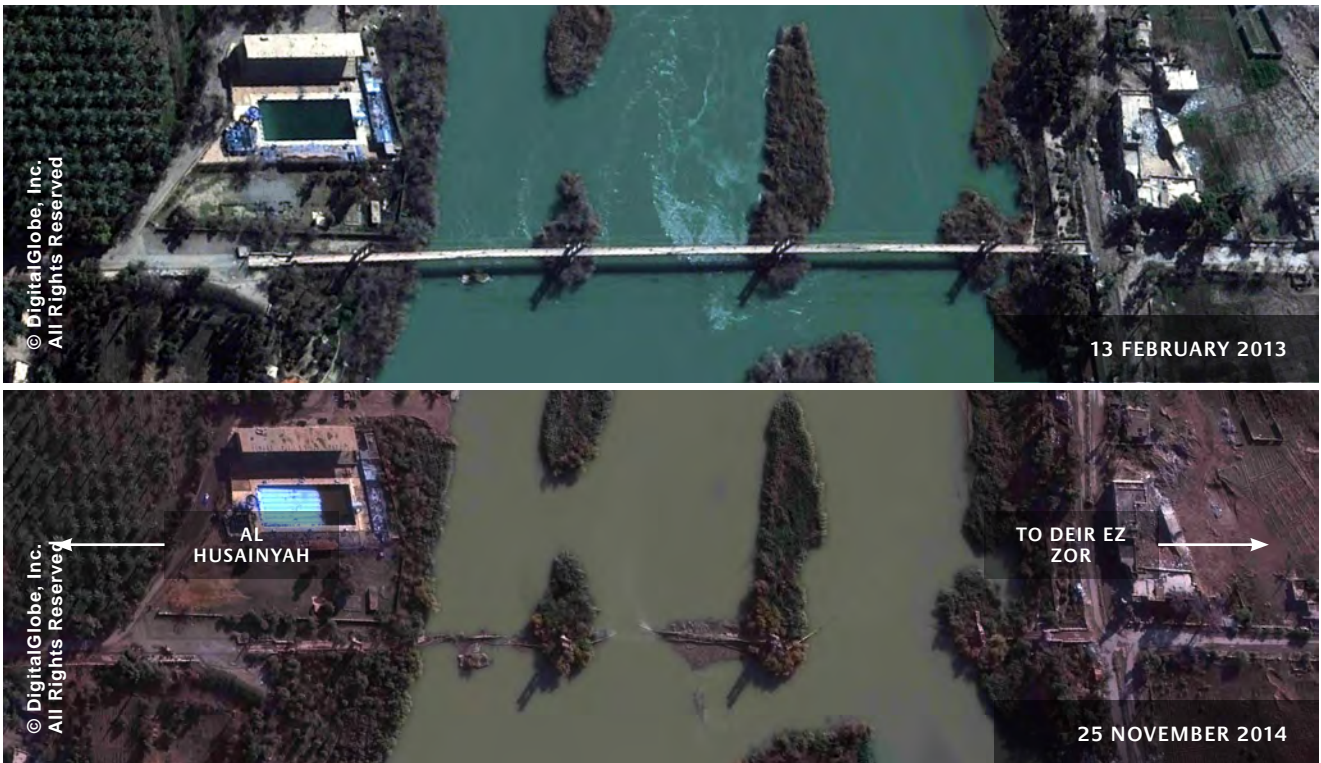
On the 2nd of May 2013 in Deir Ez Zor City, the historic pedestrian suspended bridge across the Euphrates River was reported as completely destroyed by shelling. Imagery from 25 November 2014 confirmed the destruction of the bridge, which severed communication to the neighborhood of Hasakeh, cutting off the access to an estimated 50,000 people. The same image indicates the nearby Syasiyeh Bridge, designed for vehicle traffic, was also destroyed.

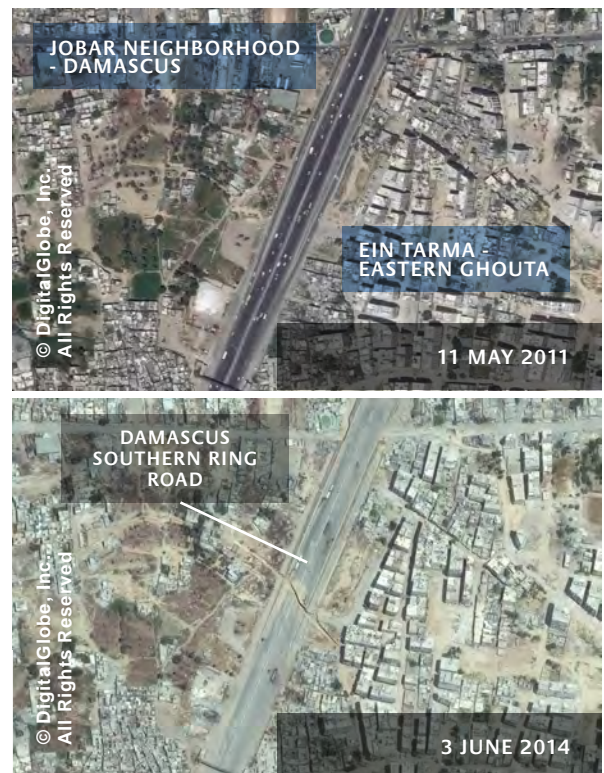
**FIGURE 22**  
Heavy damage to the Damascus Southern Ring Road that impedes vehicle traffic in the area.

Imagery collected on 3 June 2014 shows extensive damage to the Damascus Southern Ring Road that makes it impassable for normal vehicle traffic, see Figure 22. This damage to the road acts as a barrier, compromising communication between Jobar neighborhood (Damascus) and the besieged area of Ein Tarma, Eastern Ghouta. Vehicle traffic is also completely absent along this highway on 3 June 2014 and the surrounding roads, and numerous roadblocks and checkpoints are visible in the area. UNOSAT analyzed the Eastern Ghouta area multiple times to document barriers to humanitarian access and damage to civilian areas.

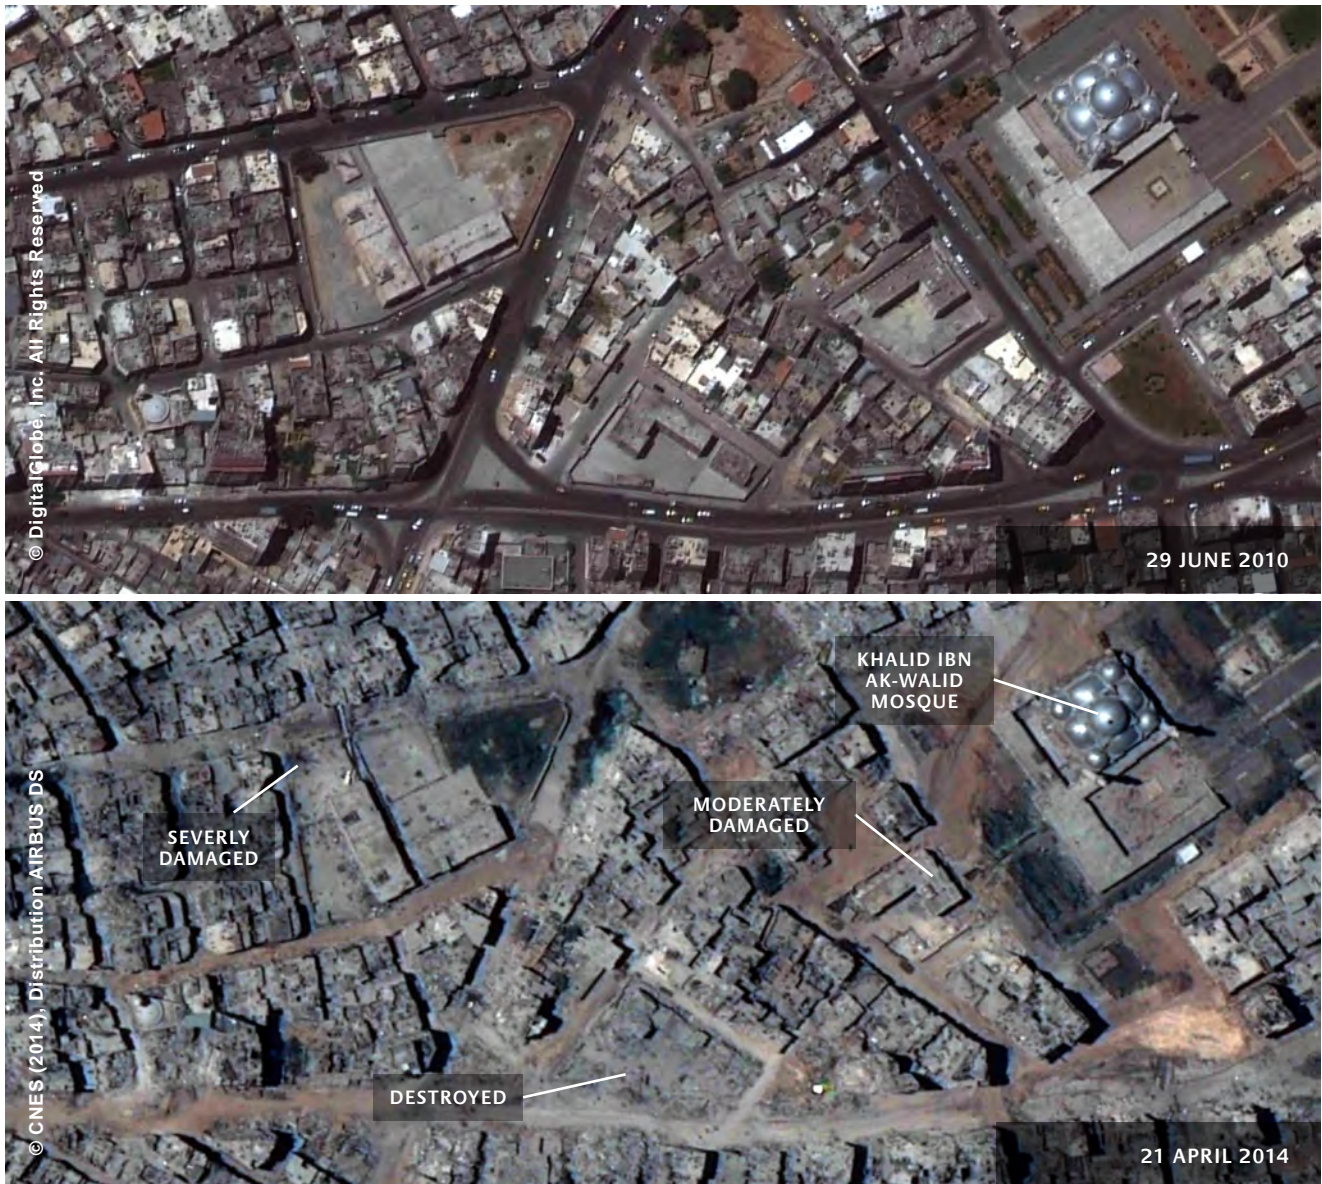
**FIGURE 23**  
Widespread damage that affects three educational facilities in the Al Hamidiyah neighborhood of Homs.

As a result of the comprehensive shelter damaged assessment carried out in the city of Homs, UNOSAT found damaged educational facilities in the neighborhoods of Akrama, Al Bayadah, Al Hamidiyah, Al Khaldiyah, Al Qarabis, Al Waer, Bab Amr, Bab Al Dreib, Bab Houd, Deir Ba Alba, Groves, Jobar, Karm Al Zeitun, Karm Shamsham, Old City, and the Walid Suburb. This imagery from 21 April 2014 shows three educational facilities in the Al Hamidiyah neighborhood that show different levels of damage: moderate, severe, and one facility that appears completely destroyed, see Figure 23. The area around the “Khalid ibn al-Walid Mosque”, one of the most famous mosques in Homs and located in the Al Hamidiyah neighborhood, has been a target of numerous attacks since the Syria conflict started.

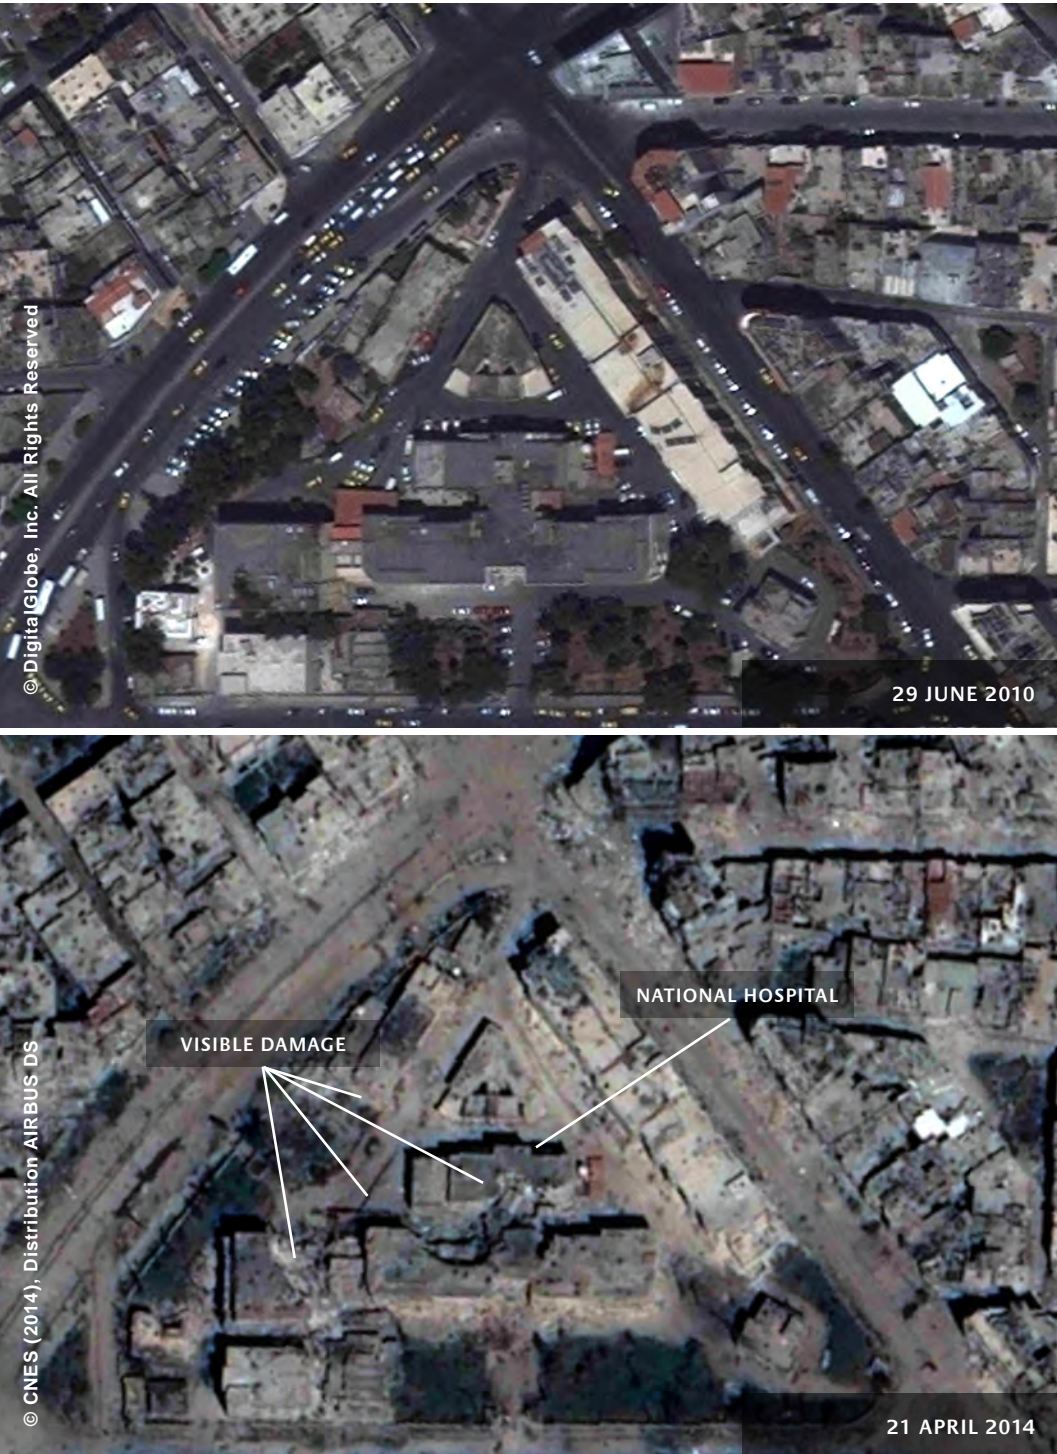
**FIGURE 24**  
Heavy damage at the National Hospital complex in the Jouret Al Shayyah neighborhood of Homs.

As part of the analysis of the city of Homs, UNOSAT identified a total of 32 damaged health facilities over the neighborhoods of Jouret Al Shayyah, Al Hamidiyah and Al Waer. Fourteen structures were categorized as destroyed, five were severely damaged and 13 indicated moderate damage. Due to numerous attacks during 2012–2013, the National Hospital complex in the Jouret Al Shayyah neighborhood of Homs experienced heavy damage, as did multiple surrounding buildings along Al Korniche Street, visible in imagery acquired 21 April 2014, see Figure 24.

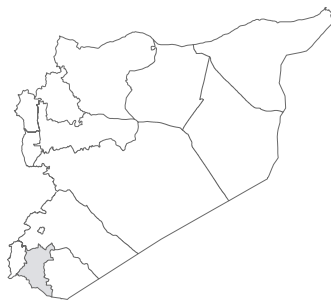
**FIGURE 25**

Damaged structures in Daraa Governorate.

In support of the World Bank and OCHA, UNOSAT conducted analysis to map destruction and damage for areas in the governorate of Daraa. UNOSAT analyzed 24 towns with populations of more than 10,000 people, reviewing 458 square kilometers and detecting a total of 6,268 destroyed or moderately damaged structures and 196 craters on roads, see Figure 25.

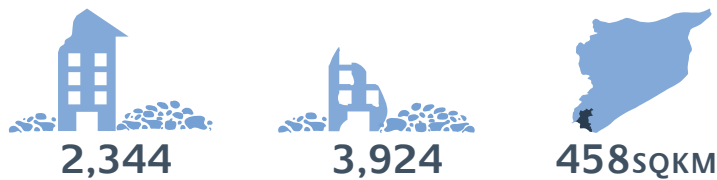
**FIGURE 26**

UNOSAT also analyzed specific features including bridges, educational facilities, government facilities, medical facilities, religious facilities, and cultural sites. Figure 26 shows the National Hospital in Jasim, one of the features assessed by UNOSAT. Satellite imagery collected on 3 March 2014 shows the hospital severely damaged, as well as a proximate electric substation that might affect electricity supply in the area. This hospital has been the scene of heavy fighting in the area due to its strategic position, north of the town, along the road that gives access to the town of Jasim.

Severe damage visible in Jasim's National Hospital and electrical substation.

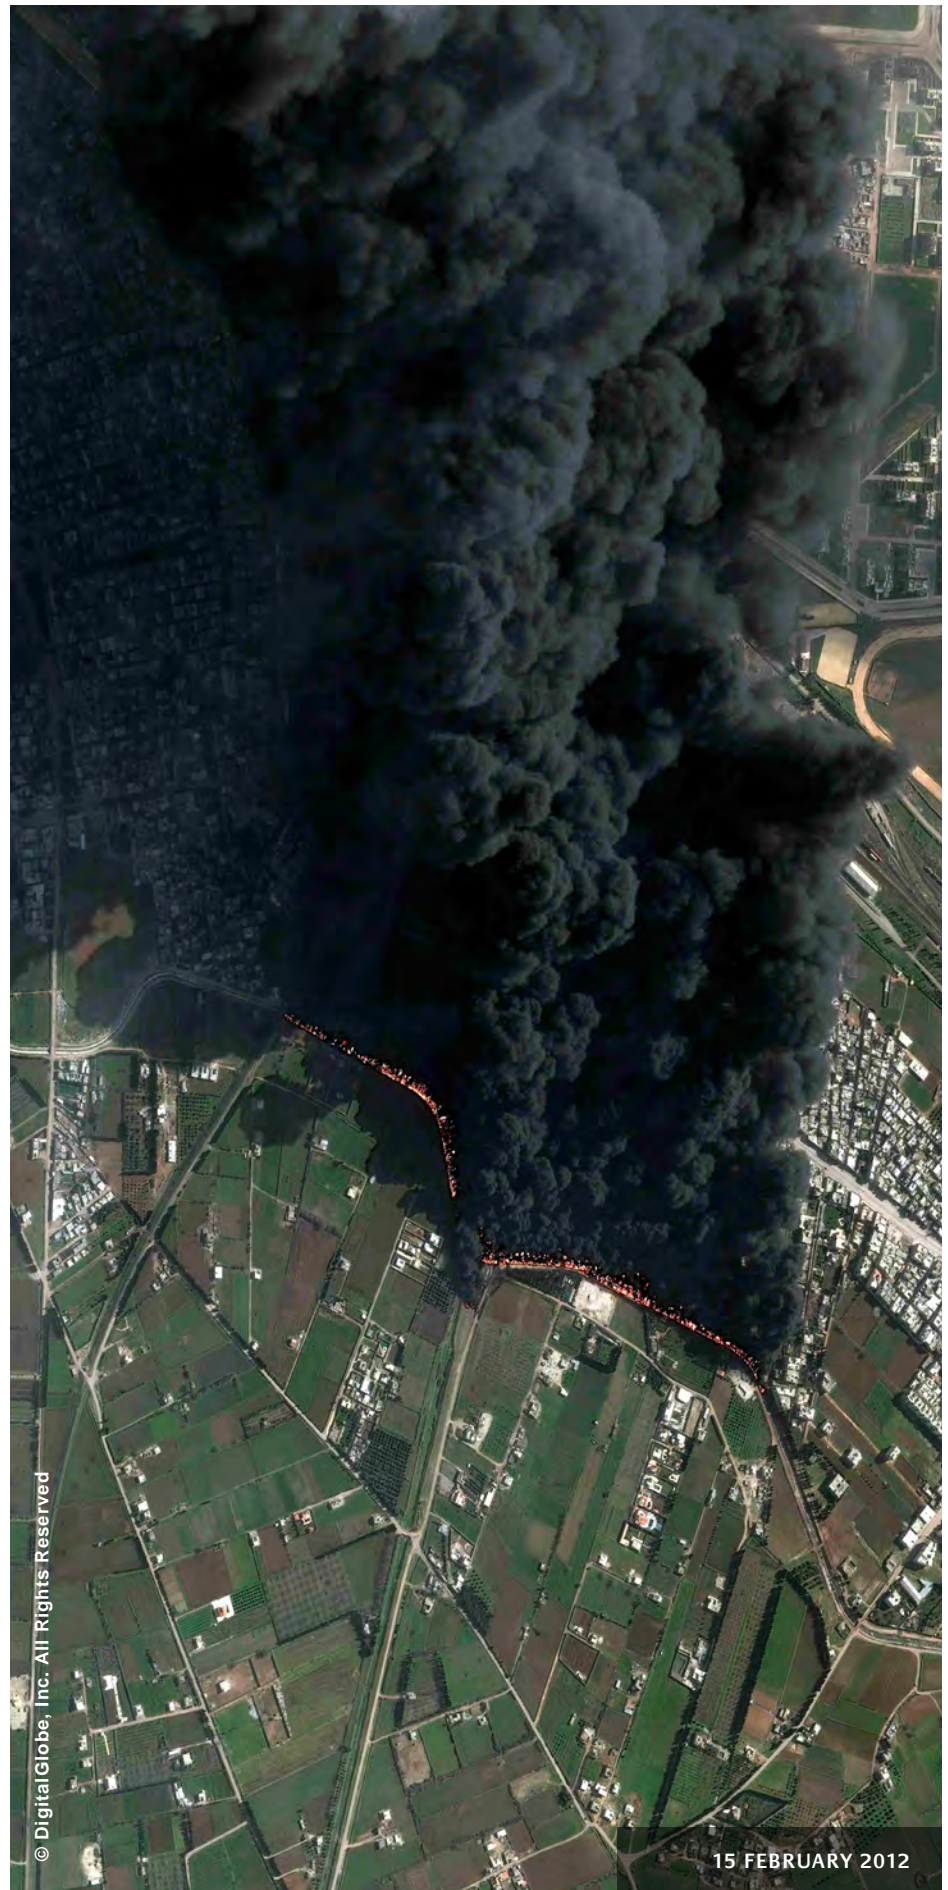
**FIGURE 27**

Imagery from 15 February 2012 shows a large plume of smoke and the oil pipeline on fire due to an explosion on the outskirts of the Baba Amr neighborhood in Homs. This pipeline carries oil to a refinery on the western edge of the Syrian city of Homs.

Damaged oil pipeline on the outskirts of the Baba Amr neighborhood, Homs.

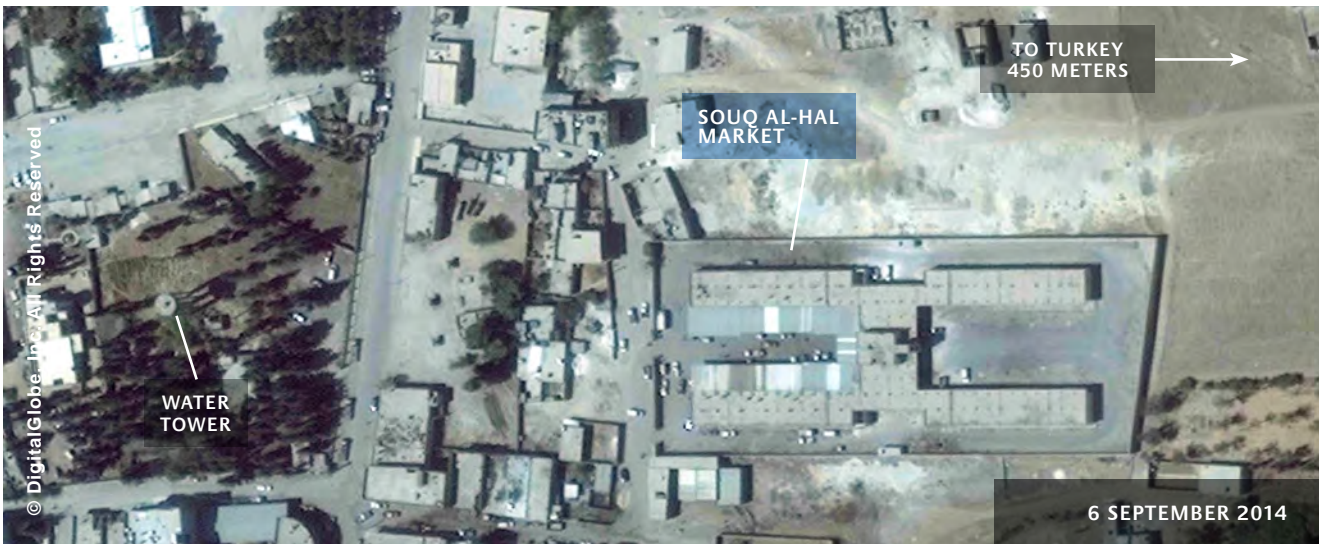
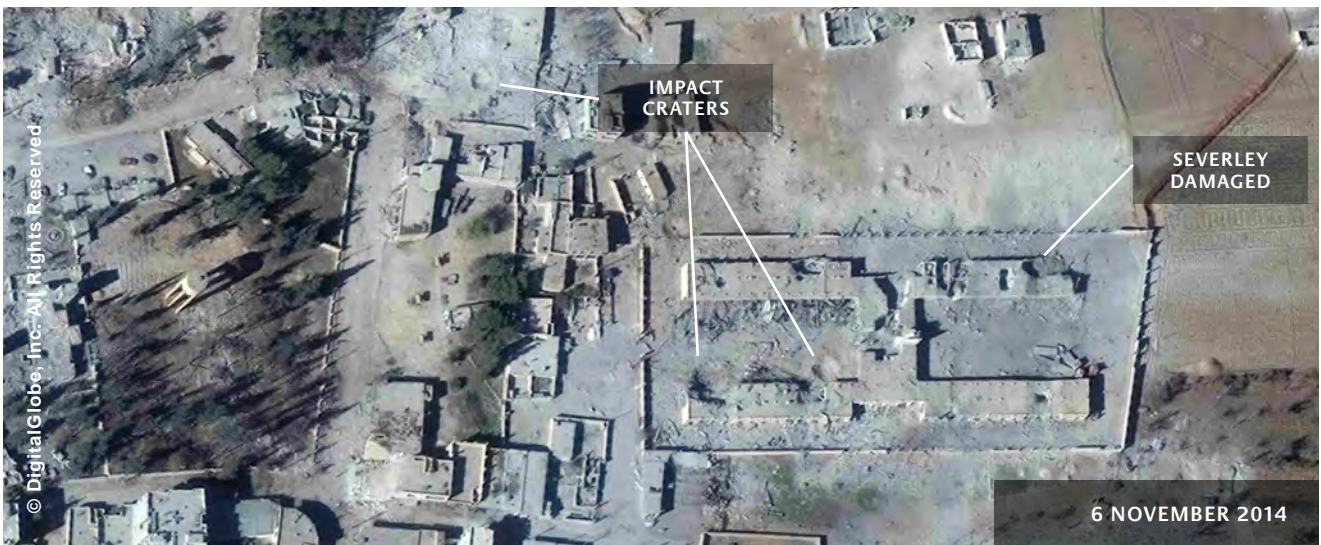
**FIGURE 28**  
Severe damage to the Souq al-Hal market in the northern area of Kobane.

Imagery from 6 November 2014 shows severe damage to the Souq al-Hal market in the northern area of Kobane, just 400 meters from the Turkish military border station. Impact craters are clearly visible inside the market and additional damage is found in the surrounding area, with multiple destroyed and damaged buildings visible, see Figure 28.

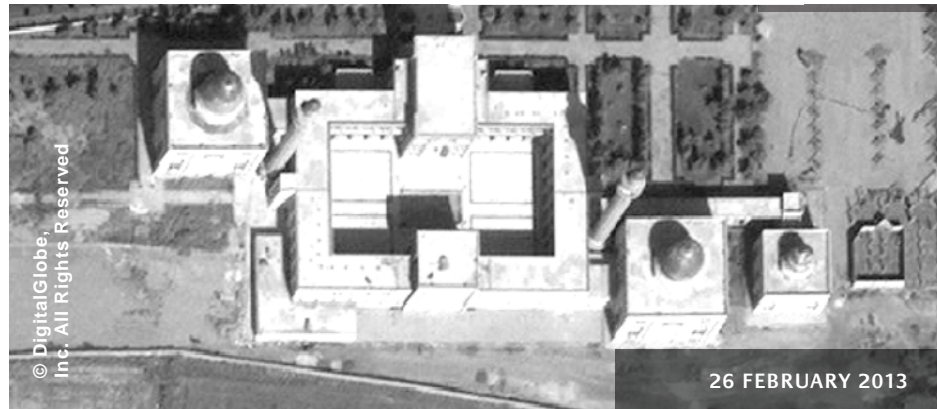
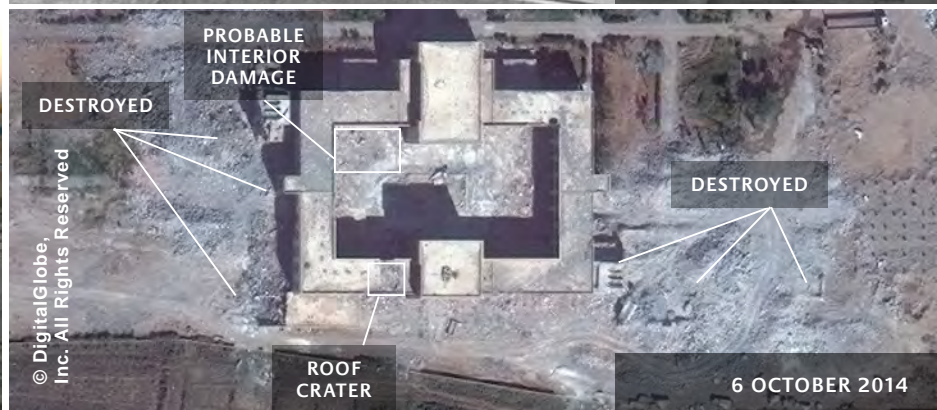
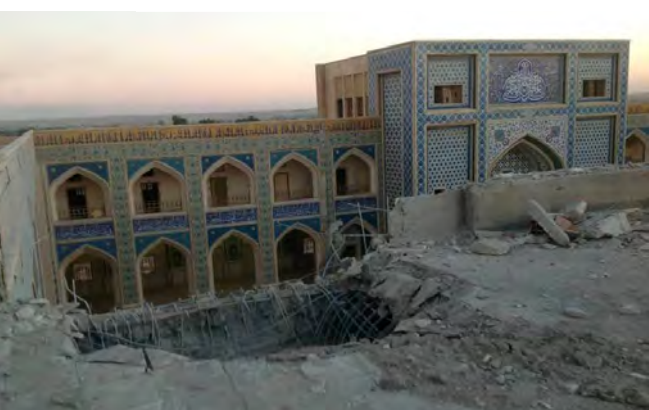
**FIGURE 38**  
Extensive damage to the buildings and structures of the Uwais al-Qarani and Ammar Bin Yasser shrines in Ar Raqqa.

In the city of Ar Raqqa, the Shrine to Uwais Al-Qarani and Ammar Bin Yasser contain the remains of two martyrs from the battle of Siffin (657 AD). Unfortunately, these shrines, including the mosque housing each tomb and the minaret, were found to be severely damaged from explosives, most likely detonated on-site. At the time of the reported detonations, the location was under Da'esh control.

(The Association for the Protection of Syrian Archaeology). Shrine to Uwais Al-Qarani & Ammar Bin Yasser. Crater on the roof of the mosque caused by alleged bombing.

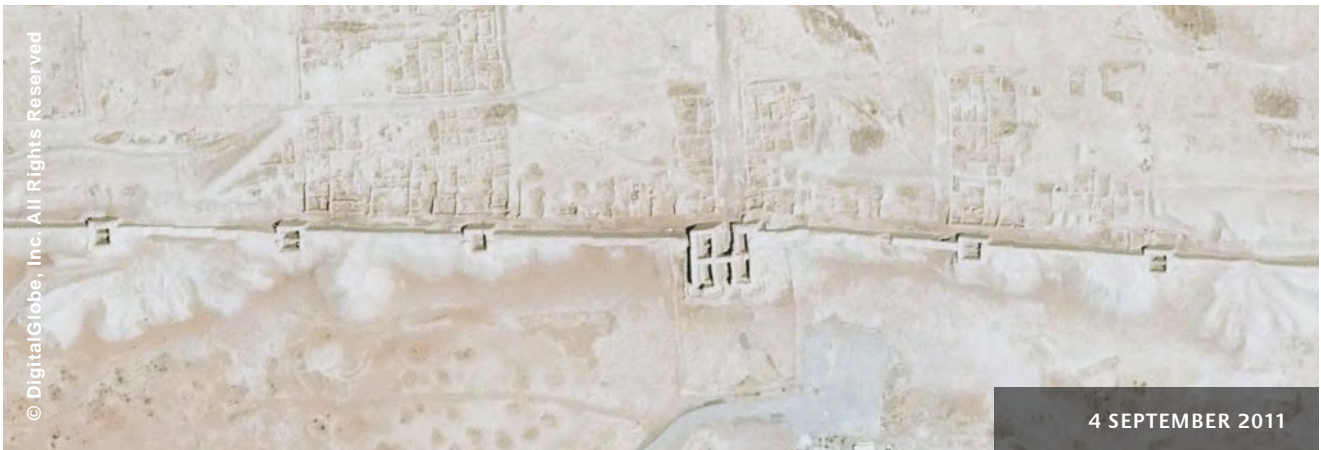
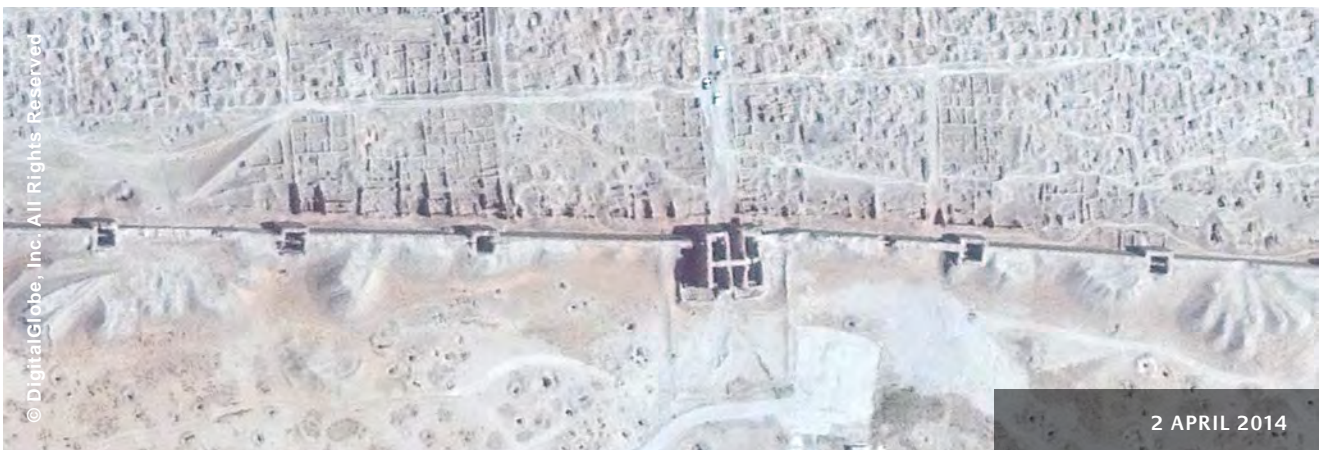
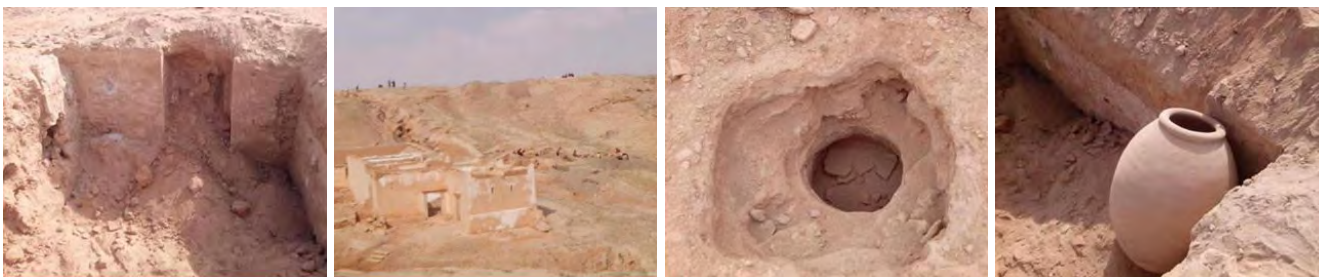
In Dura Europos, an ancient walled city dating back to 303 BC, which was at the time located on the frontier of the East and the West and was part of a series of military colonies setup by Hellenistic, Parthian and Roman ruling forces. It is highly important from an archaeological point of view since the city has not been built over since it was abandoned due to conquest in 256-7 AD. The site has been looted in the past, which was also observed in the imagery from 2009. However, from analysing imagery acquired in 2014, the site is currently subject to extensive looting. This can be observed in thousands of holes dug both over the city and the necropolis located outside of the city walls. Observed looting holes are now larger in diameter, likely dug using earth-moving equipment and drilling machinery. All these activities result in severe damage to Dura Europos.

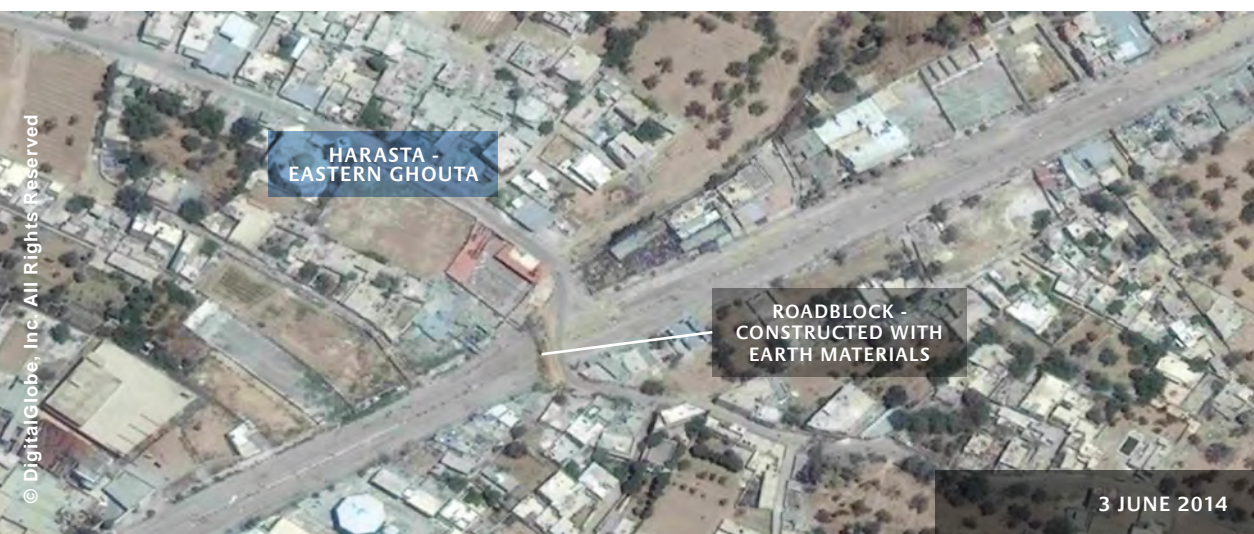
**FIGURE 41**  
Roadblock located on the outskirts of Harasta.

Figure 42 illustrates UNOSAT security analysis for the towns of Harasta and Doma, in Eastern Ghouta, Damascus Governorate. Imagery from 3 June 2014 showed 201 possible roadblocks and 11 possible checkpoints along the roads that connect and give access to these two towns, indicating that the area is besieged. Some of the roadblocks are due to debris caused by heavy damage or craters on the surface of the road which makes them impassable. Figure 40 shows an example of a checkpoint located on the M5 highway. The combination of roadblocks, a chicane barrier and a possible guard post indicate that this is a checkpoint used to control the access to Harasta and Douma. Figure 41 shows a roadblock constructed with earth materials in the outskirts of Harasta.
