# Four Years of Human Suffering

The Syria conflict as observed  
through satellite imagery

United Nations Institute for Training and Research

UNOSAT

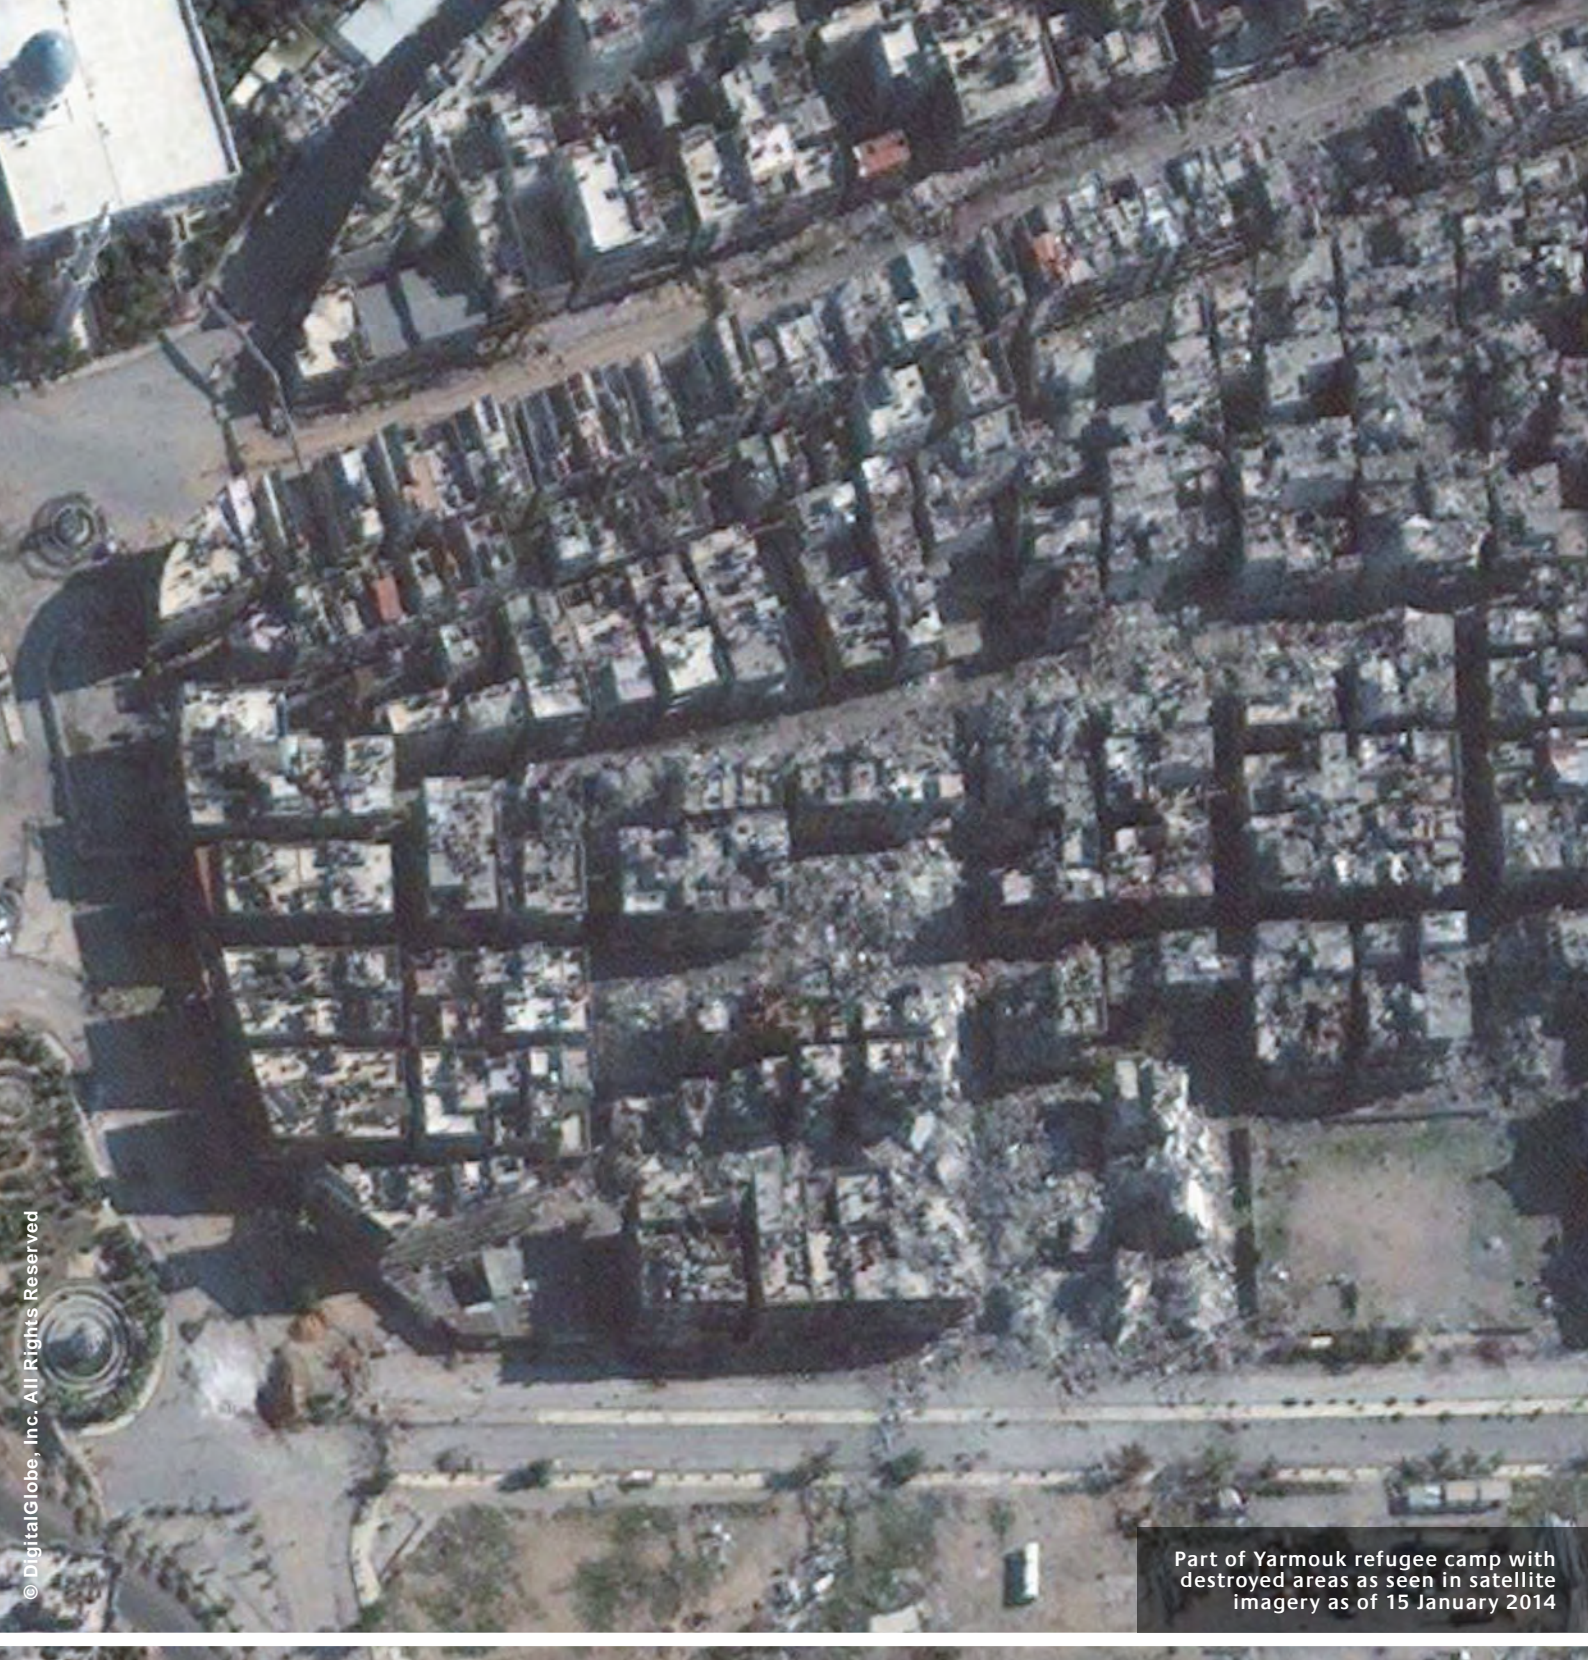
Part of Yarmouk refugee camp with destroyed areas as seen in satellite imagery as of 15 January 2014
