# SHELTER PROJECTS

## SHELTER IN EUROPE: 15 Relevant Case Studies

*CASE STUDIES OF SHELTER AND SETTLEMENT RESPONSES IN CONTEXTS RELEVANT TO EUROPE*

## Shelter Projects - Shelter in Europe: 15 Relevant Case Studies

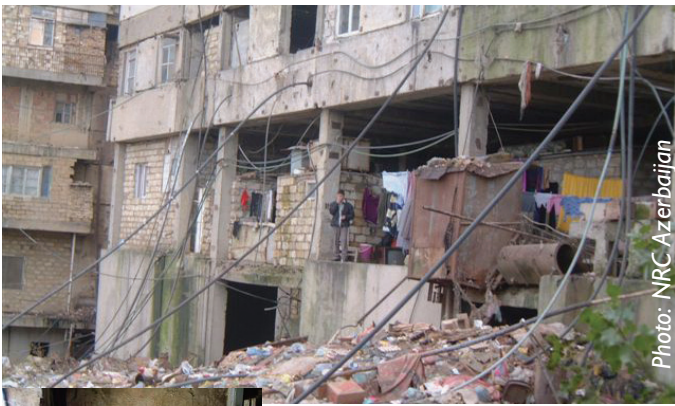
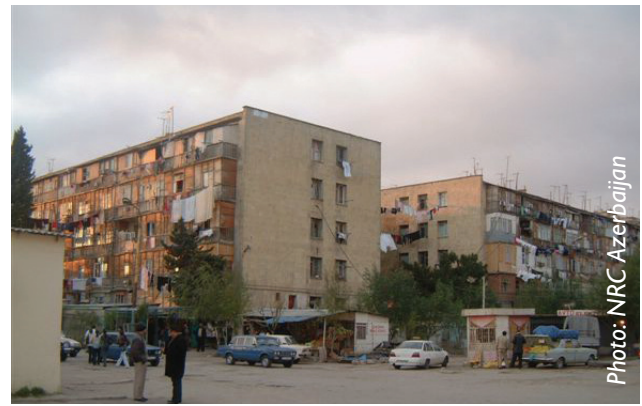
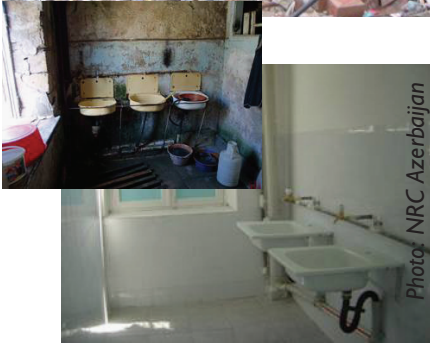
Bathrooms before and after upgrade

Inhabitants saw broken sewerage as the greatest problem in the buildings. Other common problems included shortage of water, leaking roofs and dampness. As a result, plastering, floors and ceilings in toilets and bathrooms were damaged in most buildings.

- rehabilitation of the shared areas - toilets, bathrooms, washing rooms, kitchens and corridors;
- infrastructure repairs - electricity, sewerage, water and sewerage pipes;
- repair of roofs;
- installation of new water heaters, sinks, stoves, faucets, showers, light bulbs, circuit breakers, switchboards, windows and doors;
- installation of electricity transformers (this was not costly but served a large number of IDPs).

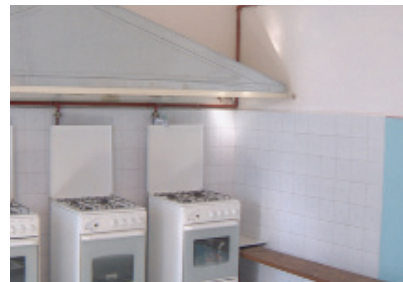
Kitchens before and after upgrade

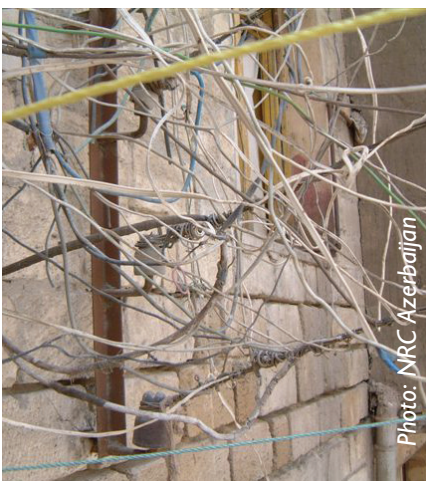
Wiring before upgrade

The most durable output of the project was the provision of electricity systems (including transformers and switchboards) and new roofs.

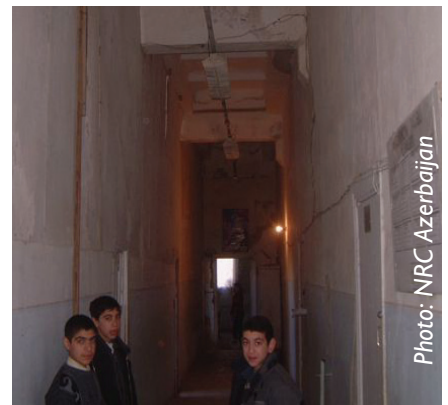
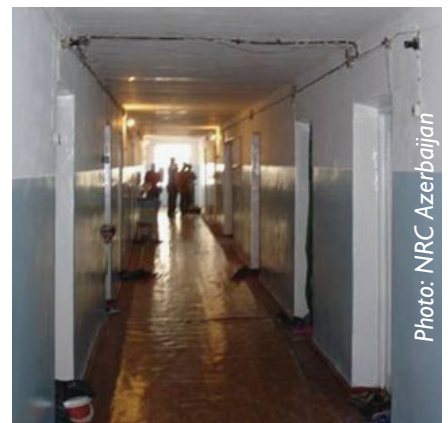
Corridors before and after upgrade

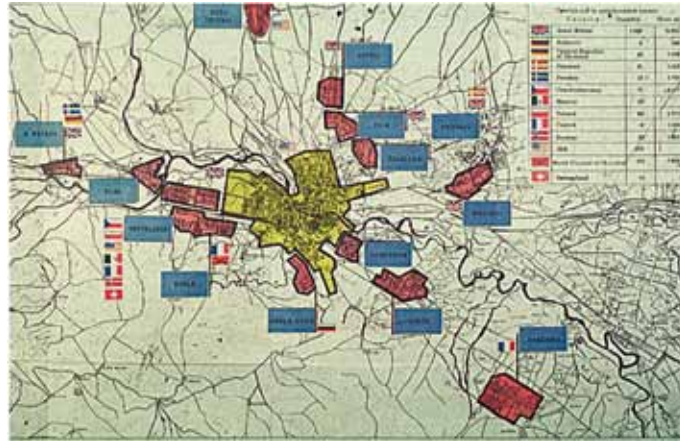
Map prepared by authorities (using army engineers) immediately after the earthquake to indicate the sites (in purple) of temporary housing. The temporary housing was built with a 9 month lifetime. These temporary housing sites inevitably became permanent and adversely influenced the layout of the future city development.

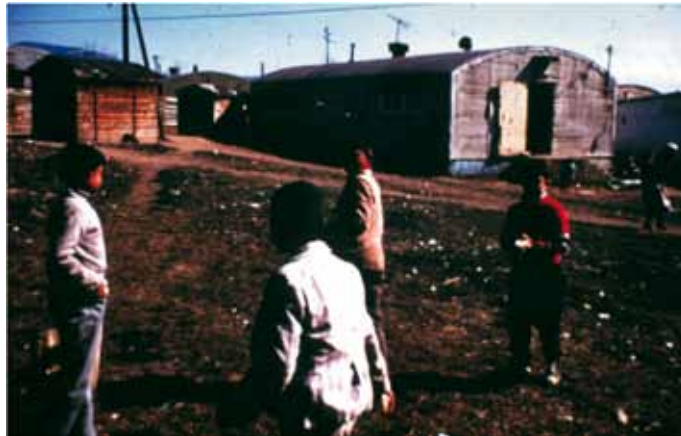
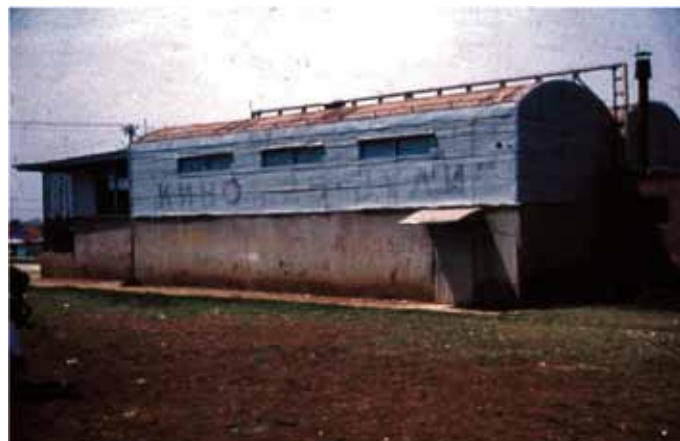
US army Quonset huts built after the earthquake.

Top image: taken in 1974, 11 years after the earthquake.  
Bottom image: taken in 1987, 25 years after the earthquake. Two of these huts had been elevated and joined together to form a small cinema.

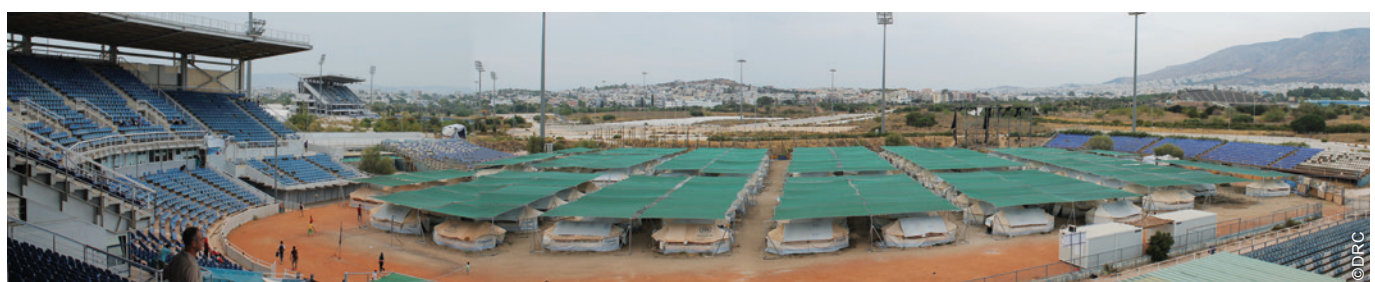
In Greece, many refugees were accommodated in tented camps. In summer, tents had to be shaded, also by building metal-framed structures (Elliniko, Athens).

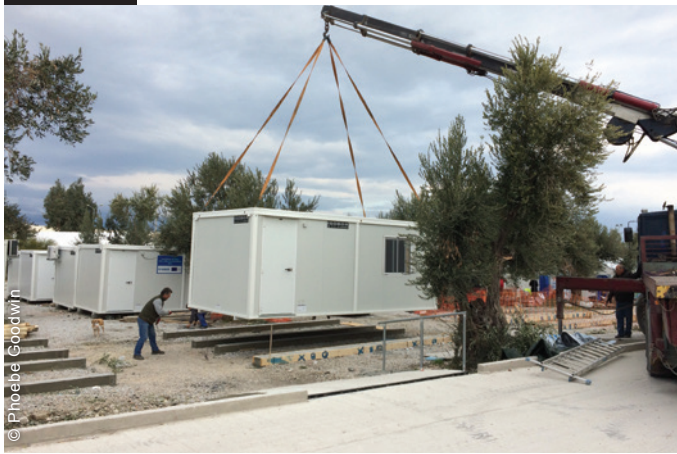
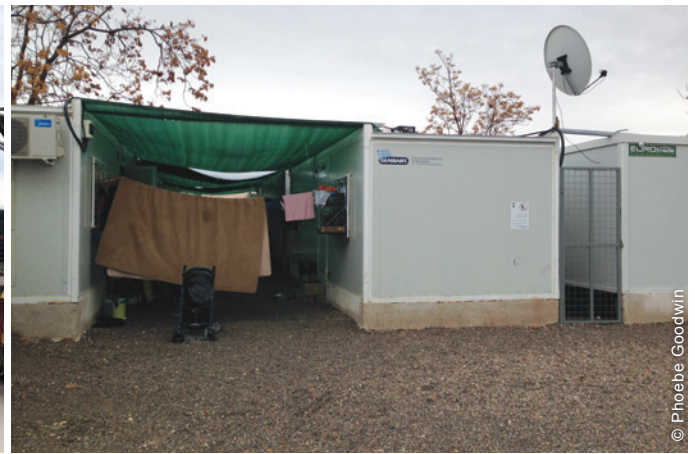
Many refugee camps in Greece were either upgraded from tents or built from the start with containers (Left: Kara Tepe camp, Lesbos. Right: Eleonas, Athens).

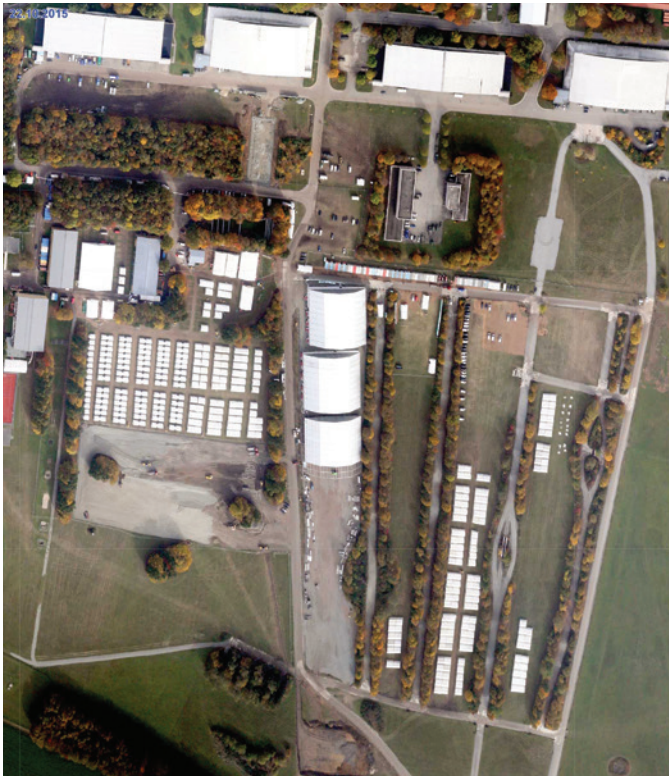
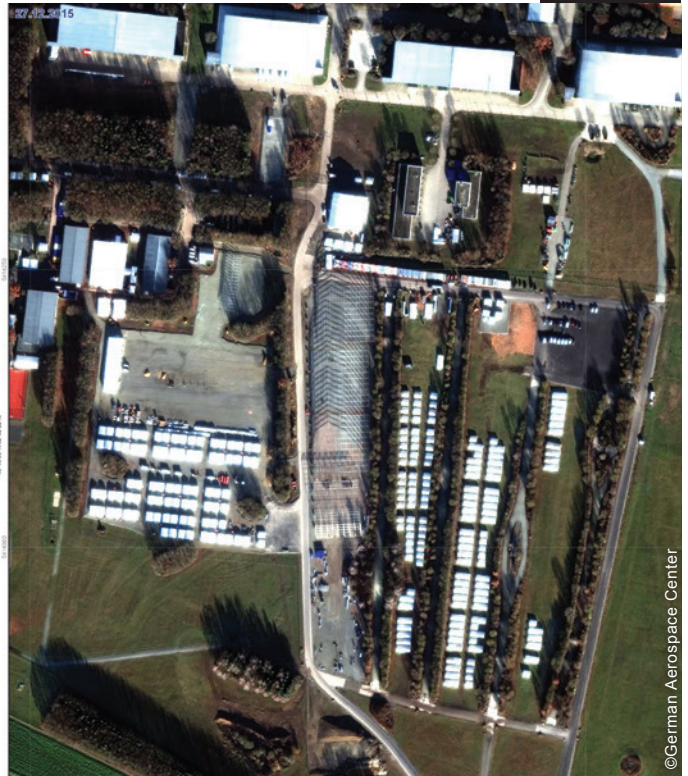
Two short-term accommodation sites for new arrivals were set up and upgraded in phases before the winter. Here, Feldkirchen in October (left) and December (right).

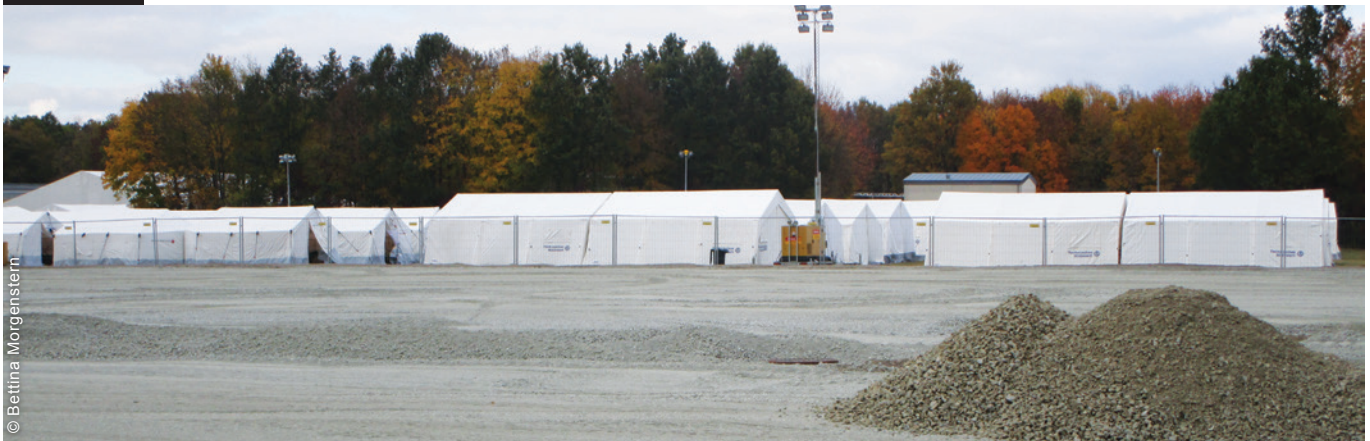
The reception centres were upgraded/winterized, while in operation, through several steps between October and December (e.g., by adding a layer of gravel).

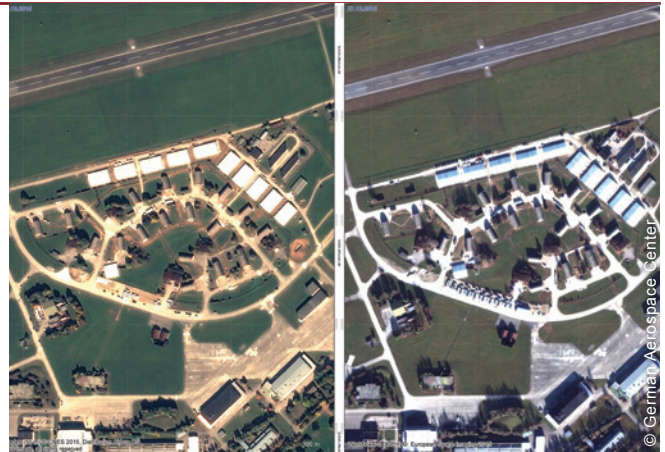
The site in Erding between October (left) and December 2015 (right).

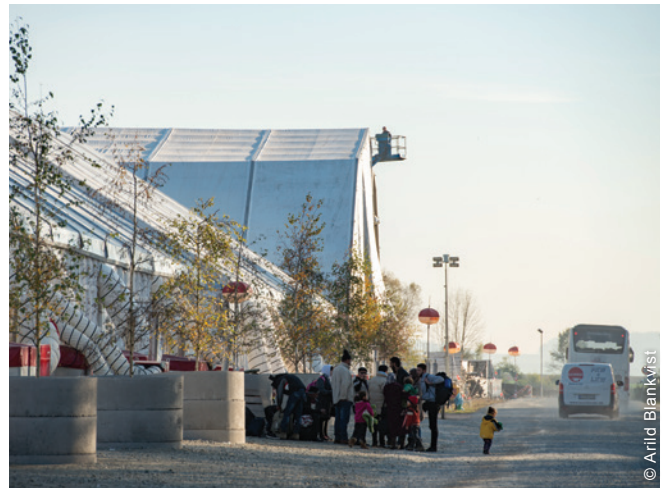
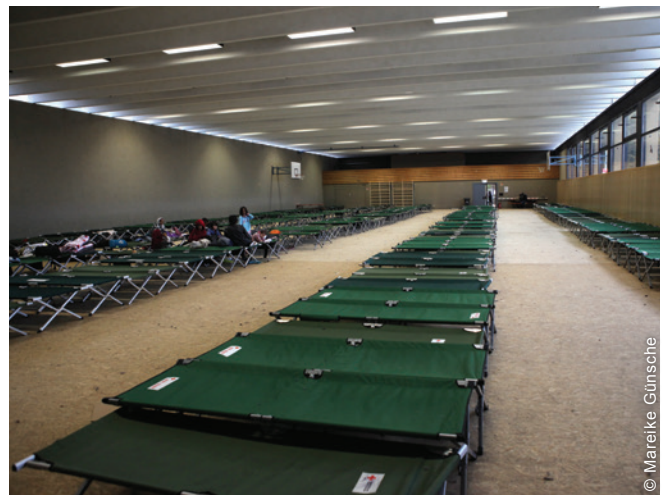
Accommodation options varied greatly in the two sites. From individual family tents, to large collective tents or field beds in gymnasiums.

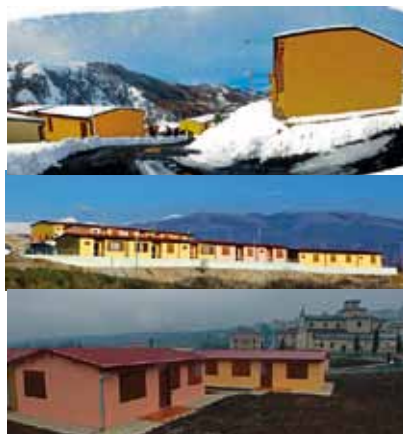
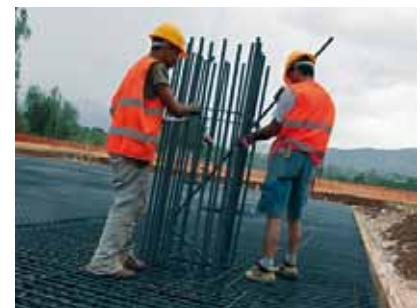
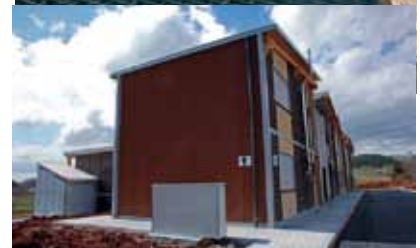
Left: tent camps,  
Centre: modular housing units  
Right: apartment blocks  
Photos: Dipartimento Protezione Civile  
Croce Rossa Italiana

Buildings and housing schemes were designed to reduce seismic risks. They also included schemes to reduce energy consumption. Many included solar and photovoltaic panels, rainwater harvesting, and thermal and sound insulation

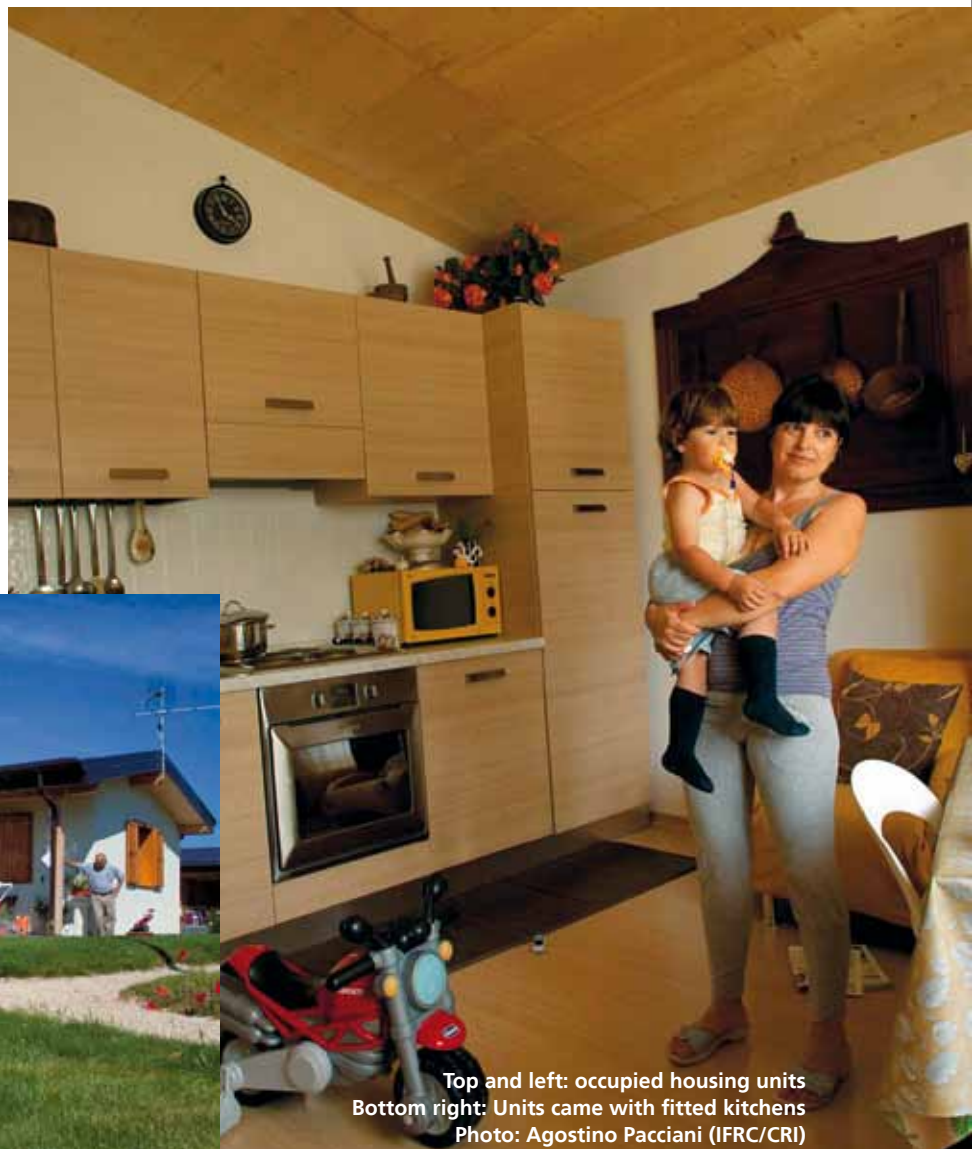
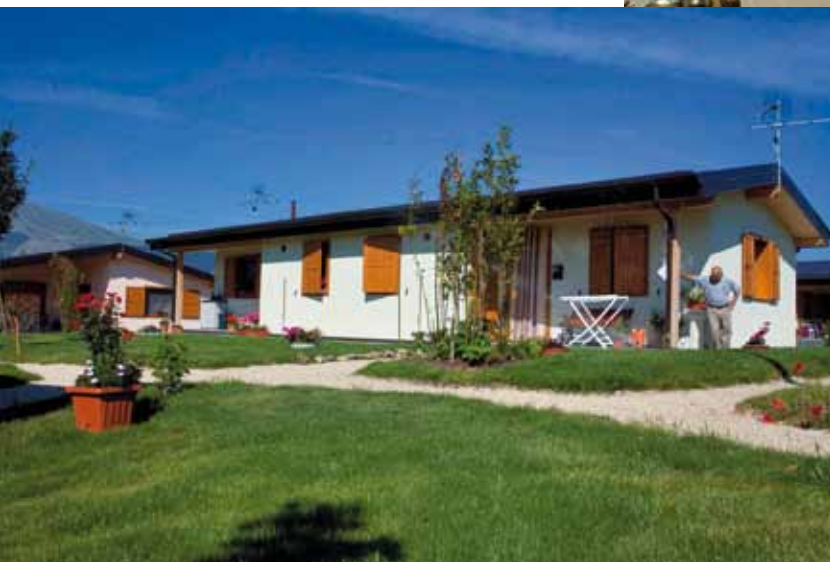
Top and left: occupied housing units  
 Bottom right: Units came with fitted kitchens  
 Photo: Agostino Pacciani (IFRC/CRI)

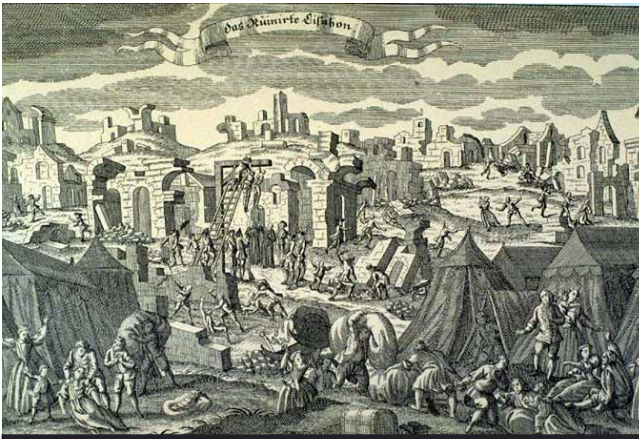
Following the earthquake, Lisbon was hit by a tidal wave and then a fire that burned for six days. Many in the clergy believed that people were being punished for their sins.  
Image: 1755 German copperplate image, "The Ruins of Lisbon" Wikimedia Commons, public domain

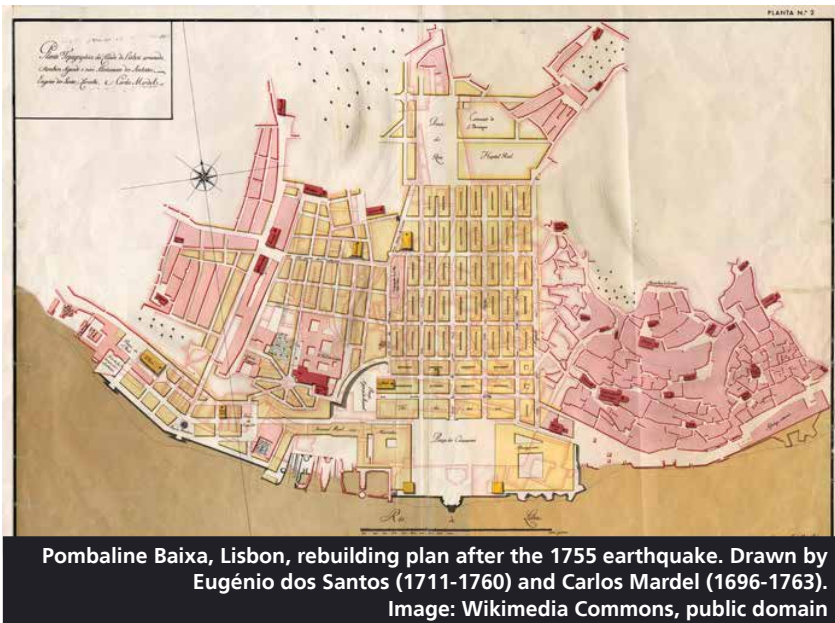
Pombaline Baixa, Lisbon, rebuilding plan after the 1755 earthquake. Drawn by Eugénio dos Santos (1711-1760) and Carlos Mardel (1696-1763). Image: Wikimedia Commons, public domain

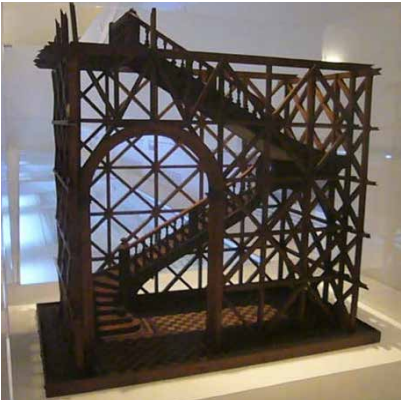
**A model showing the Pombaline cage design. The design is said to have been tested by getting the army to walk up and down on the roof of a full-size model.**

The new anti-seismic design by Carlos Mardel included an internal timber-frame with an embedded post-and-beam construction with high levels of bracing. The frame was filled with rubble and then plastered to add protection against fire. The design became known as the "Pombaline Cage" and the first building began in 1759, a year after

The design was apparently tested by running a stress-test on a full-scale model in the city's main square. The military were ordered to march in uncoordinated, uneven rhythms on top of the building to simulate the tremor conditions of an earthquake (Mata dos Santos 2008).

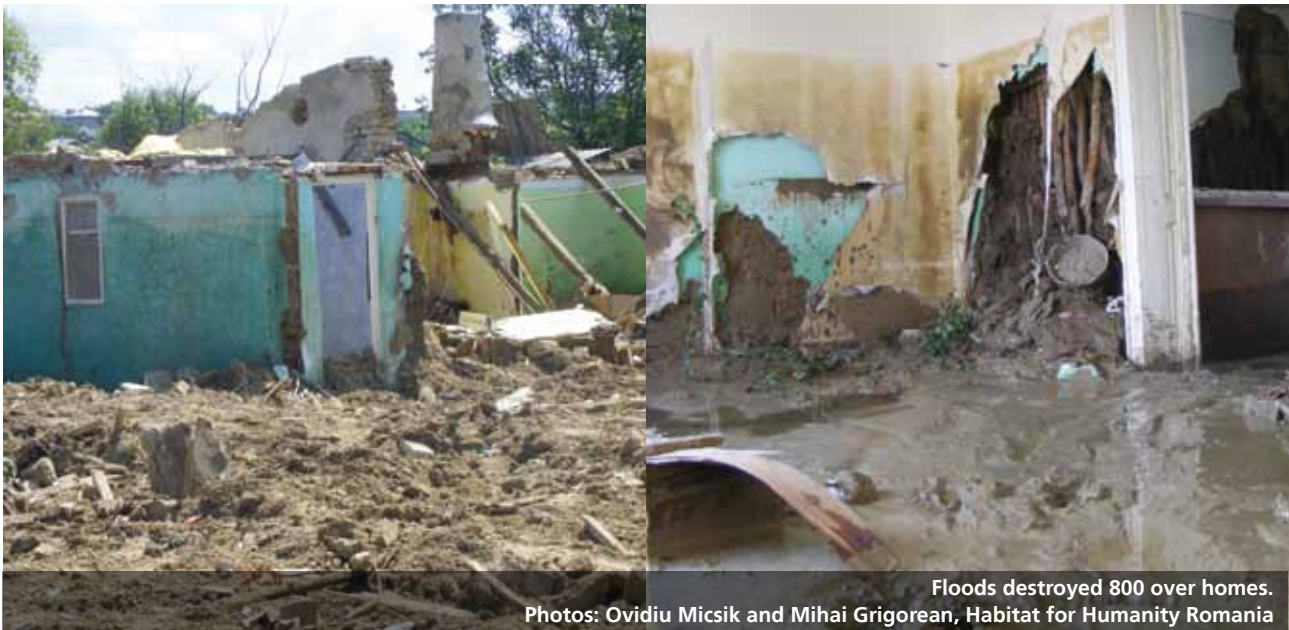
Floods destroyed 800 over homes.  
Photos: Ovidiu Micsik and Mihai Grigorean, Habitat for Humanity Romania

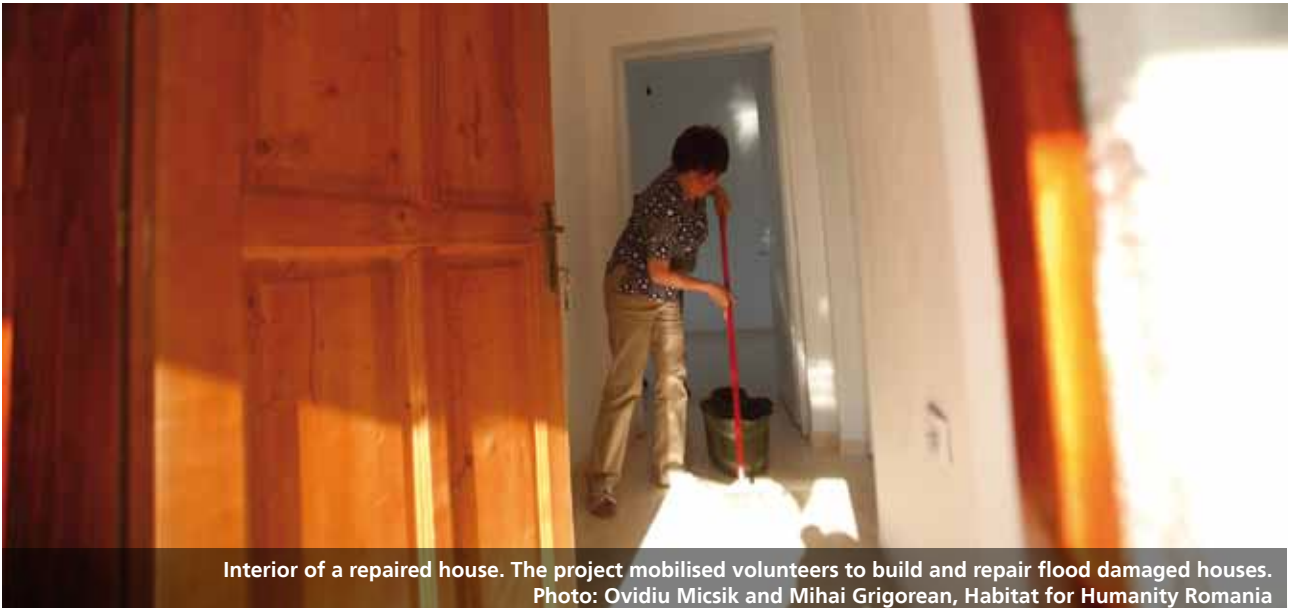
Interior of a repaired house. The project mobilised volunteers to build and repair flood damaged houses. Photo: Ovidiu Micsik and Mihai Grigorean, Habitat for Humanity Romania

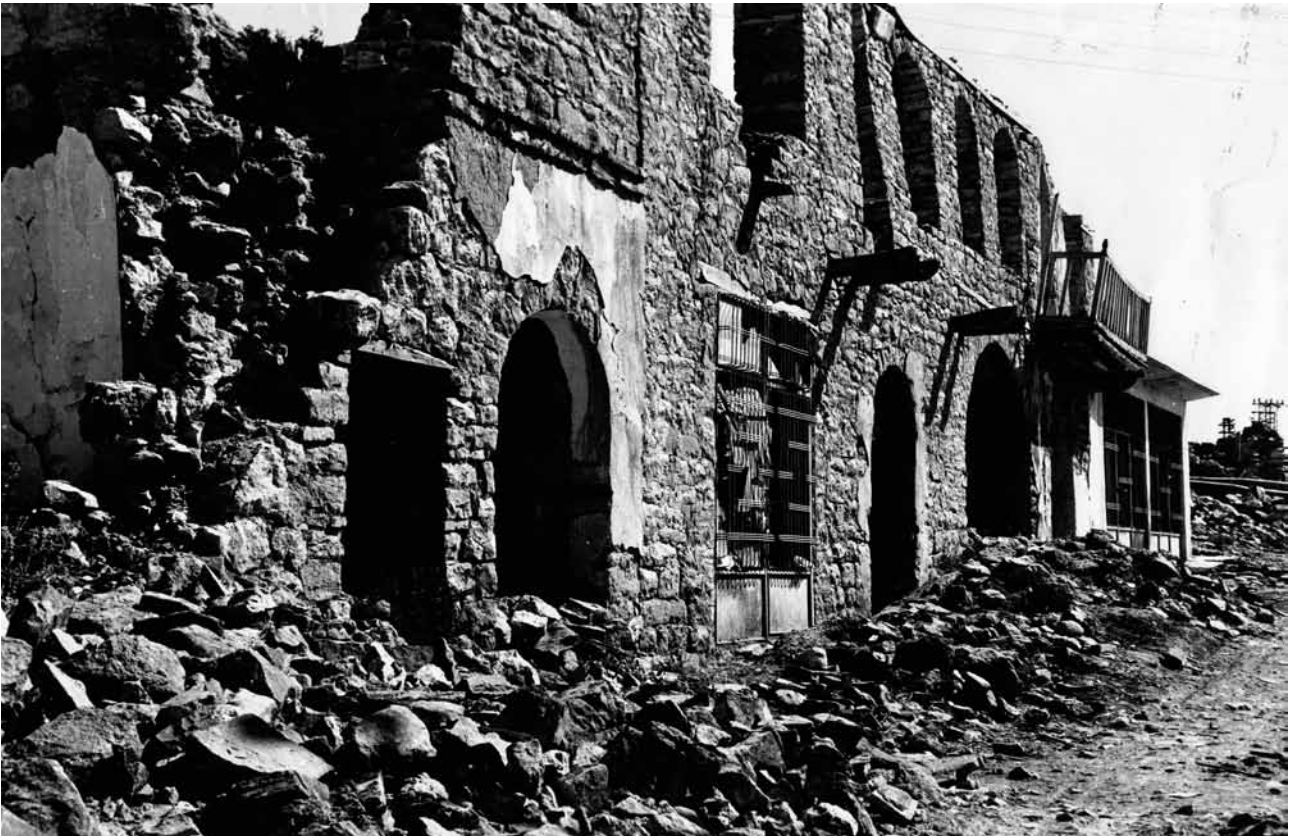
Traditional masonry housing in Lice in eastern Turkey that was damaged in the earthquake of September 1975. The old town of Lice was sited on a steep hillside (vulnerable to rock falls in any future earthquake.) The government decided to move the settlement to a new safe location, in a plain at the foot of the slope. However, this land was prime agricultural land. Further the hillside provided better protection from northerly winds than the new exposed site.

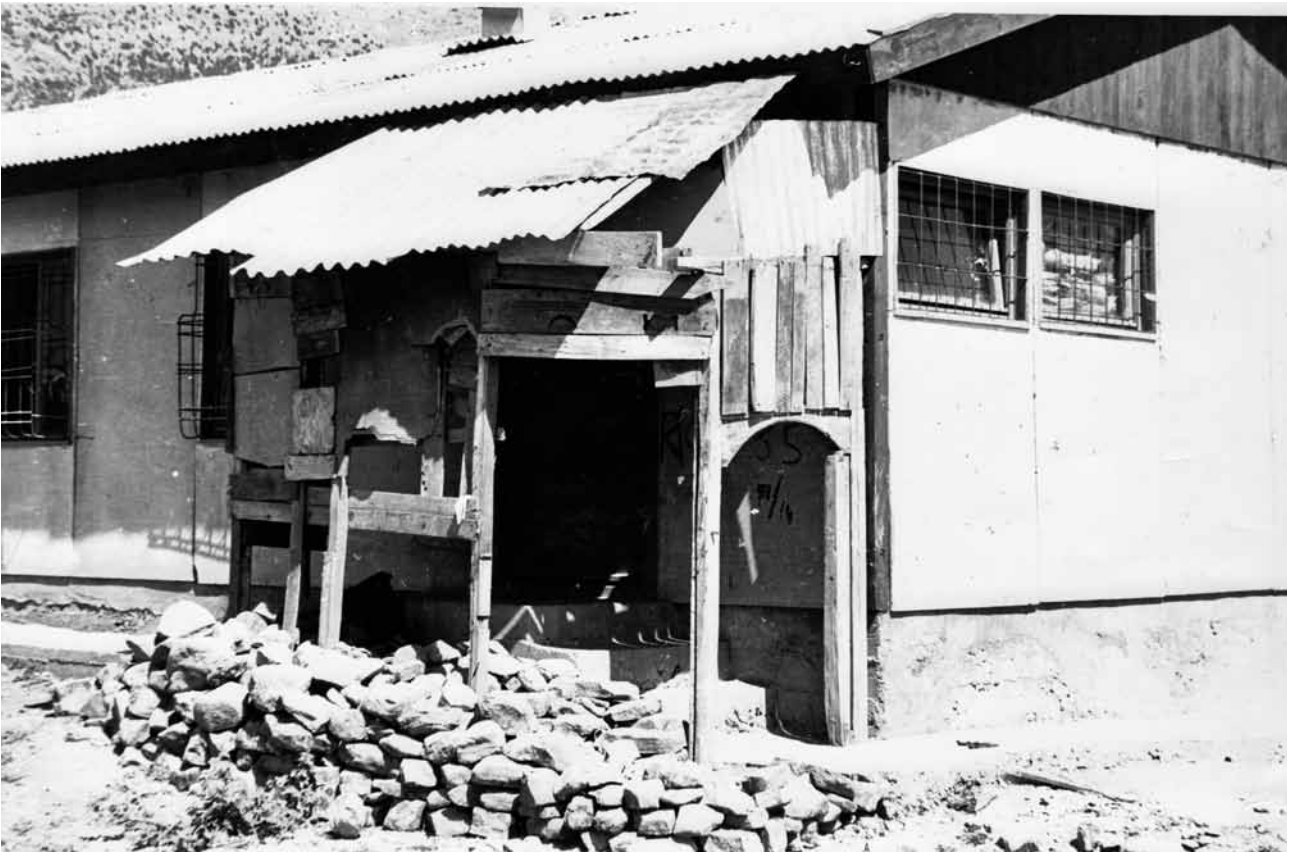
A family added this porch to their new prefabricated home. It is an example of the need for protection for an animal, and also some protection for the door.

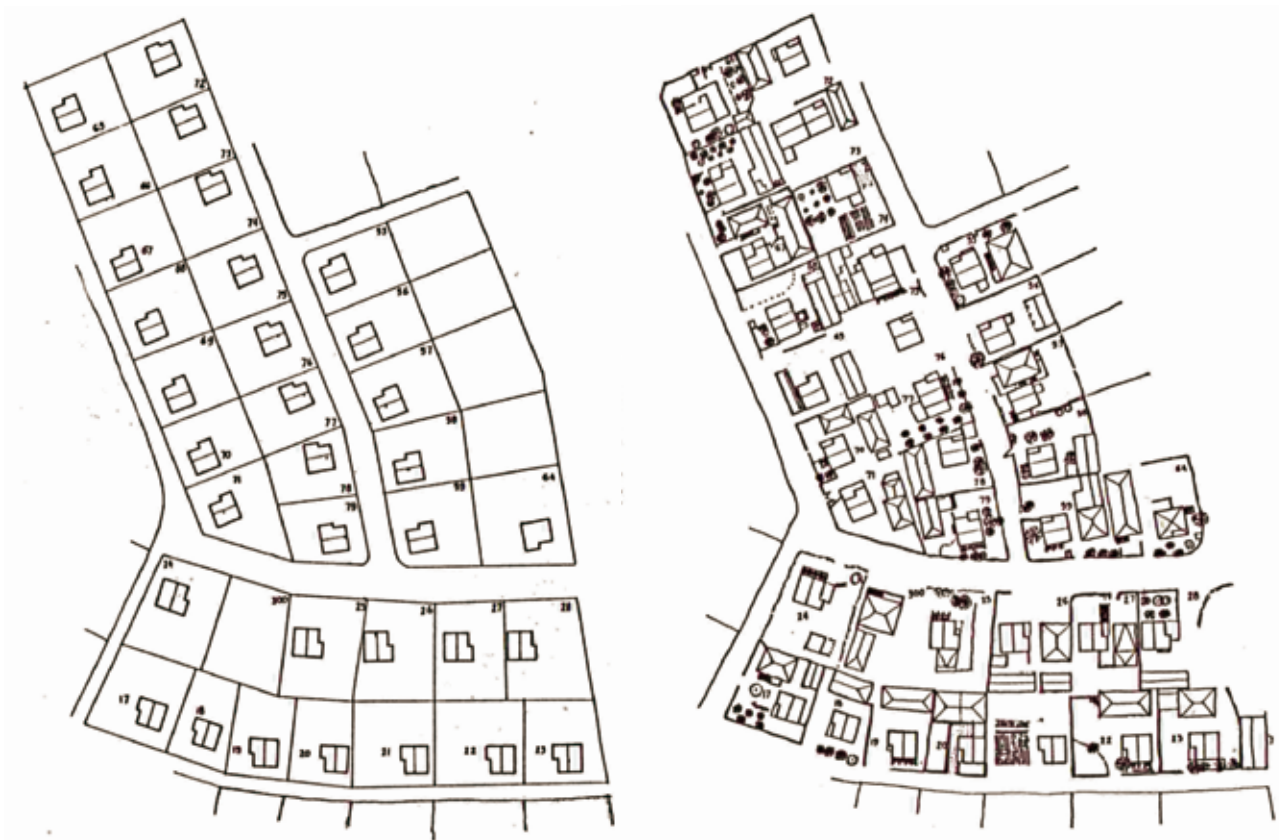
Maps of a neighbourhood of the resettlement village of new Muhipler drawn 13 years apart. Left 1971, Right 1984  
 Illustration: Housing and Culture after Earthquakes / Yasemin Aysan / Paul Oliver / Ian Davis

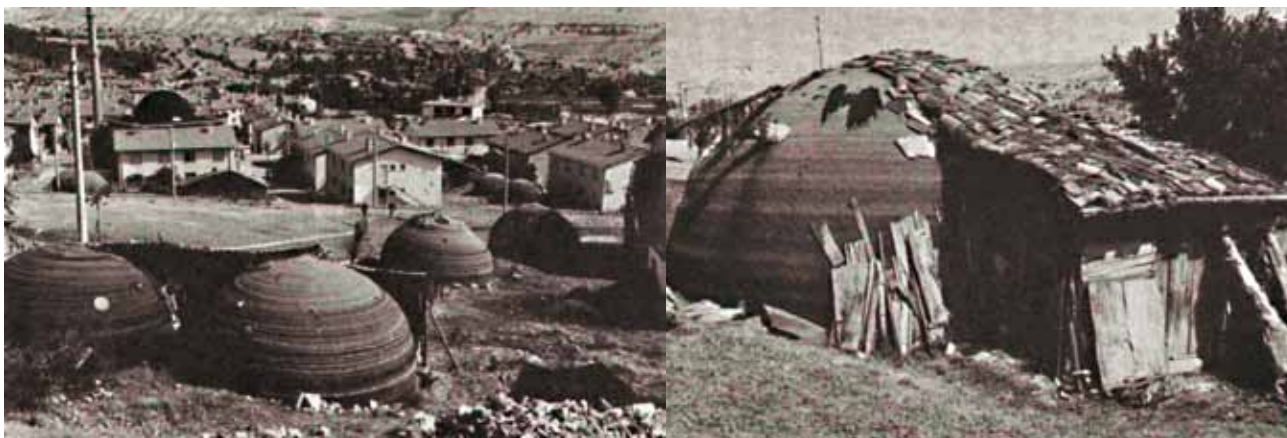
Polyurethane 'igloos' were deployed. An experiment that was discontinued after the 1975 Lice earthquake  
 Photos: Housing and Culture after Earthquakes / Yasemin Aysan / Paul Oliver

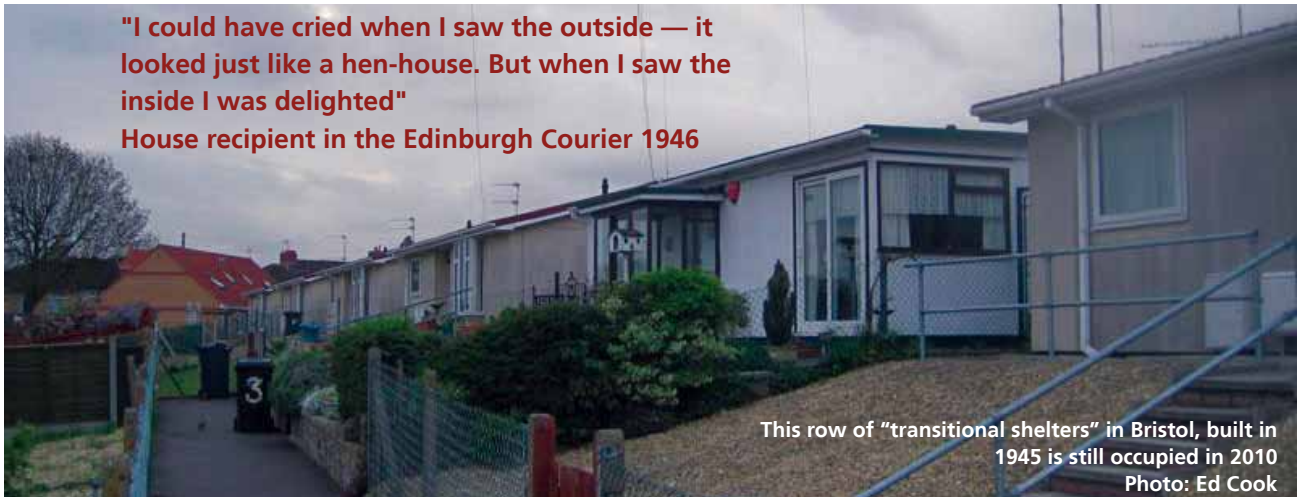
This row of "transitional shelters" in Bristol, built in 1945 is still occupied in 2010  
 Photo: Ed Cook

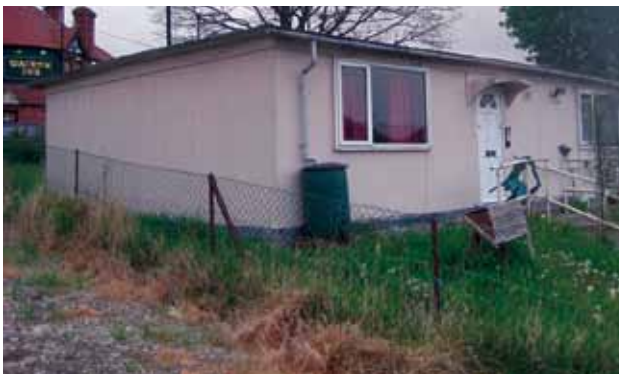
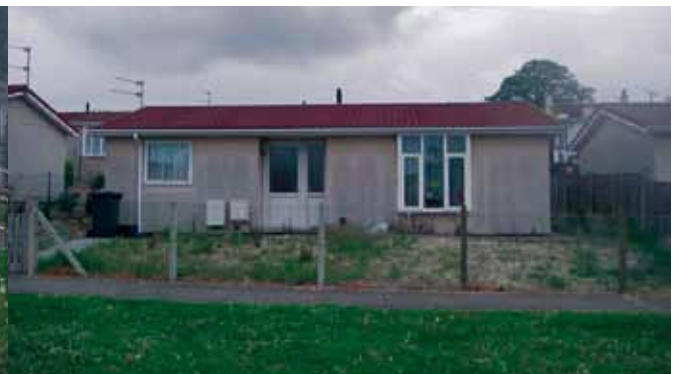
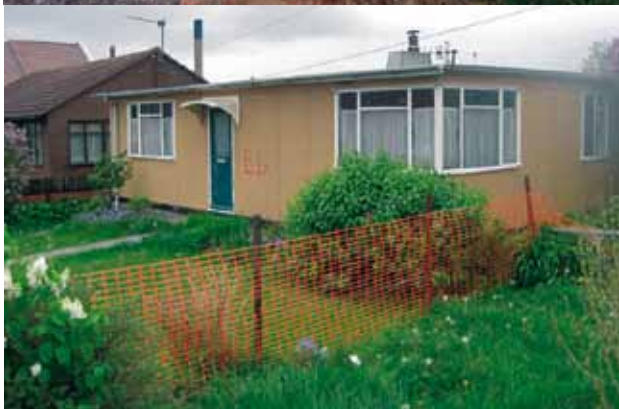
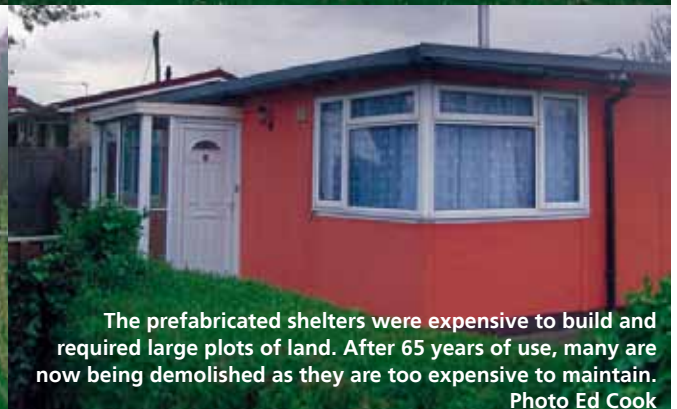
The prefabricated shelters were expensive to build and required large plots of land. After 65 years of use, many are now being demolished as they are too expensive to maintain.  
Photo Ed Cook

Of the prefabricated houses built, some have remained in use over 65 years, although many now fail the government's 'Decent Homes Standard'. In general there is now a policy of replacing prefabs, although this is moving into redevelopment of sites as it is cheaper to demolish and rebuild rather than continue to repair them.

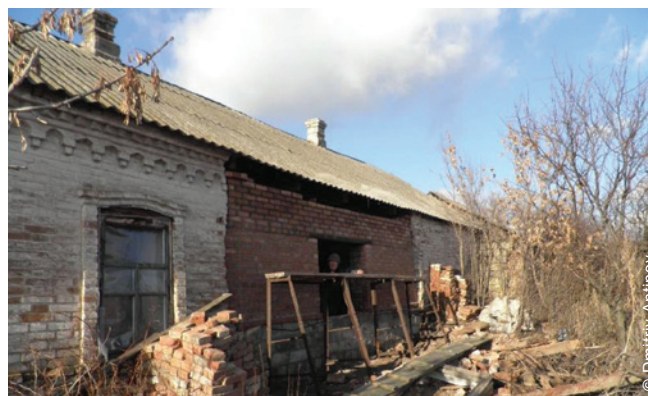
Interventions included housing repairs (Starohnativka, Dec 2015).

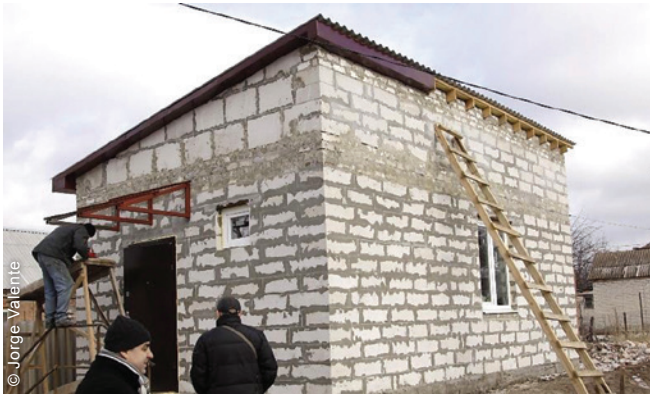
Some projects aimed at re-building completely destroyed houses (Sloviansk).

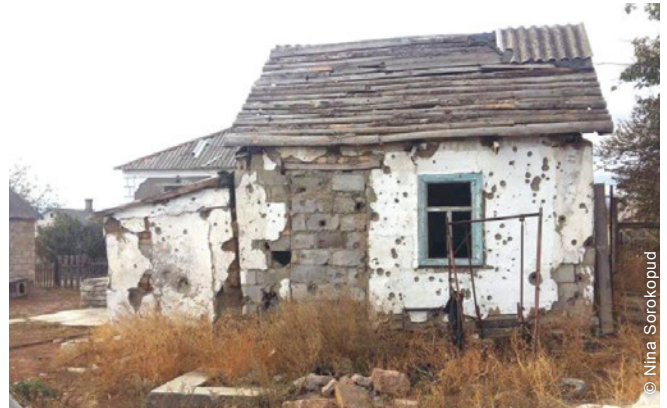
Multistorey buildings (top) and houses (bottom) in conflict zones sustained significant damage due to shrapnel punctures, and required urgent repairs.
