Satellite-Based Damage Assessment for City of Sittwe, Sittwe Township

Assessment based on satellite imagery recorded on morning of 31 October 2012

Sittwe – Overview of Building Destruction Zones as on 31 October 2012

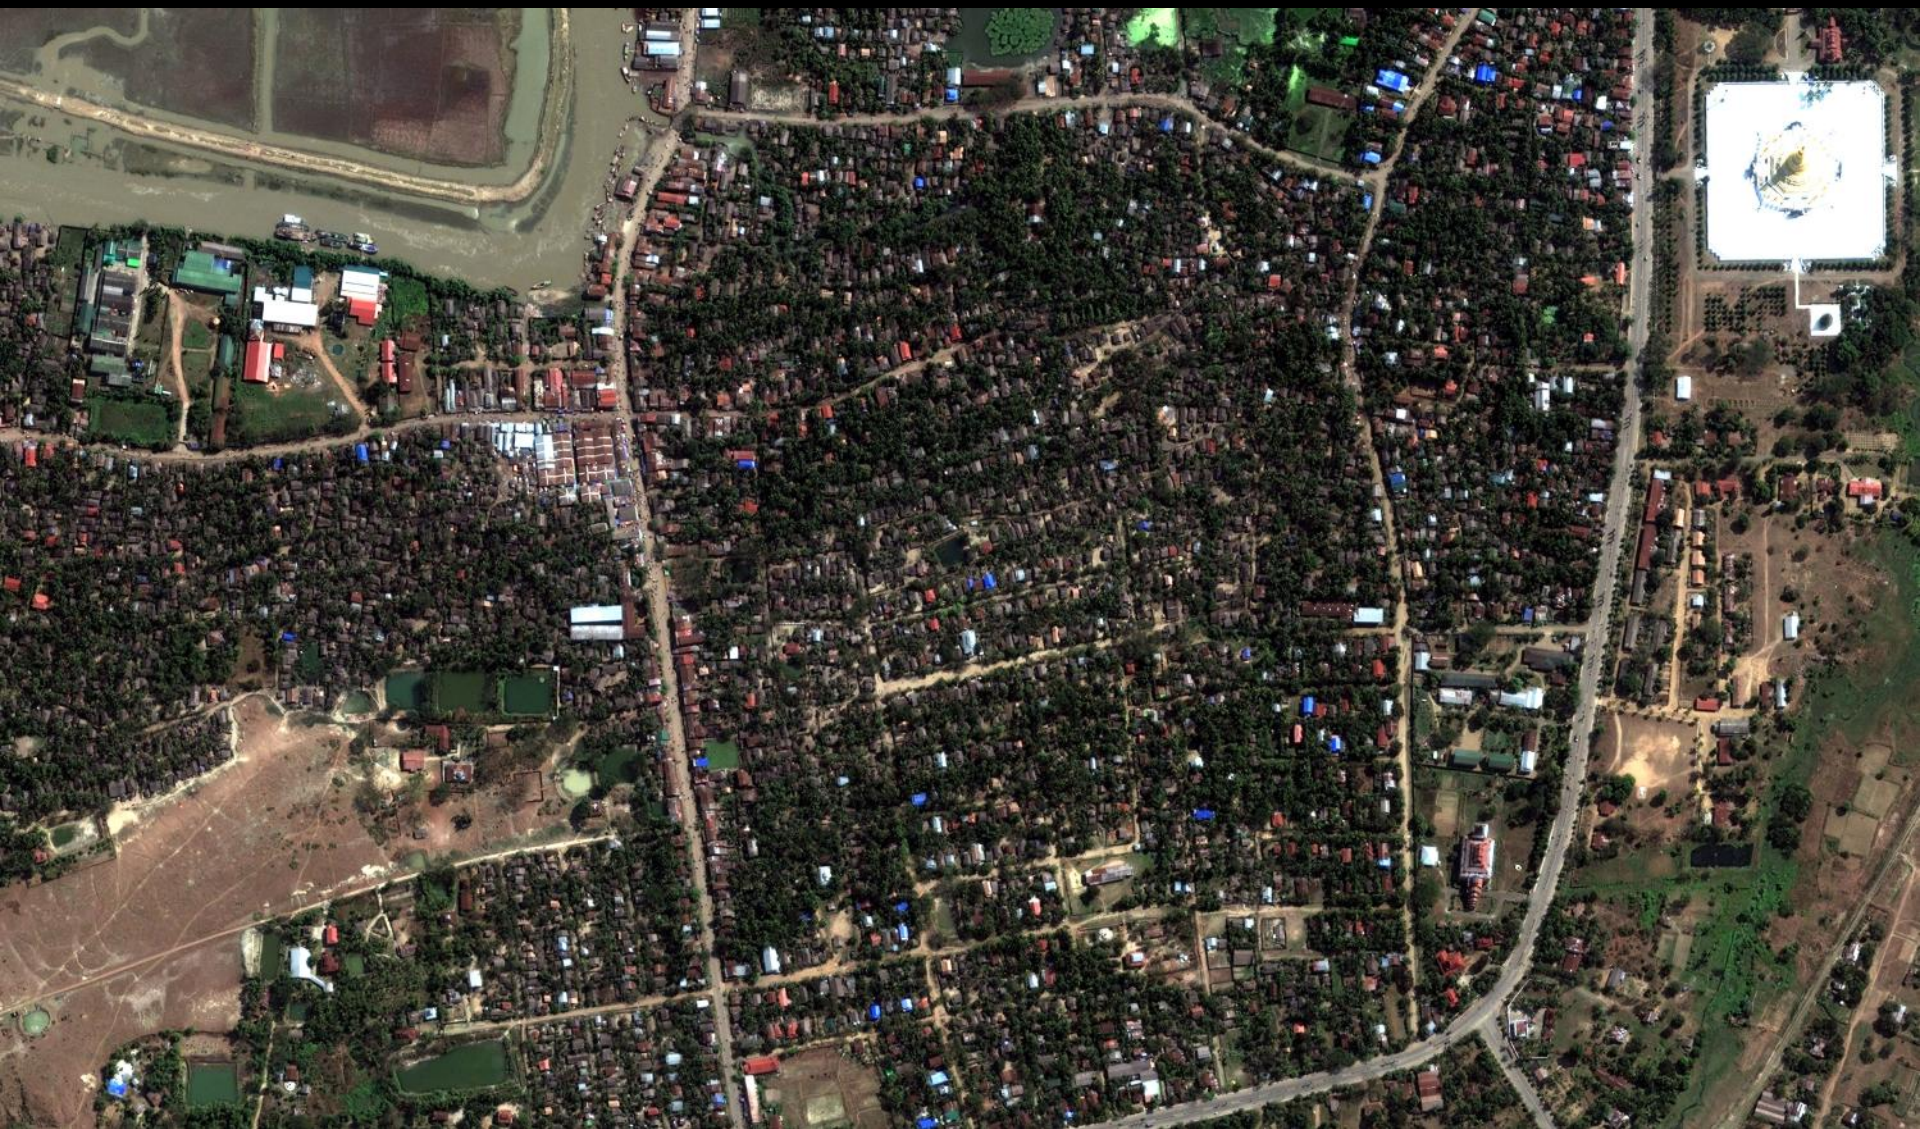
Sittwe (Destruction Zone 1) on 21 February 2011

Pre-attack view of largest concentration of building destruction

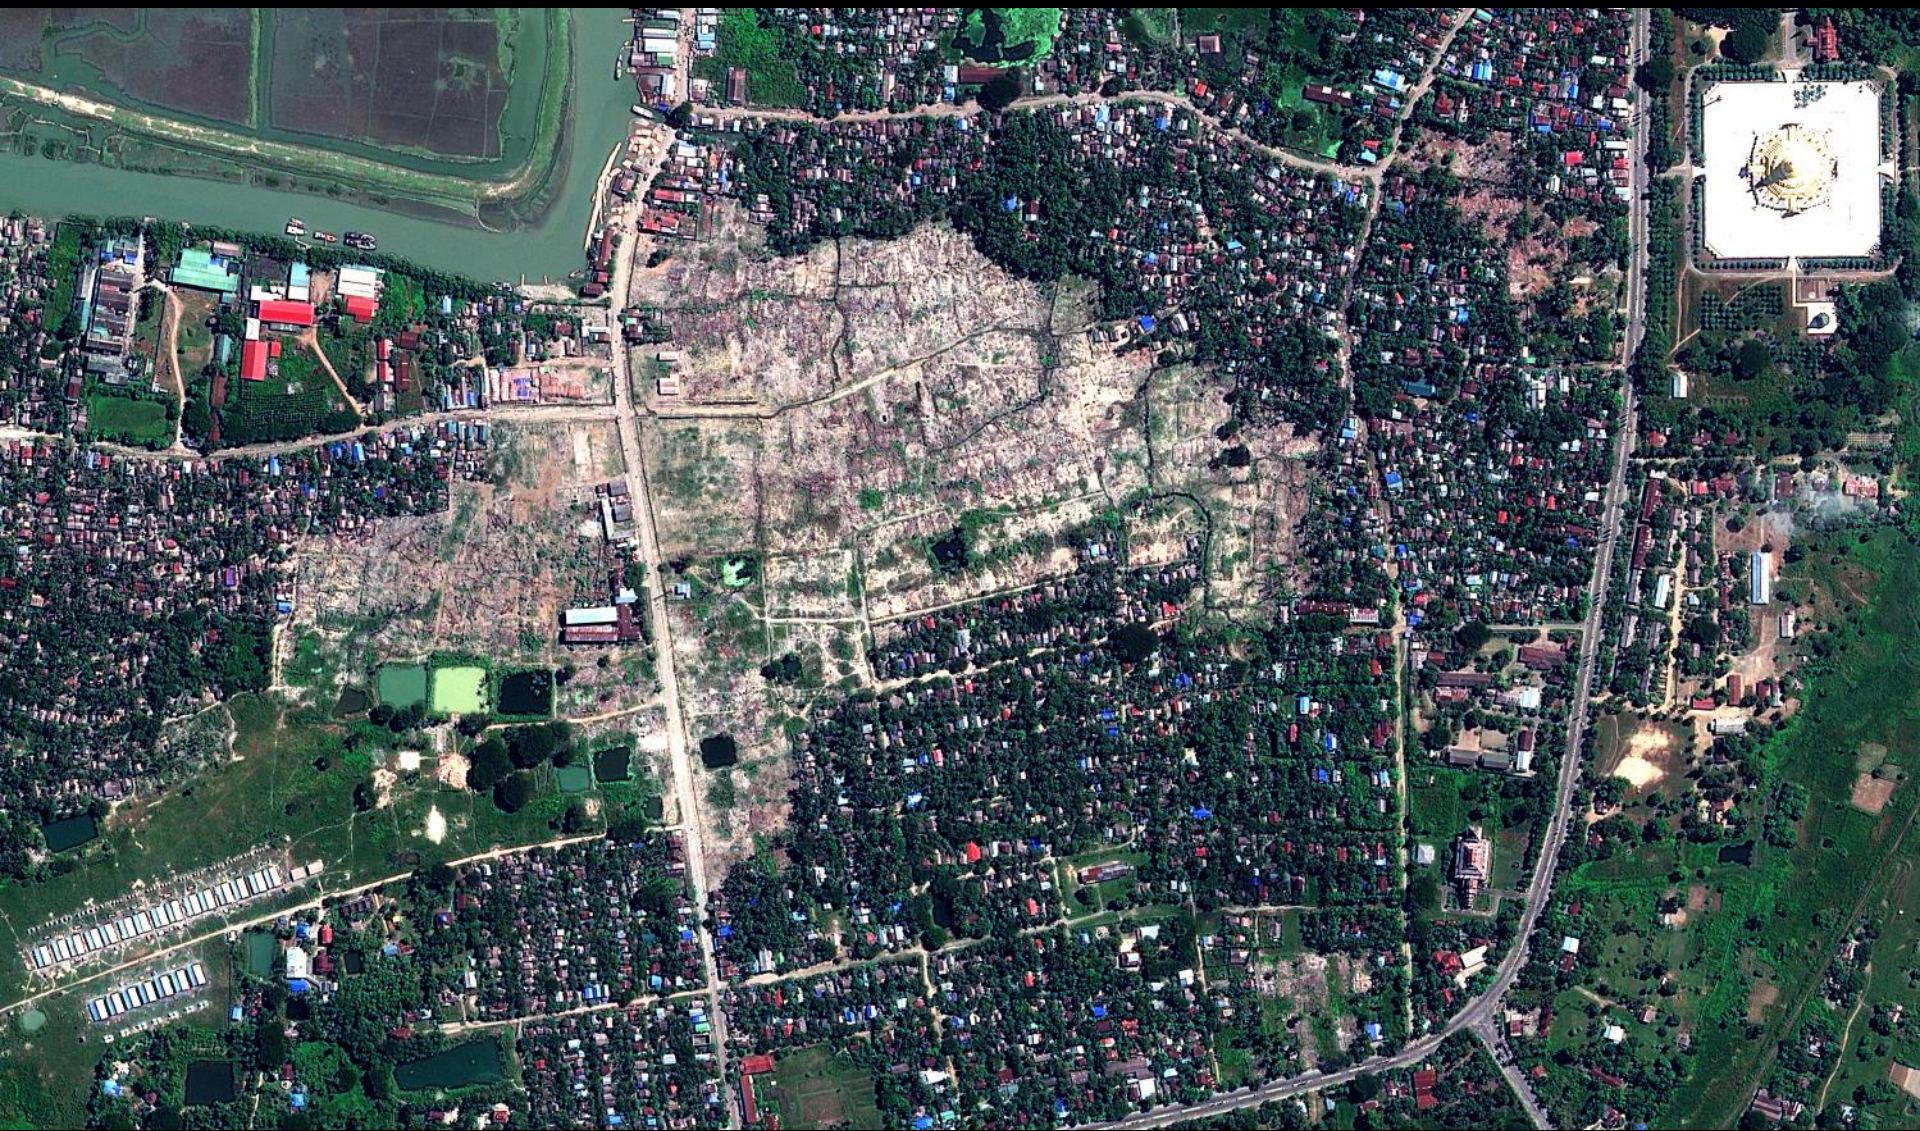
Sittwe (Destruction Zone 1) on 31 October 2012

Post-attack view of largest concentration of building destruction

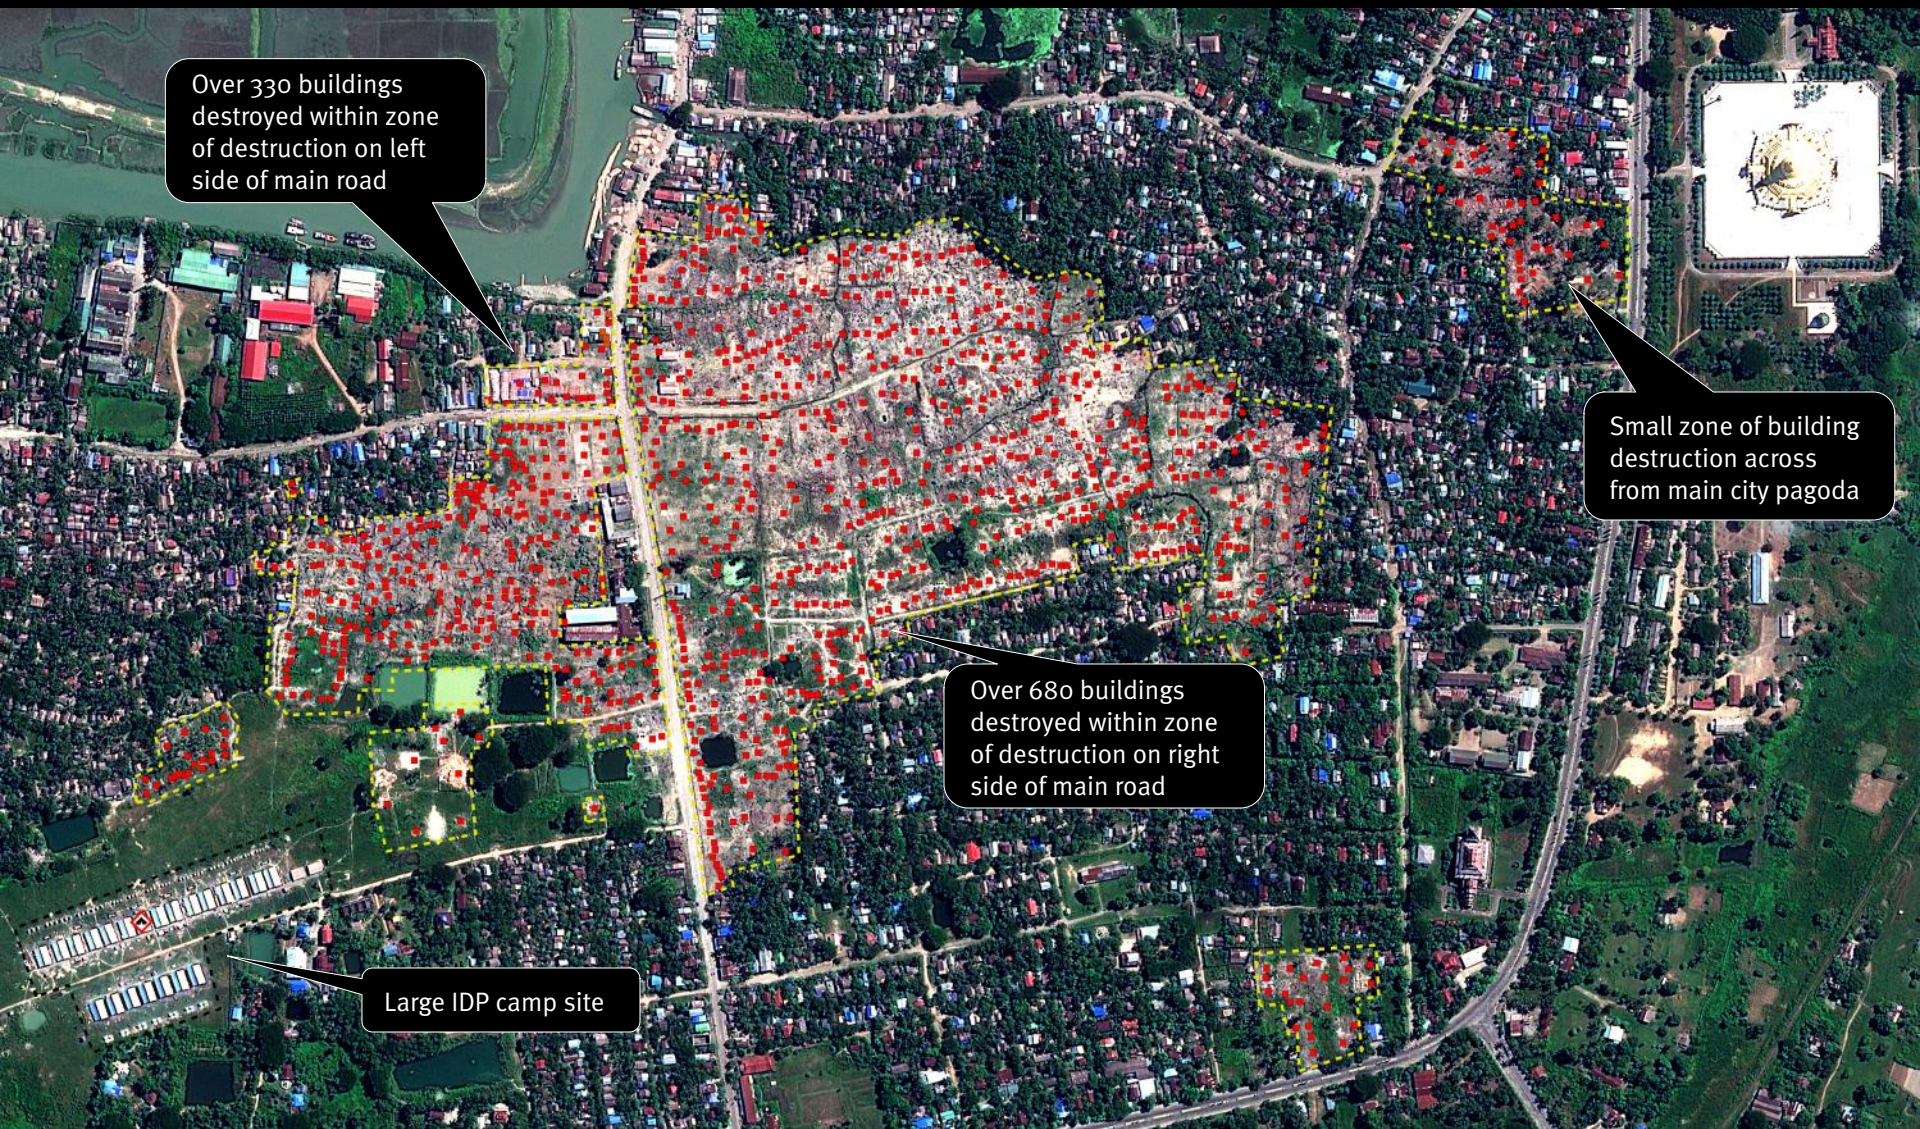
Sittwe (Destruction Zone 1) on 31 October 2012

Post-attack view of largest concentration of building destruction—Damage sites annotated

Over 330 buildings destroyed within zone of destruction on left side of main road

Small zone of building destruction across from main city pagoda

Over 680 buildings destroyed within zone of destruction on right side of main road

Large IDP camp site

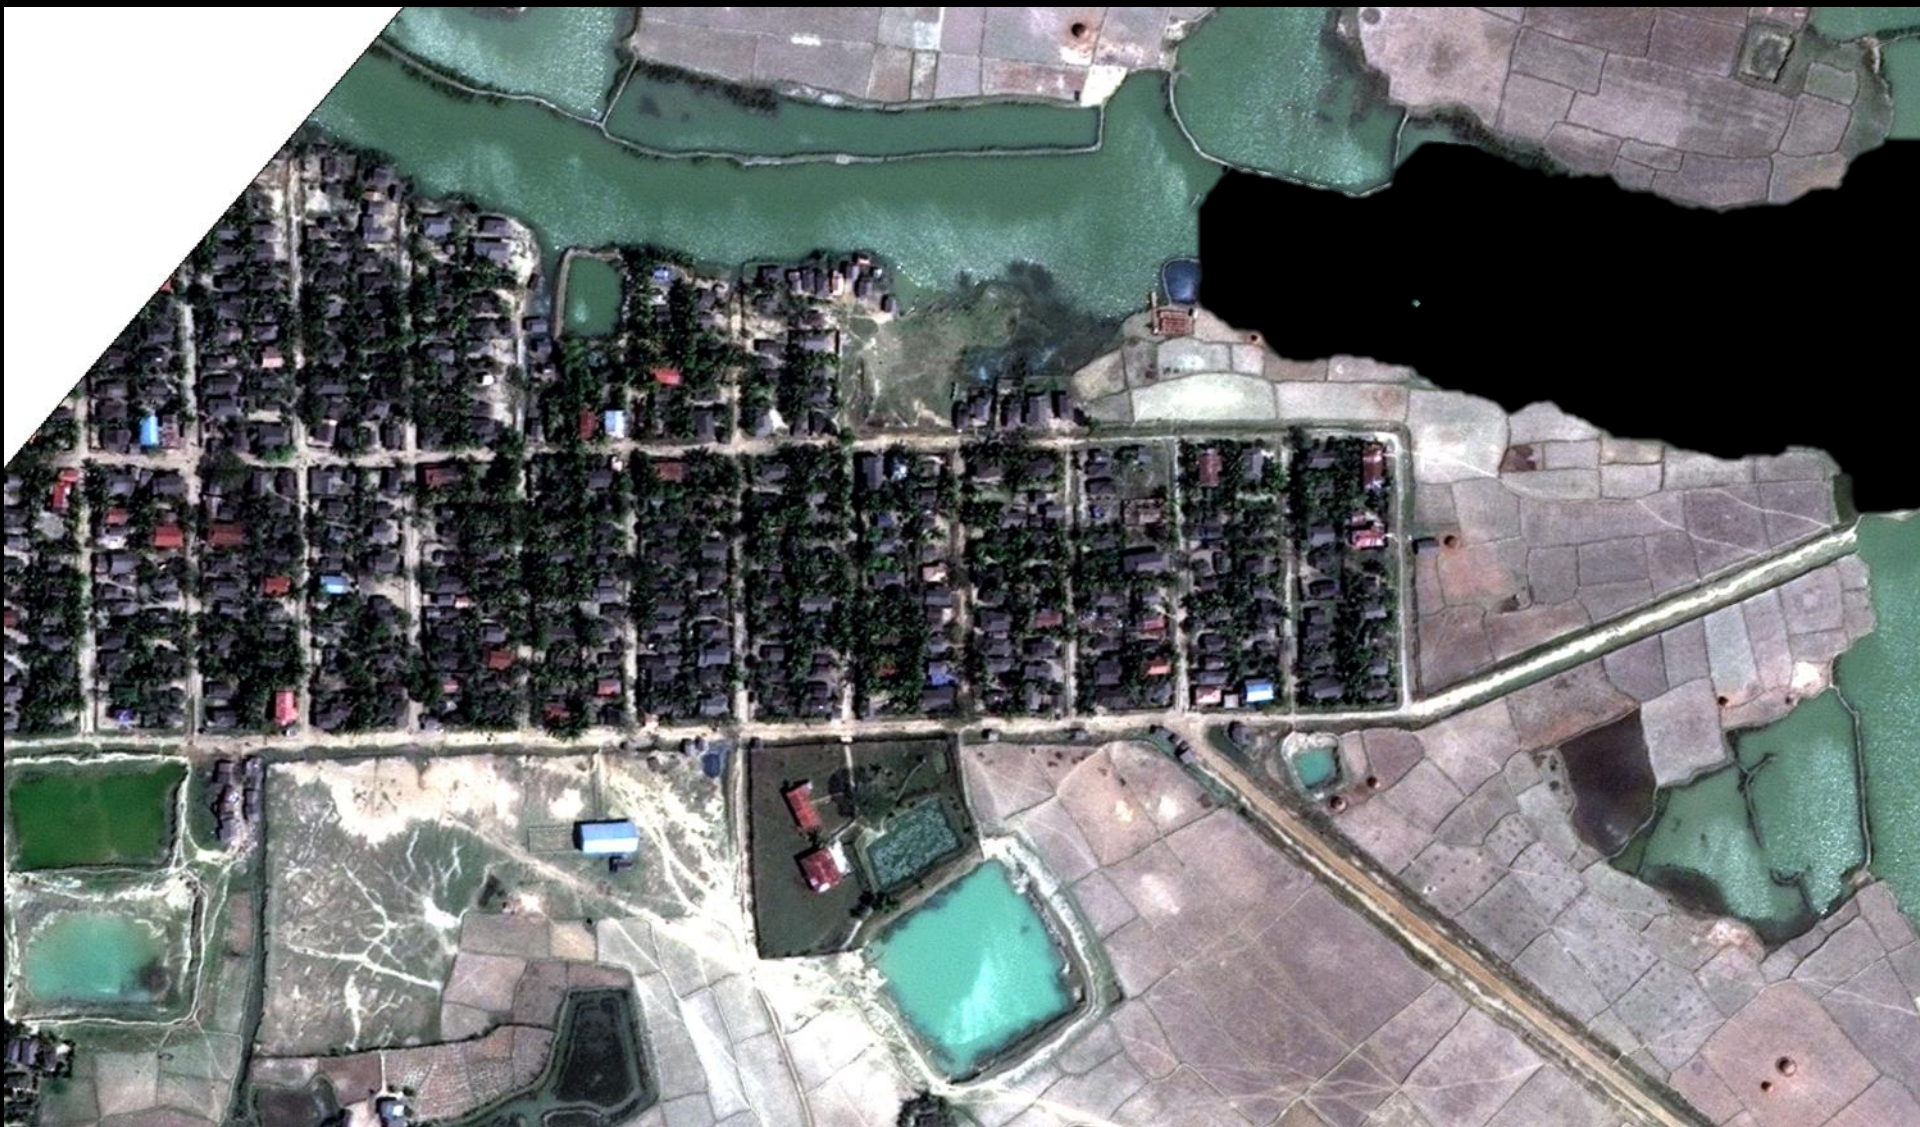
Sittwe (Destruction Zone 2) on 21 February 2011

Pre-attack view of northern-most concentration of building destruction

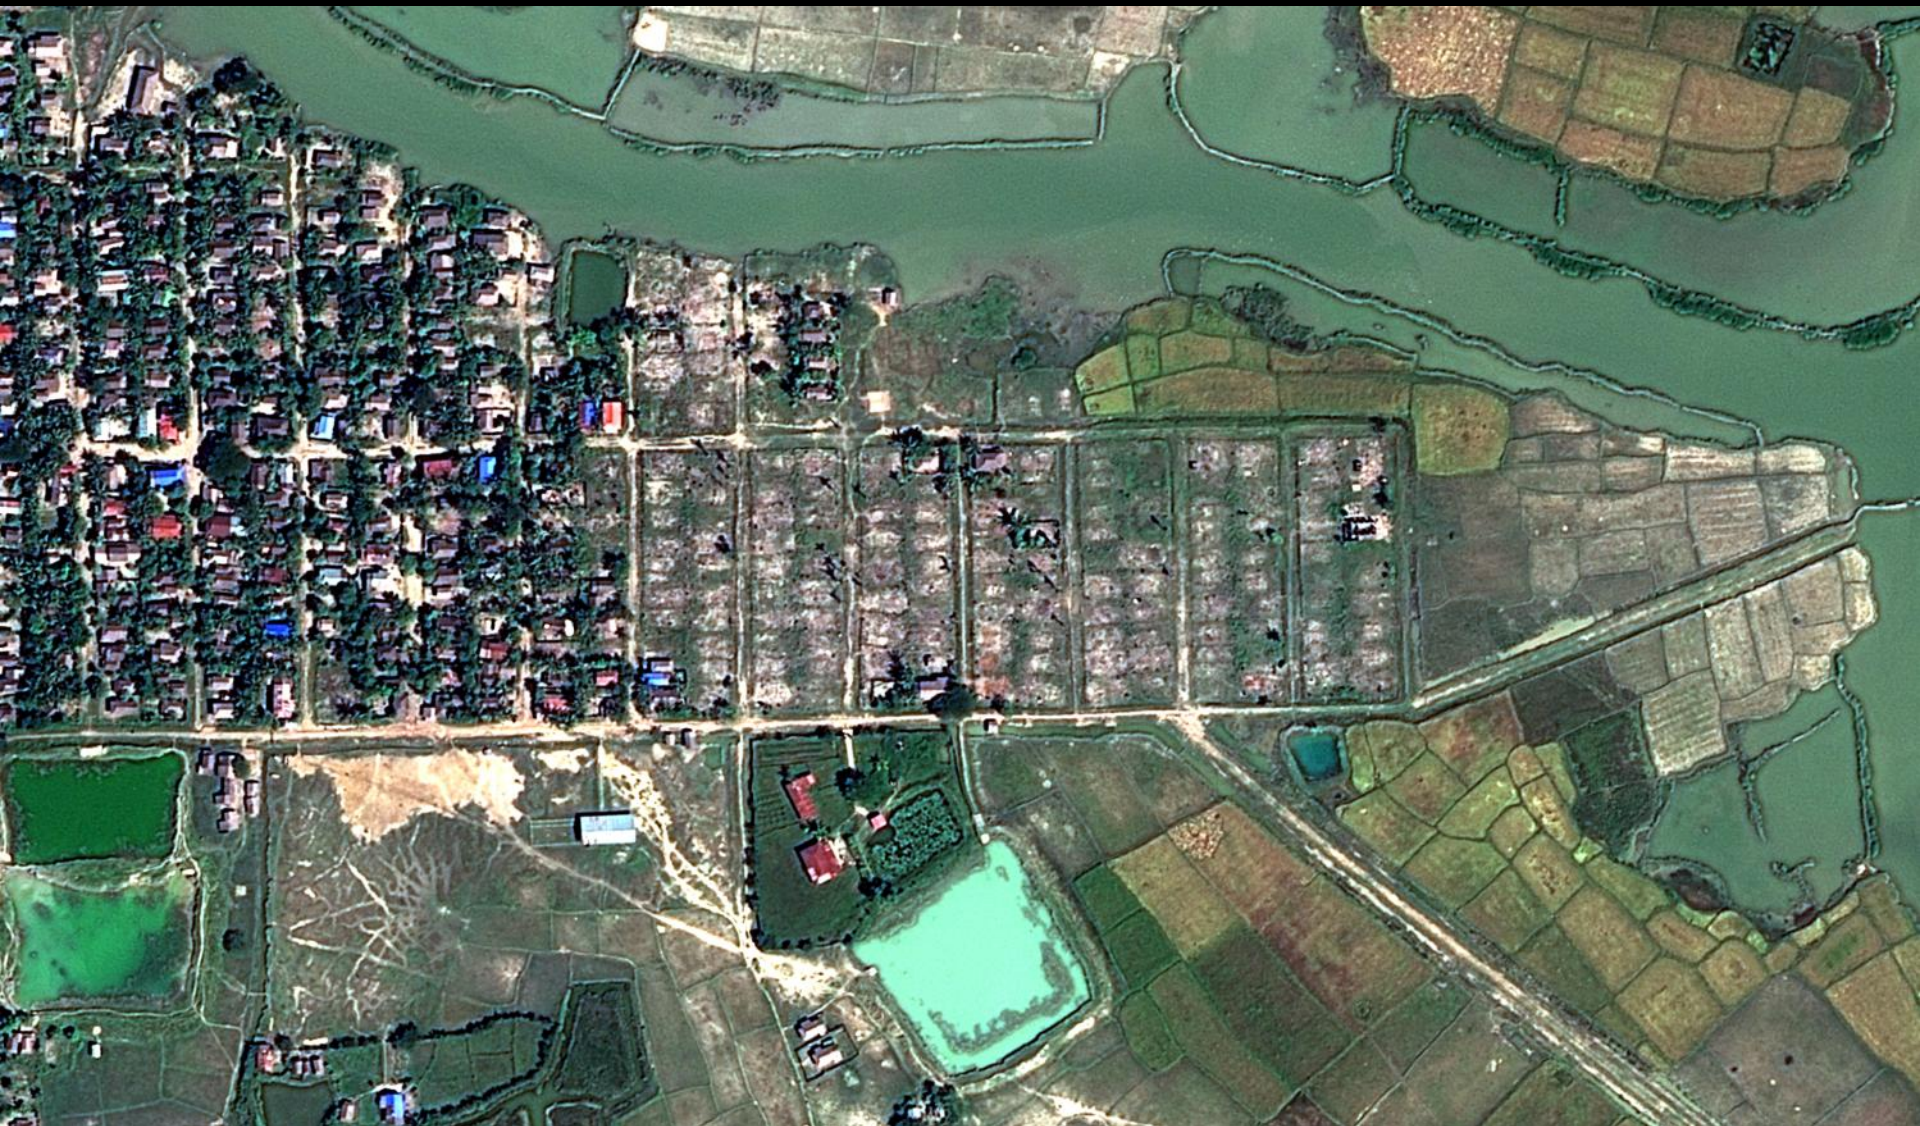
Sittwe (Destruction Zone 2) on 31 October 2012

Post-attack view of northern-most concentration of building destruction

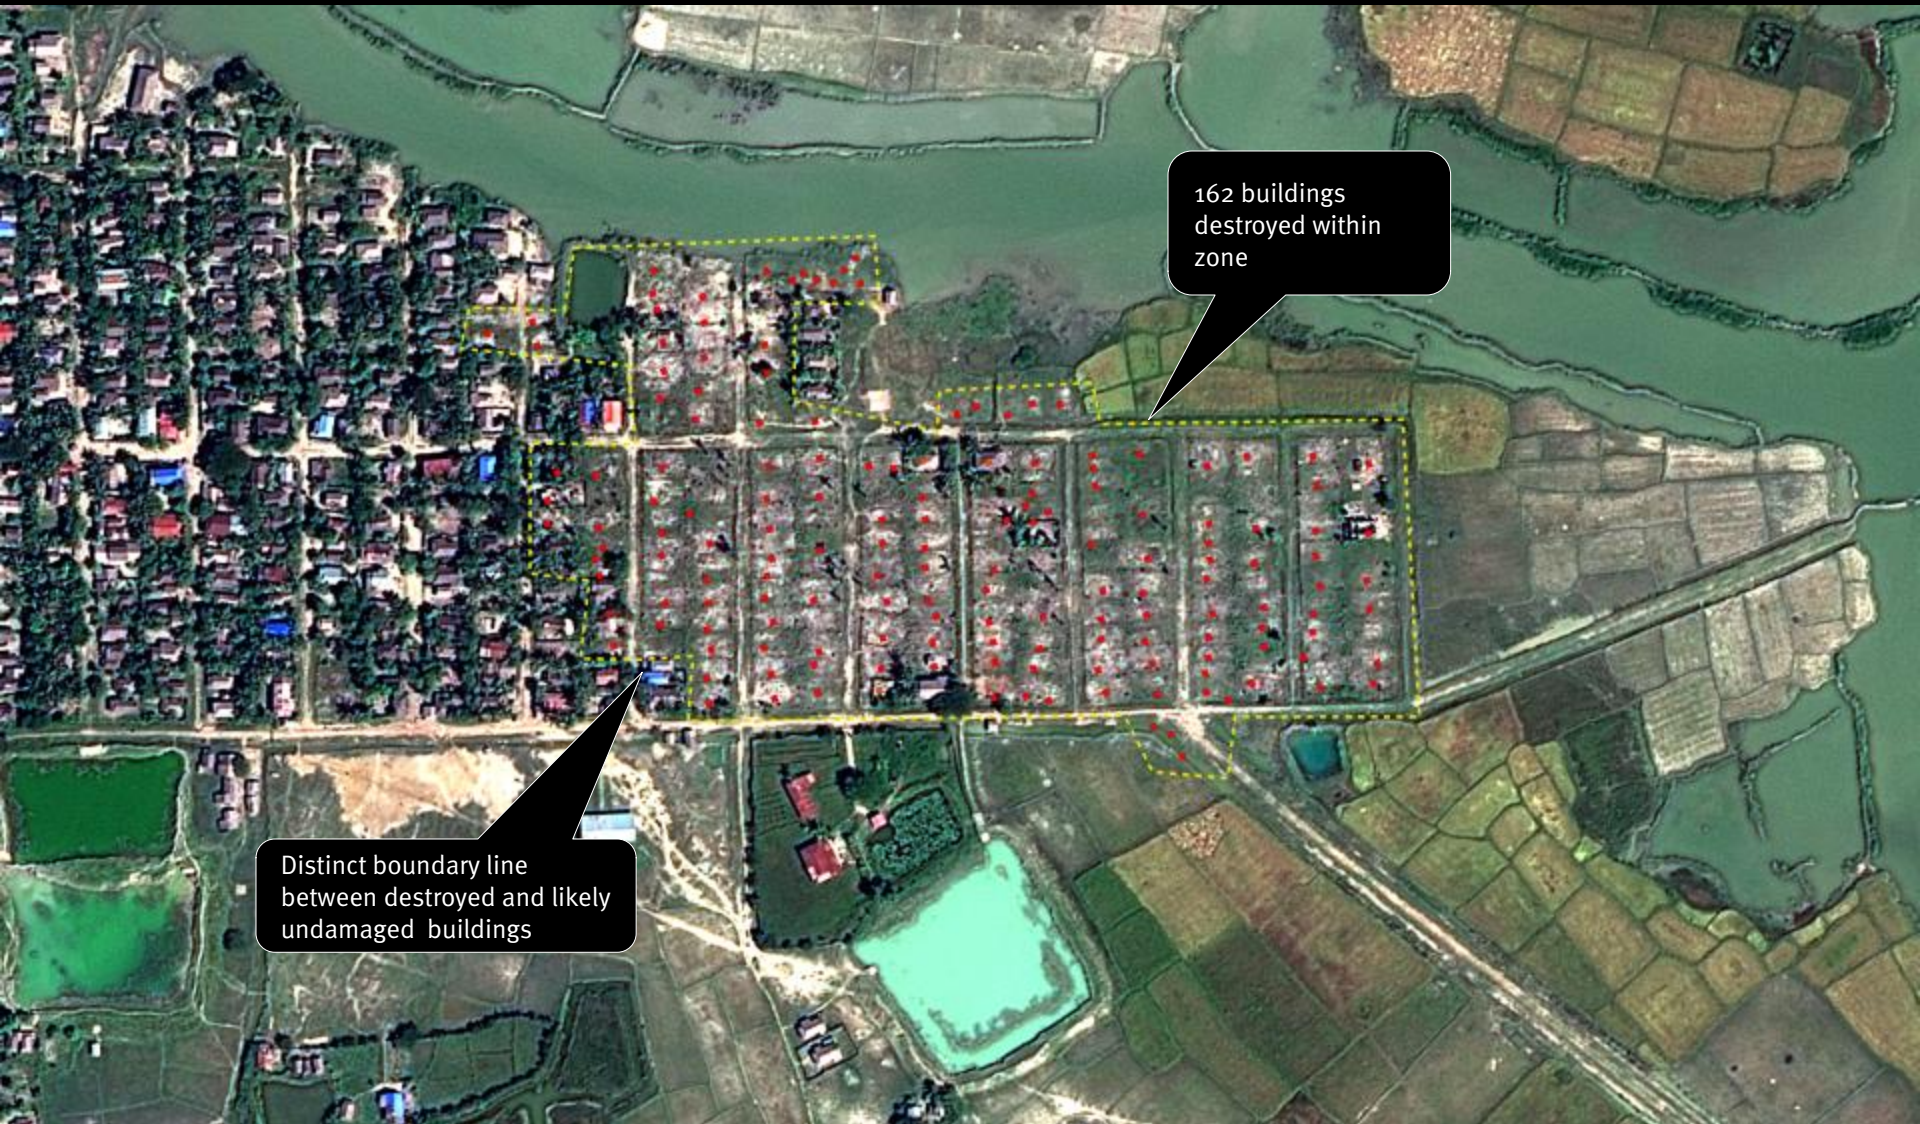
Sittwe (Destruction Zone 2) on 31 October 2012:

Post-attack view of northern-most concentration of building destruction—Damage sites annotated

162 buildings destroyed within zone

Distinct boundary line between destroyed and likely undamaged buildings

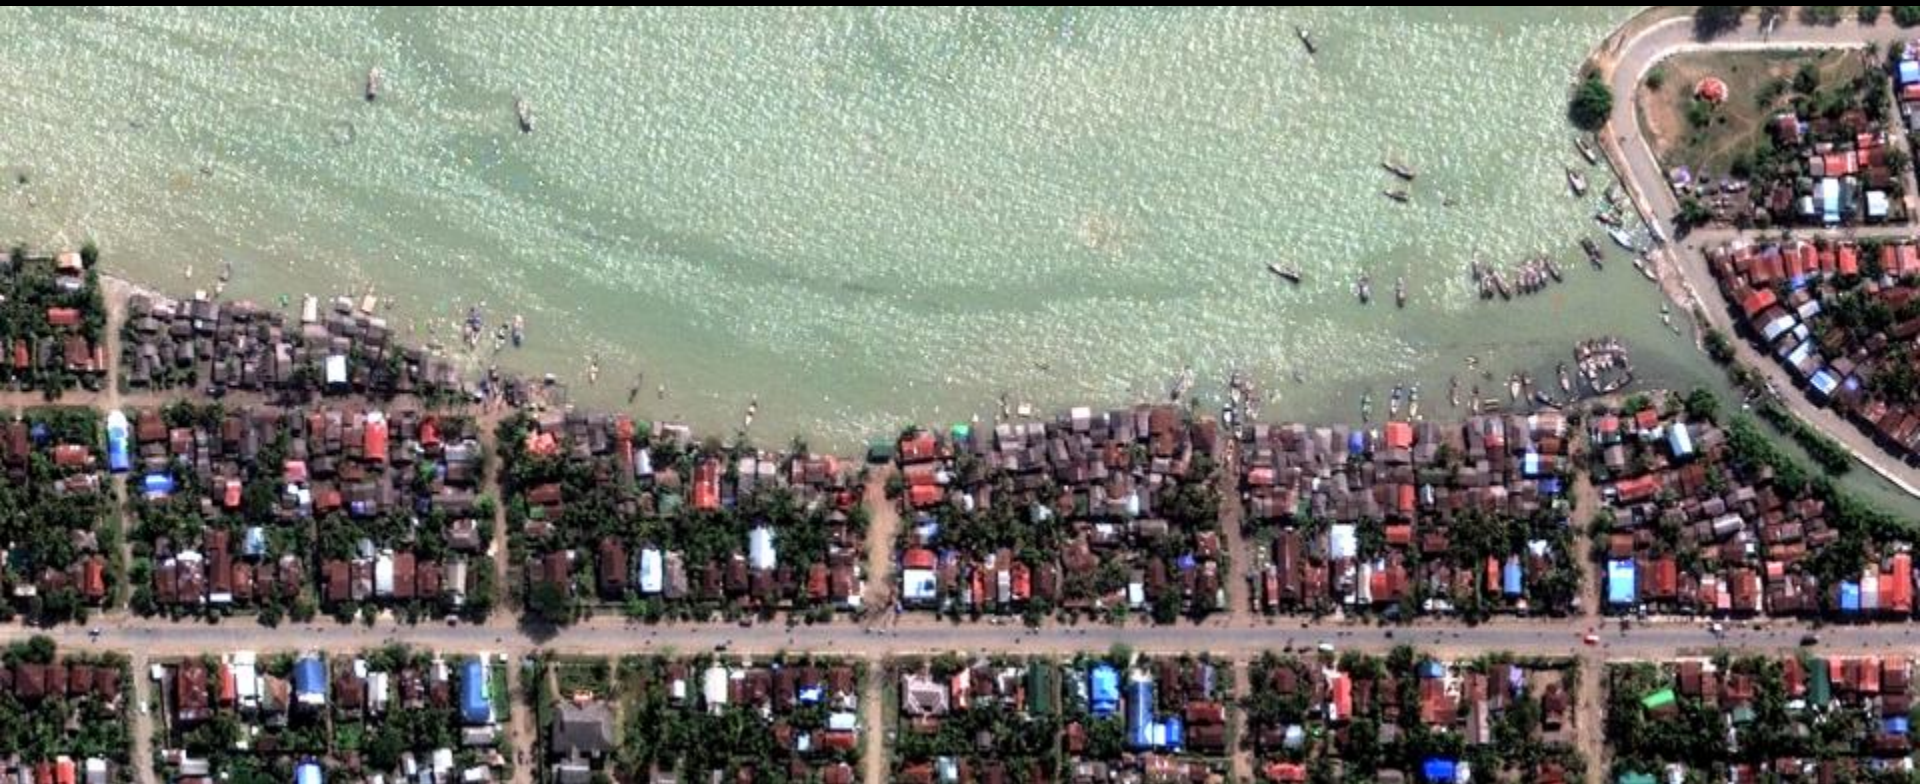
Sittwe (Destruction Zone 3) on 21 February 2011

Pre-attack view of concentration of building destruction along water front

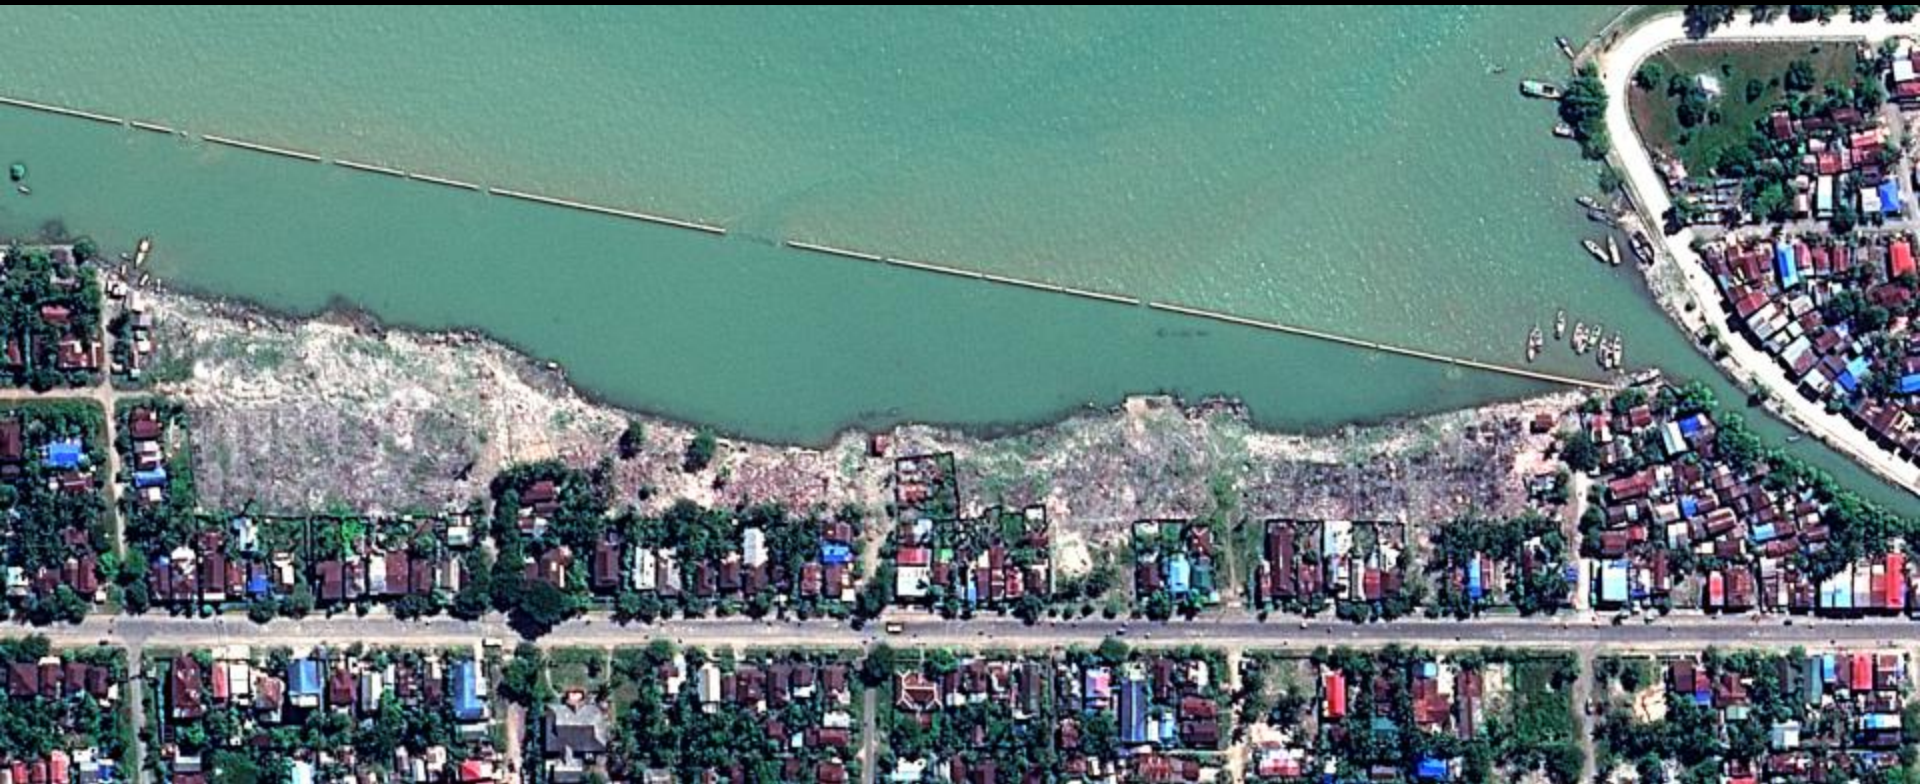
Sittwe (Destruction Zone 3) on 31 October 2012

Post-attack view of concentration of building destruction along water front

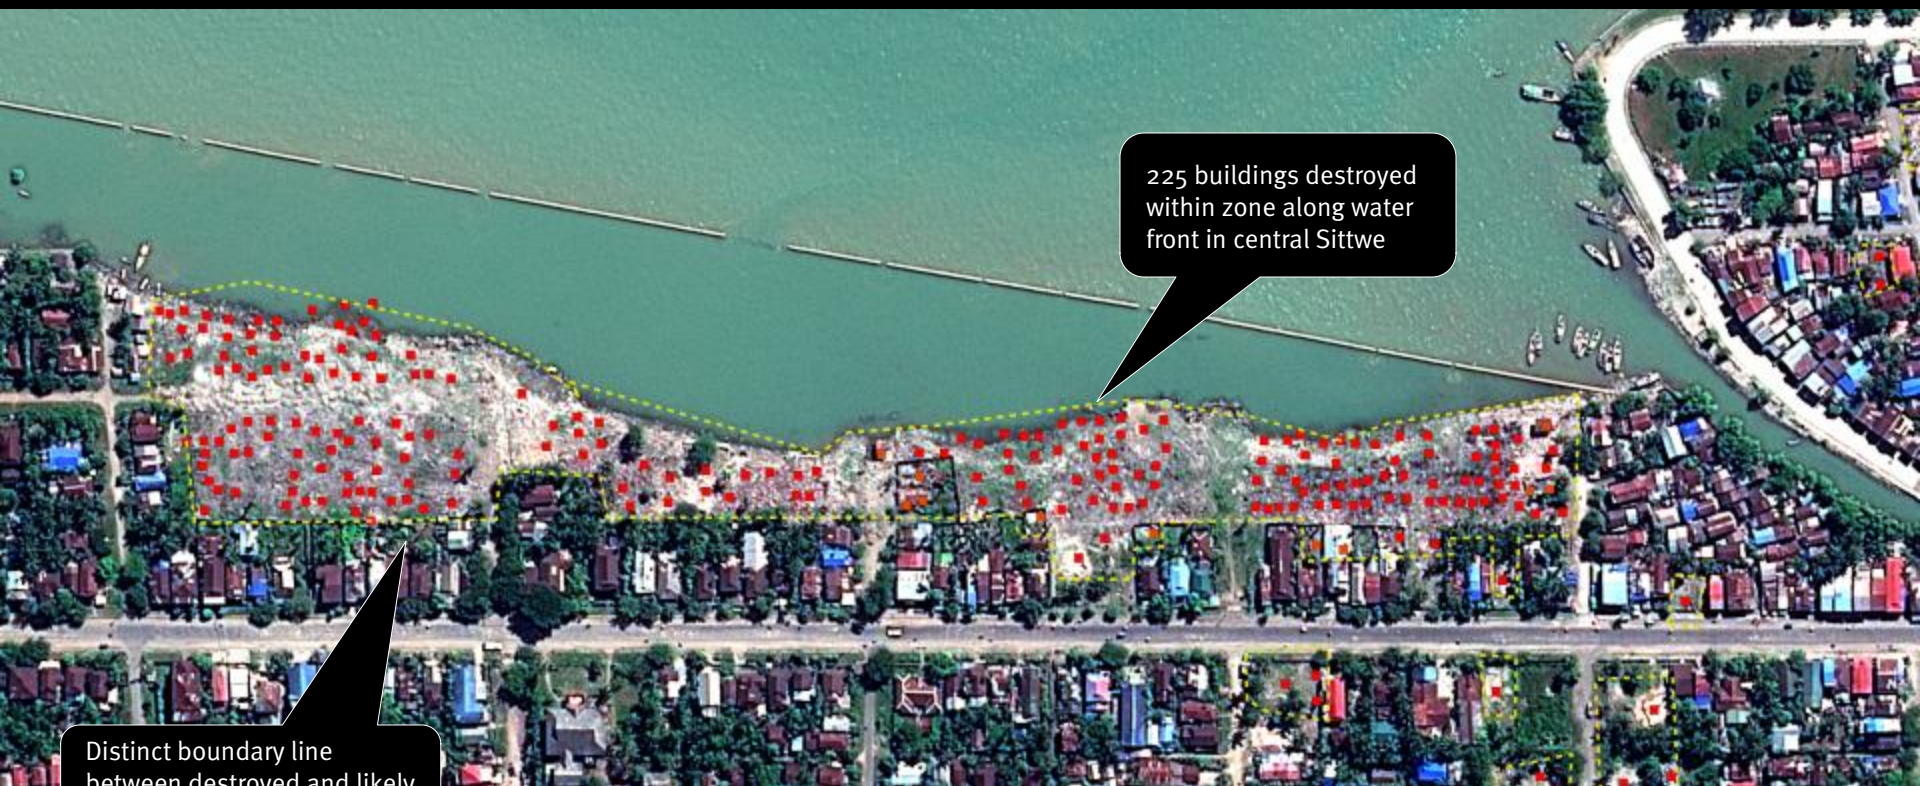
Sittwe (Destruction Zone 3) on 31 October 2012

Post-attack view of concentration of building destruction along water front

225 buildings destroyed within zone along water front in central Sittwe

Distinct boundary line between destroyed and likely undamaged buildings
