Satellite-Based Damage Assessment for Town of Pauktaw, Pauktaw Township

Assessment based on satellite imagery recorded on morning of 8 November 2012

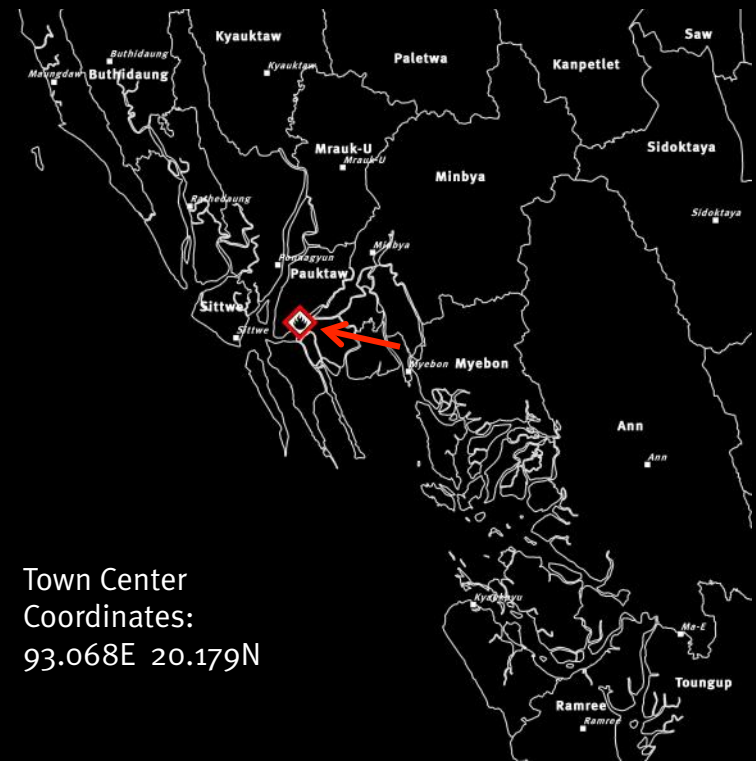
Pauktaw, Pauktaw Township, on 8 November 2012

Post-attack overview of the two zones of building destruction

First zone of destruction
measuring 5.8ha in area:
total of 294 buildings
destroyed

Second zone of destruction
measuring 4.8ha in area:
total of 198 buildings
destroyed

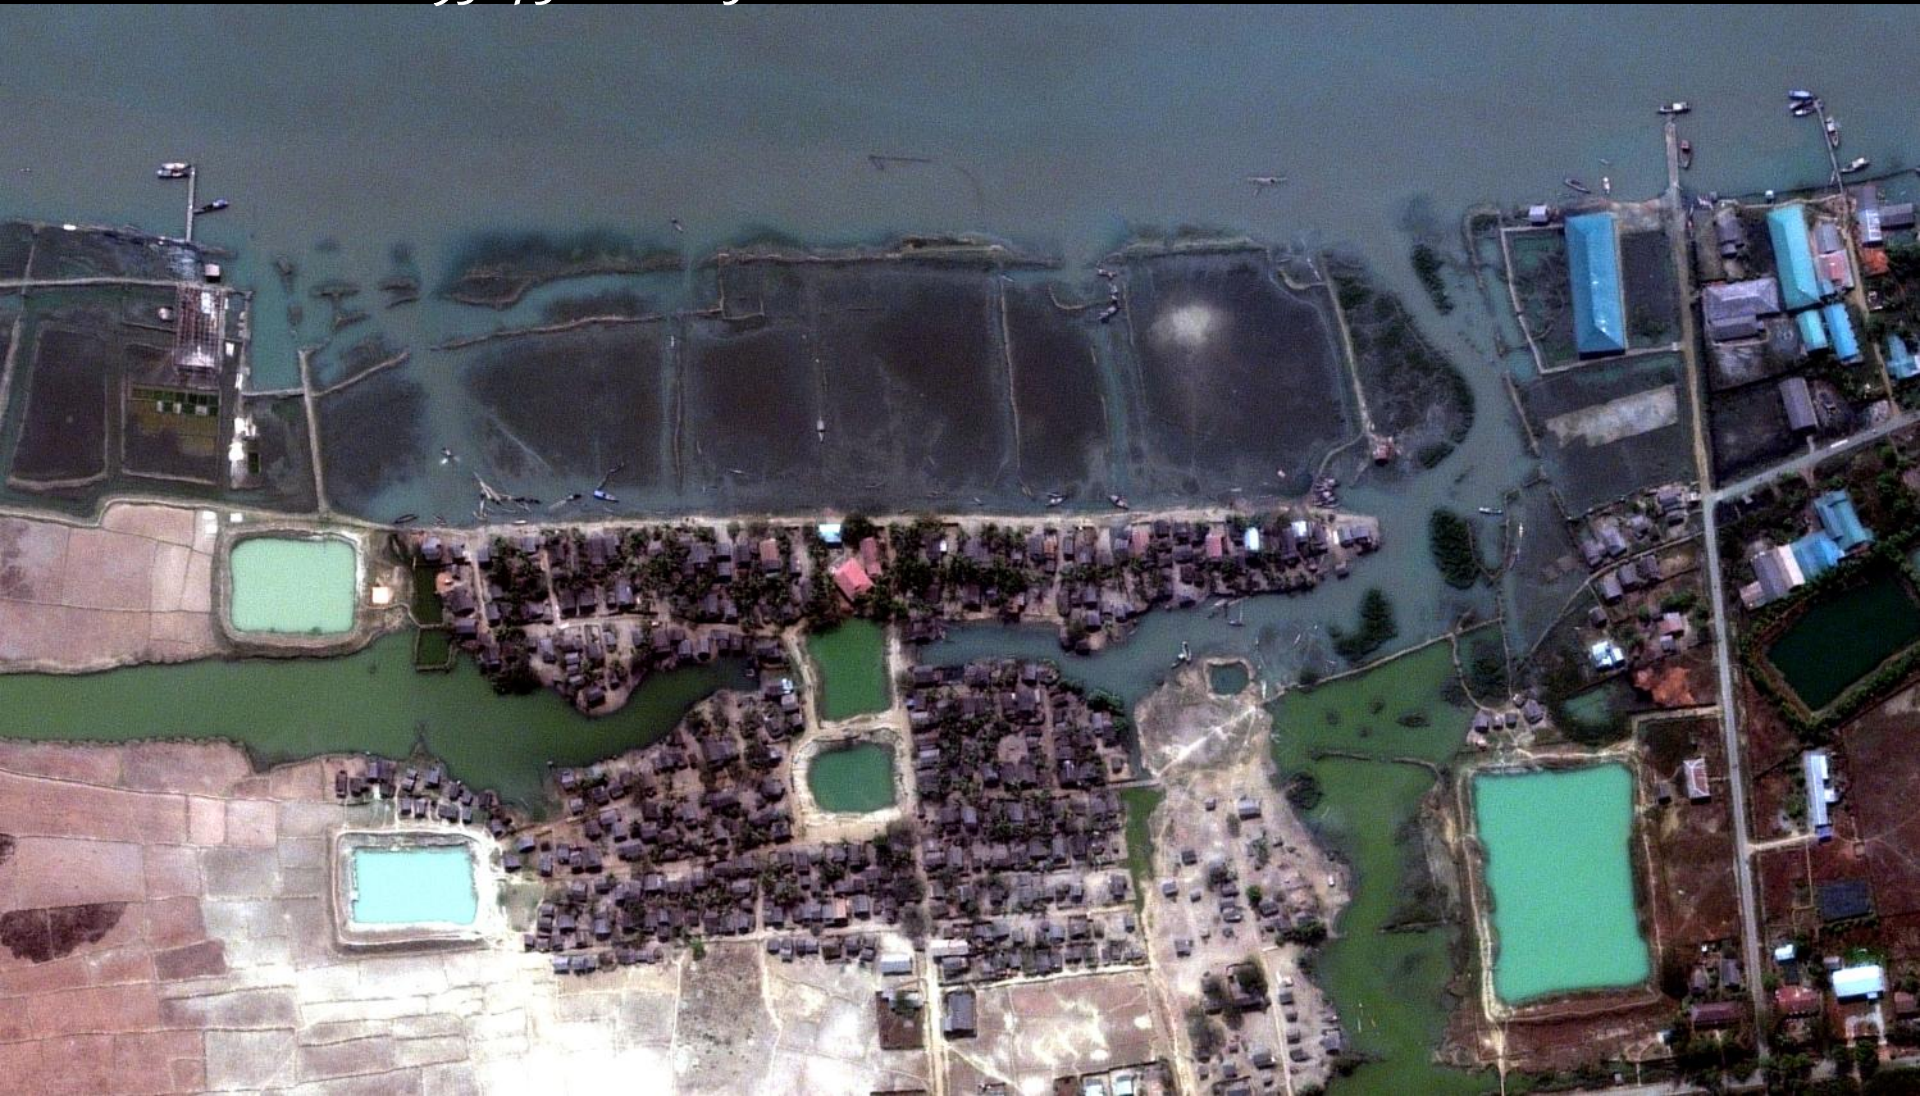
Pauktaw, Pauktaw Township, on 18 February 2010

Pre-attack focus on the first zone of building destruction

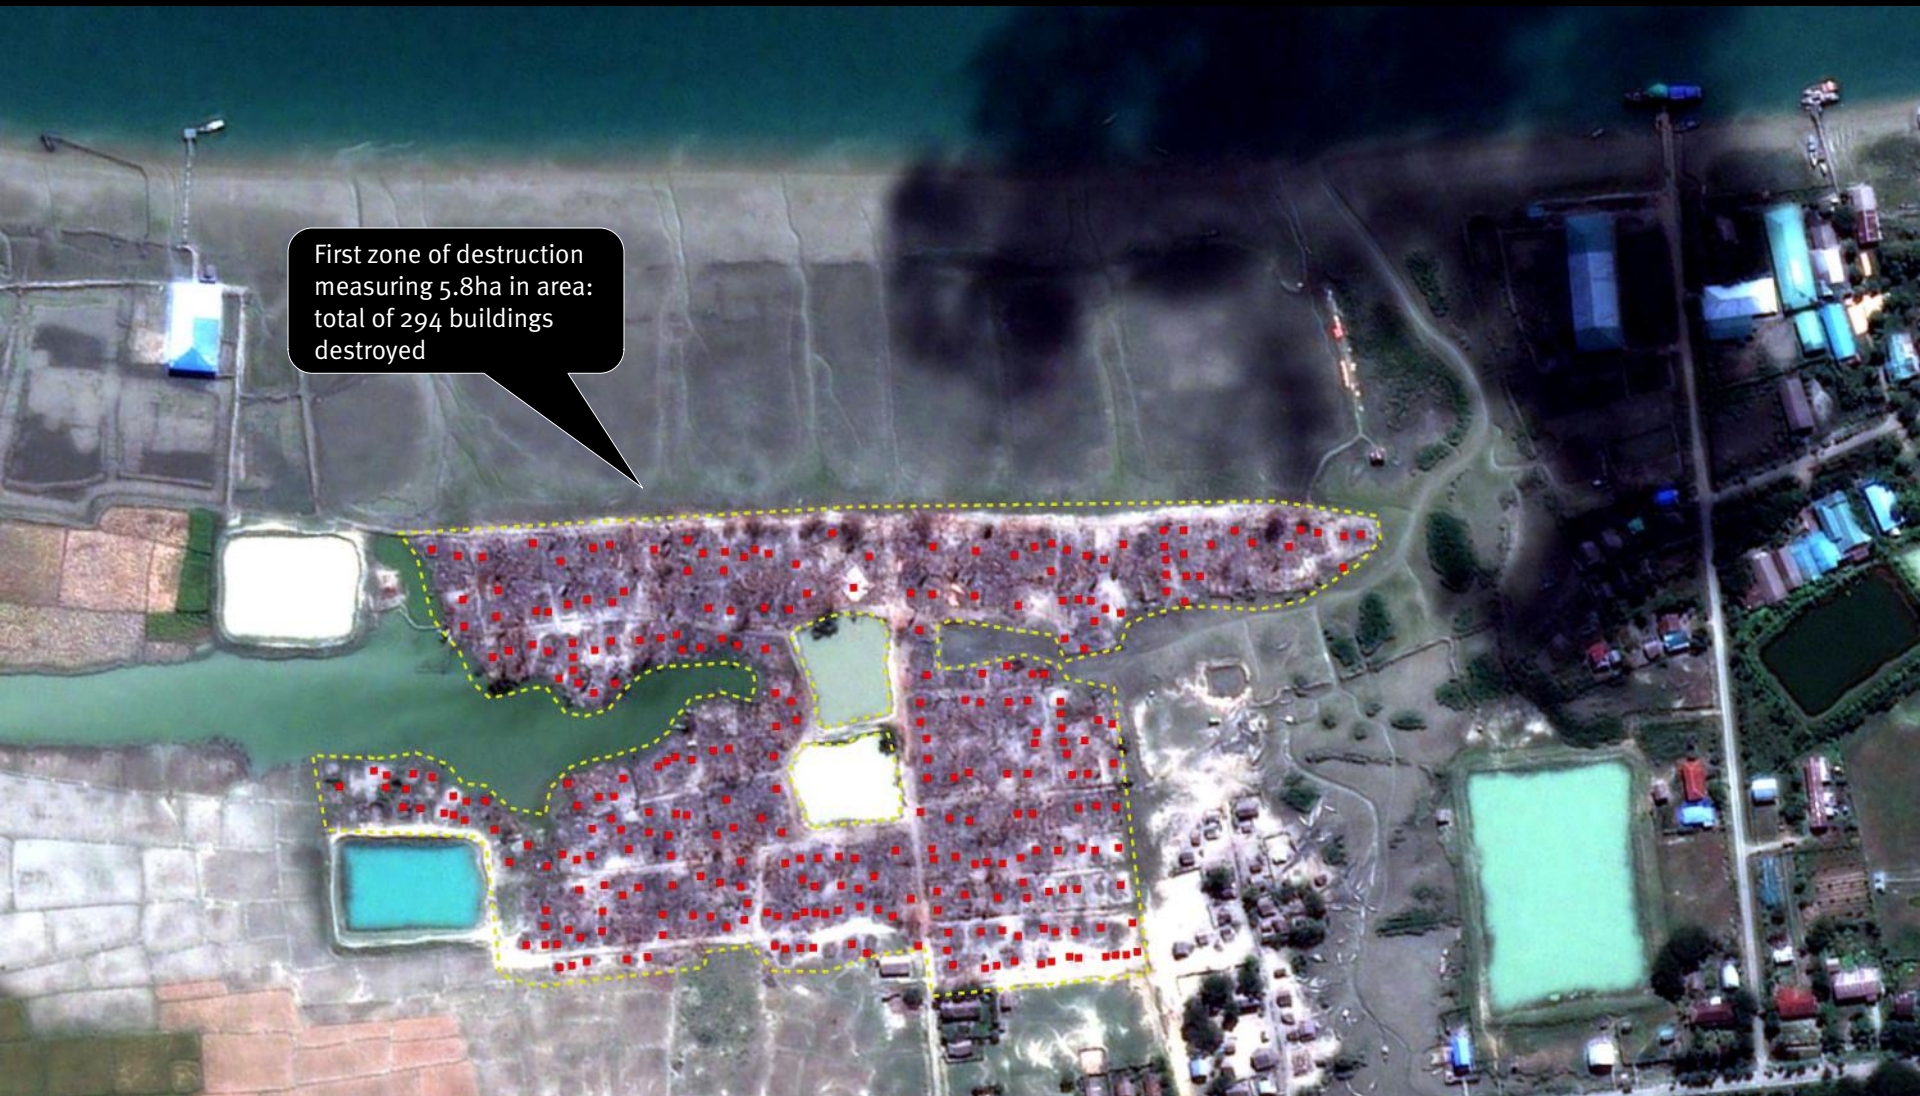
Pauktaw, Pauktaw Township, on 8 November 2012

Post-attack focus on the first zone of building destruction with annotated building damages

First zone of destruction measuring 5.8ha in area: total of 294 buildings destroyed

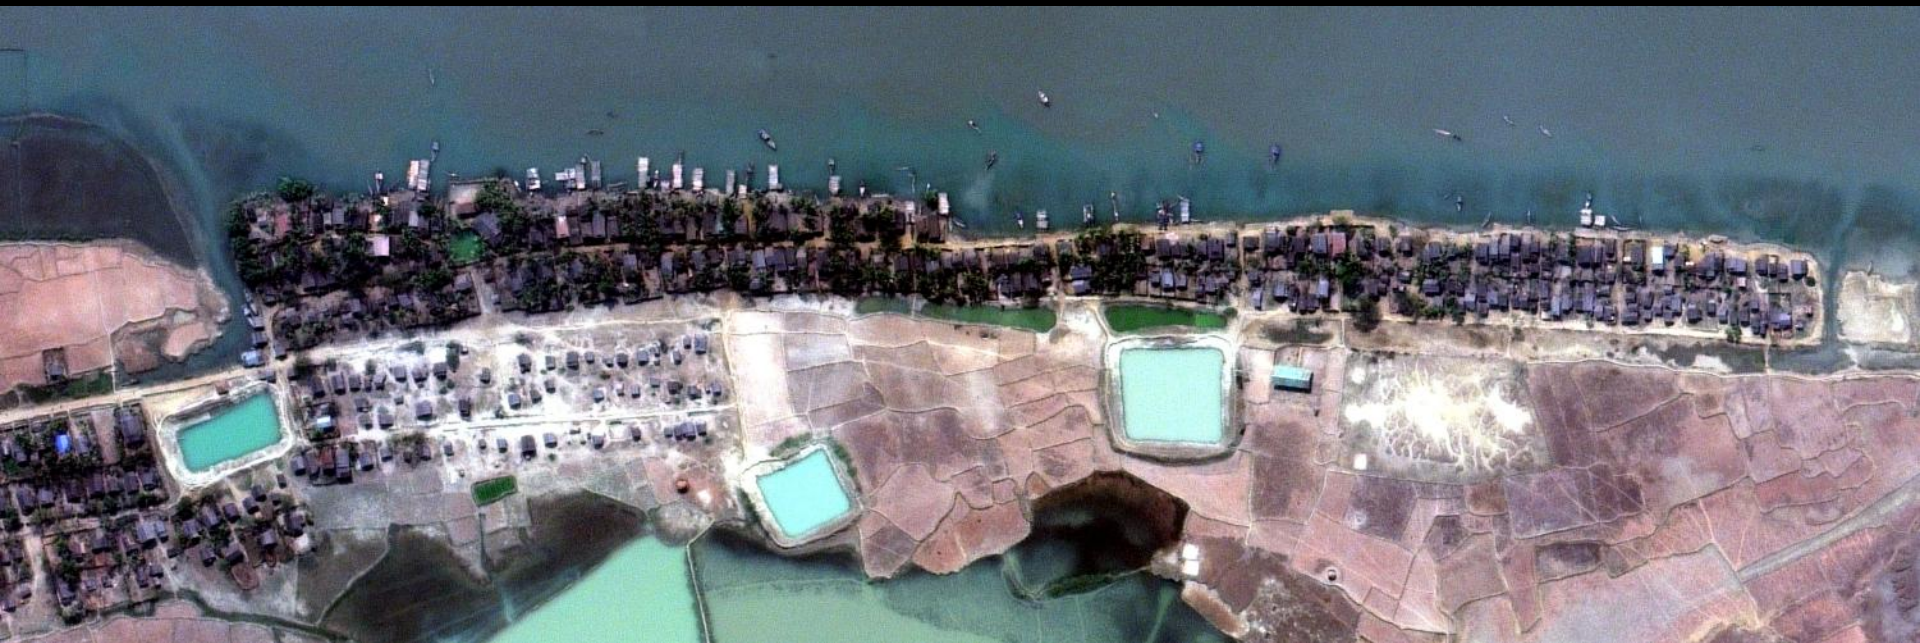
Pauktaw, Pauktaw Township, on 18 February 2010

Pre-attack focus on the second zone of building destruction
