TECHNICAL ORIENTATIONS

FOR *BUILDING BACK SAFER* INTERVENTIONS

Draft 24th April 2019

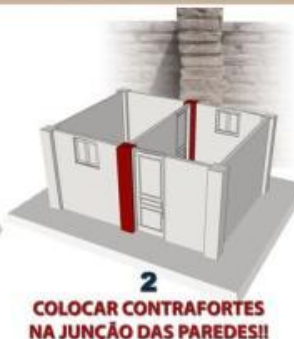
1
REFORÇAR OS CANTOS COM
CONTRAFORTES
DE BLOCOS!!

2
COLOCAR CONTRAFORTES
NA JUNÇÃO DAS PAREDES!!

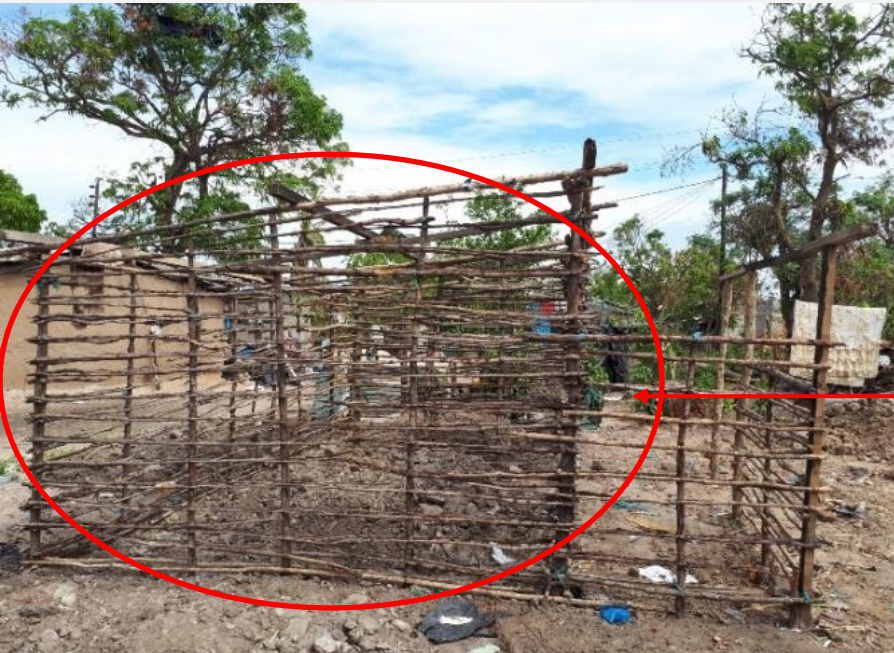
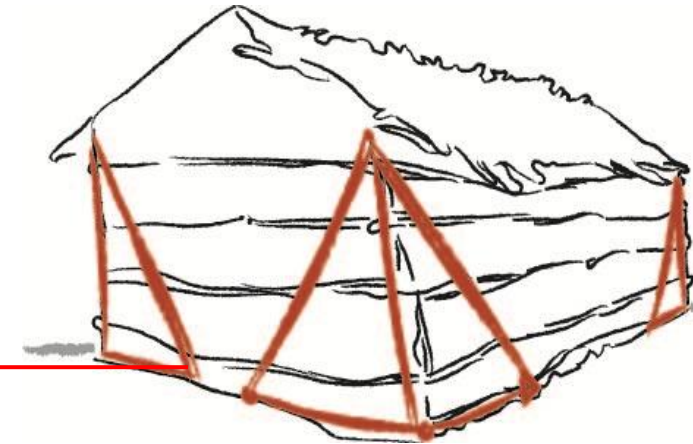
WALLS BRACING

- Possible interventions on existing houses:
- Reinforcement and bracing of the walls
 - Reinforcement of the corners and connections of the walls

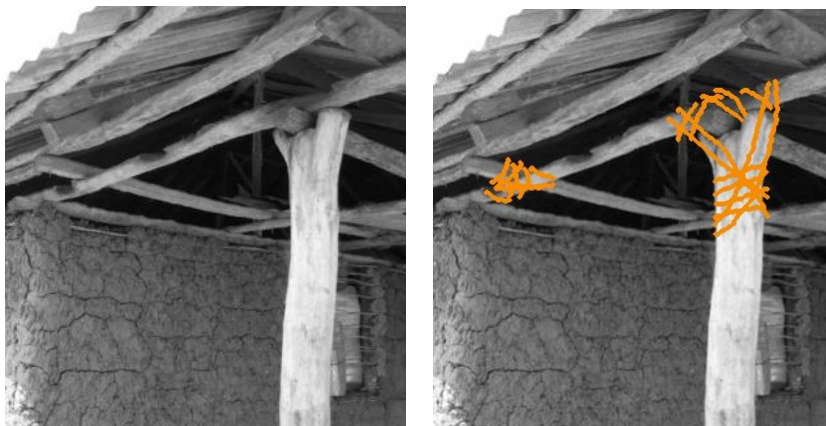
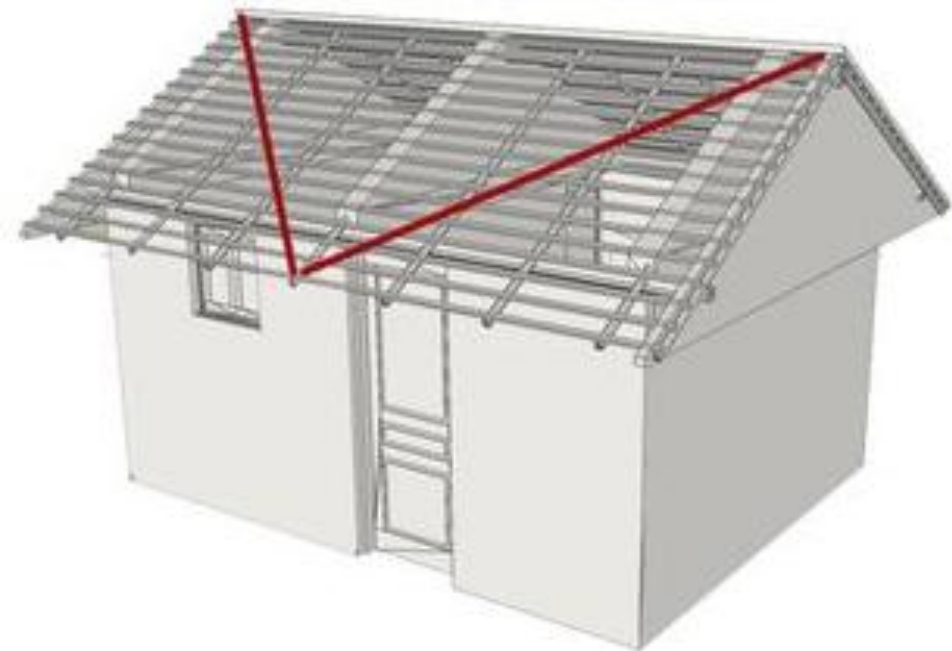
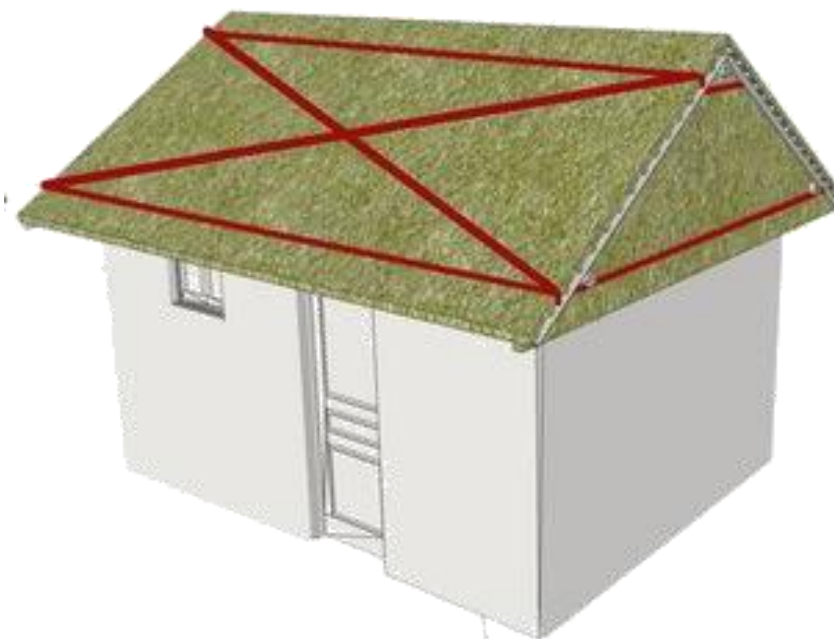
REINFORCEMENT OF ROOF / STRUCTURE CONNECTIONS

ROOF BRACING AND CONNECTIONS OF THE COVER (CGI, THATCH) TO THE ROOF STRUCTURE
