Cyclone-resistant houses for developing countries

Alan Mayo

Building Research Station

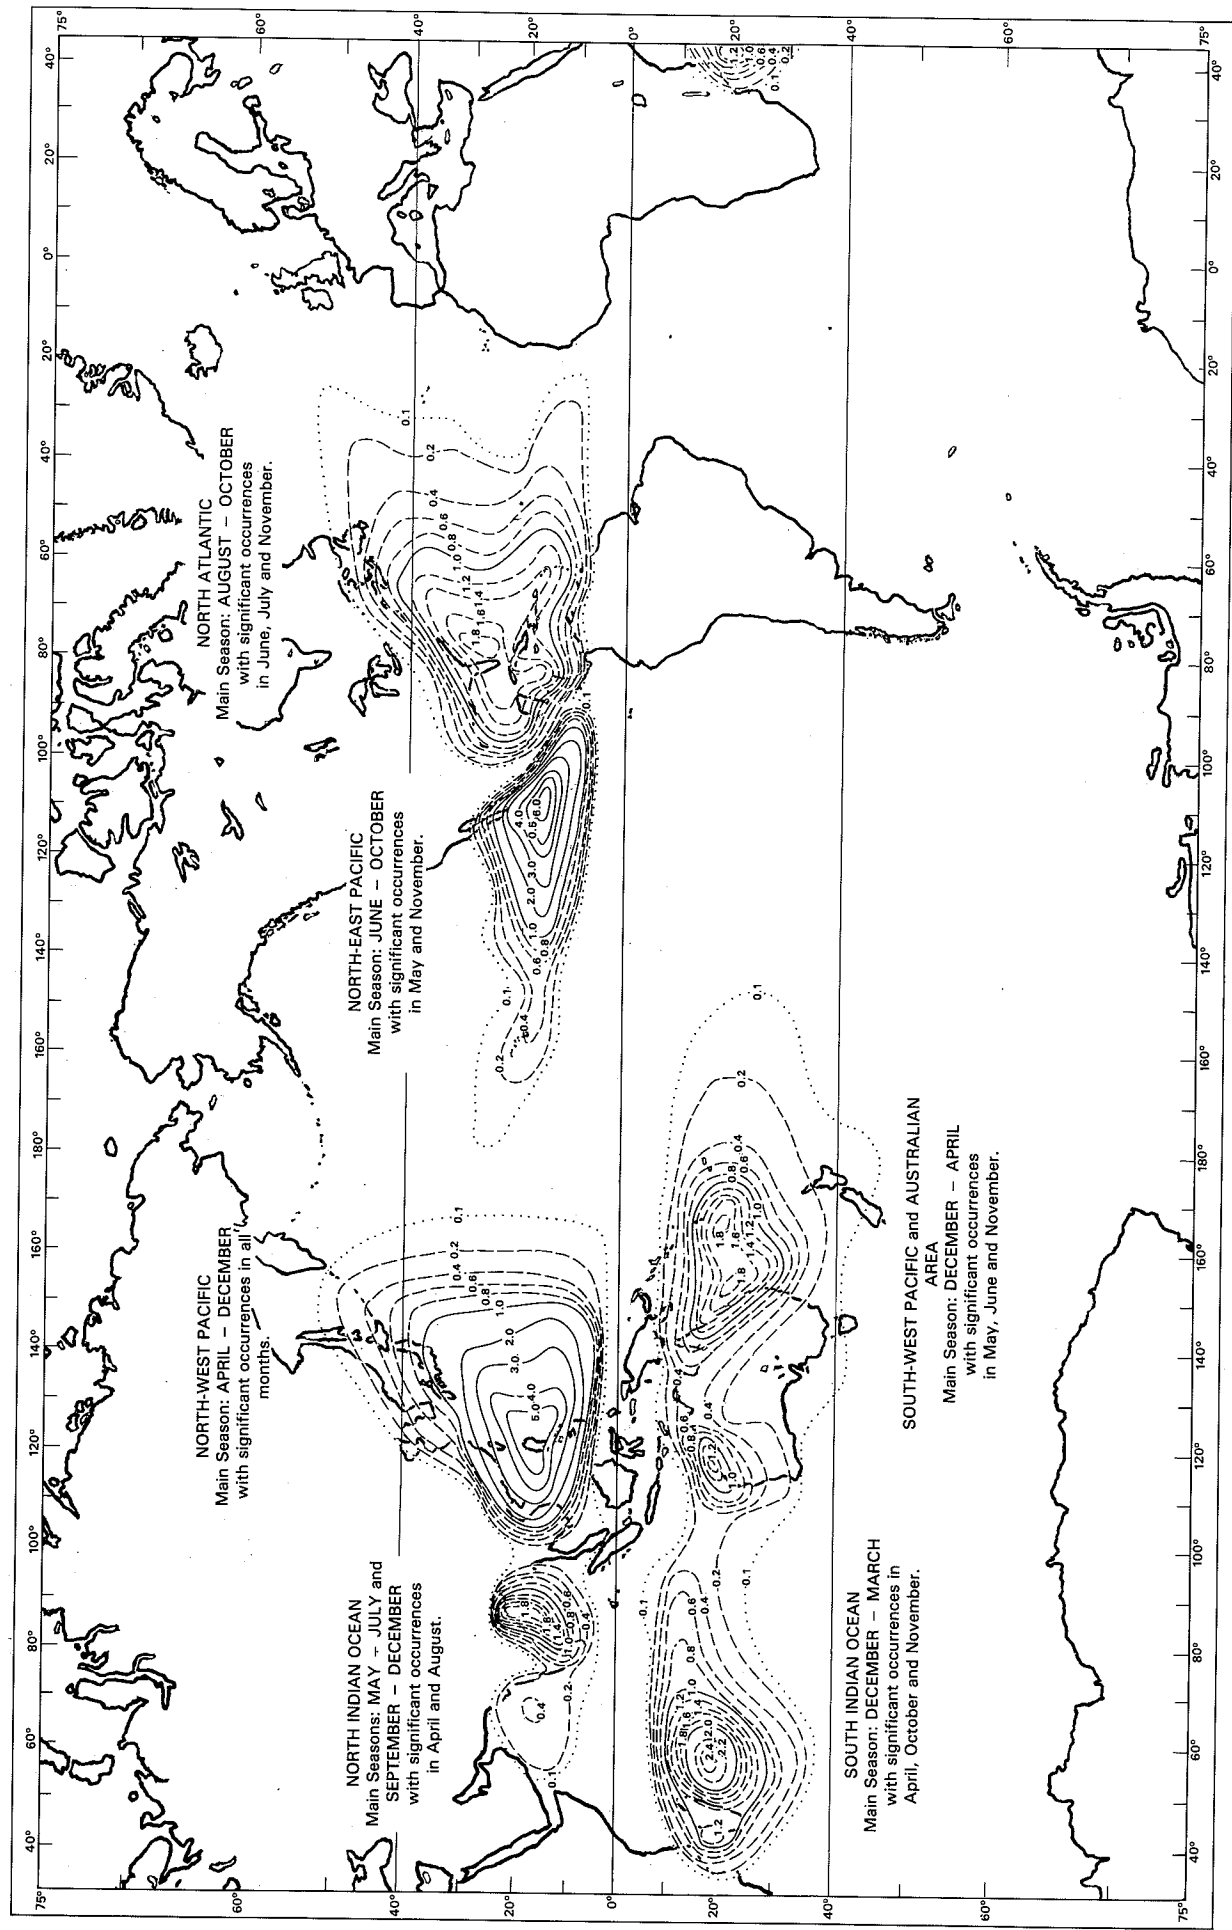
Figure 1 Areas of tropical cyclones showing the average number of occurrences per five-degree square per year

Cyclones originate over tropical oceans and seas when air is still and the water warm. These conditions can exist for lengthy periods during late summer in six main areas of the world¹ (Figure 1). Many cyclones dissipate at sea but those which come ashore can cause serious damage to buildings (Figure 2) resulting in many people being made homeless as well as causing injury and loss of life.

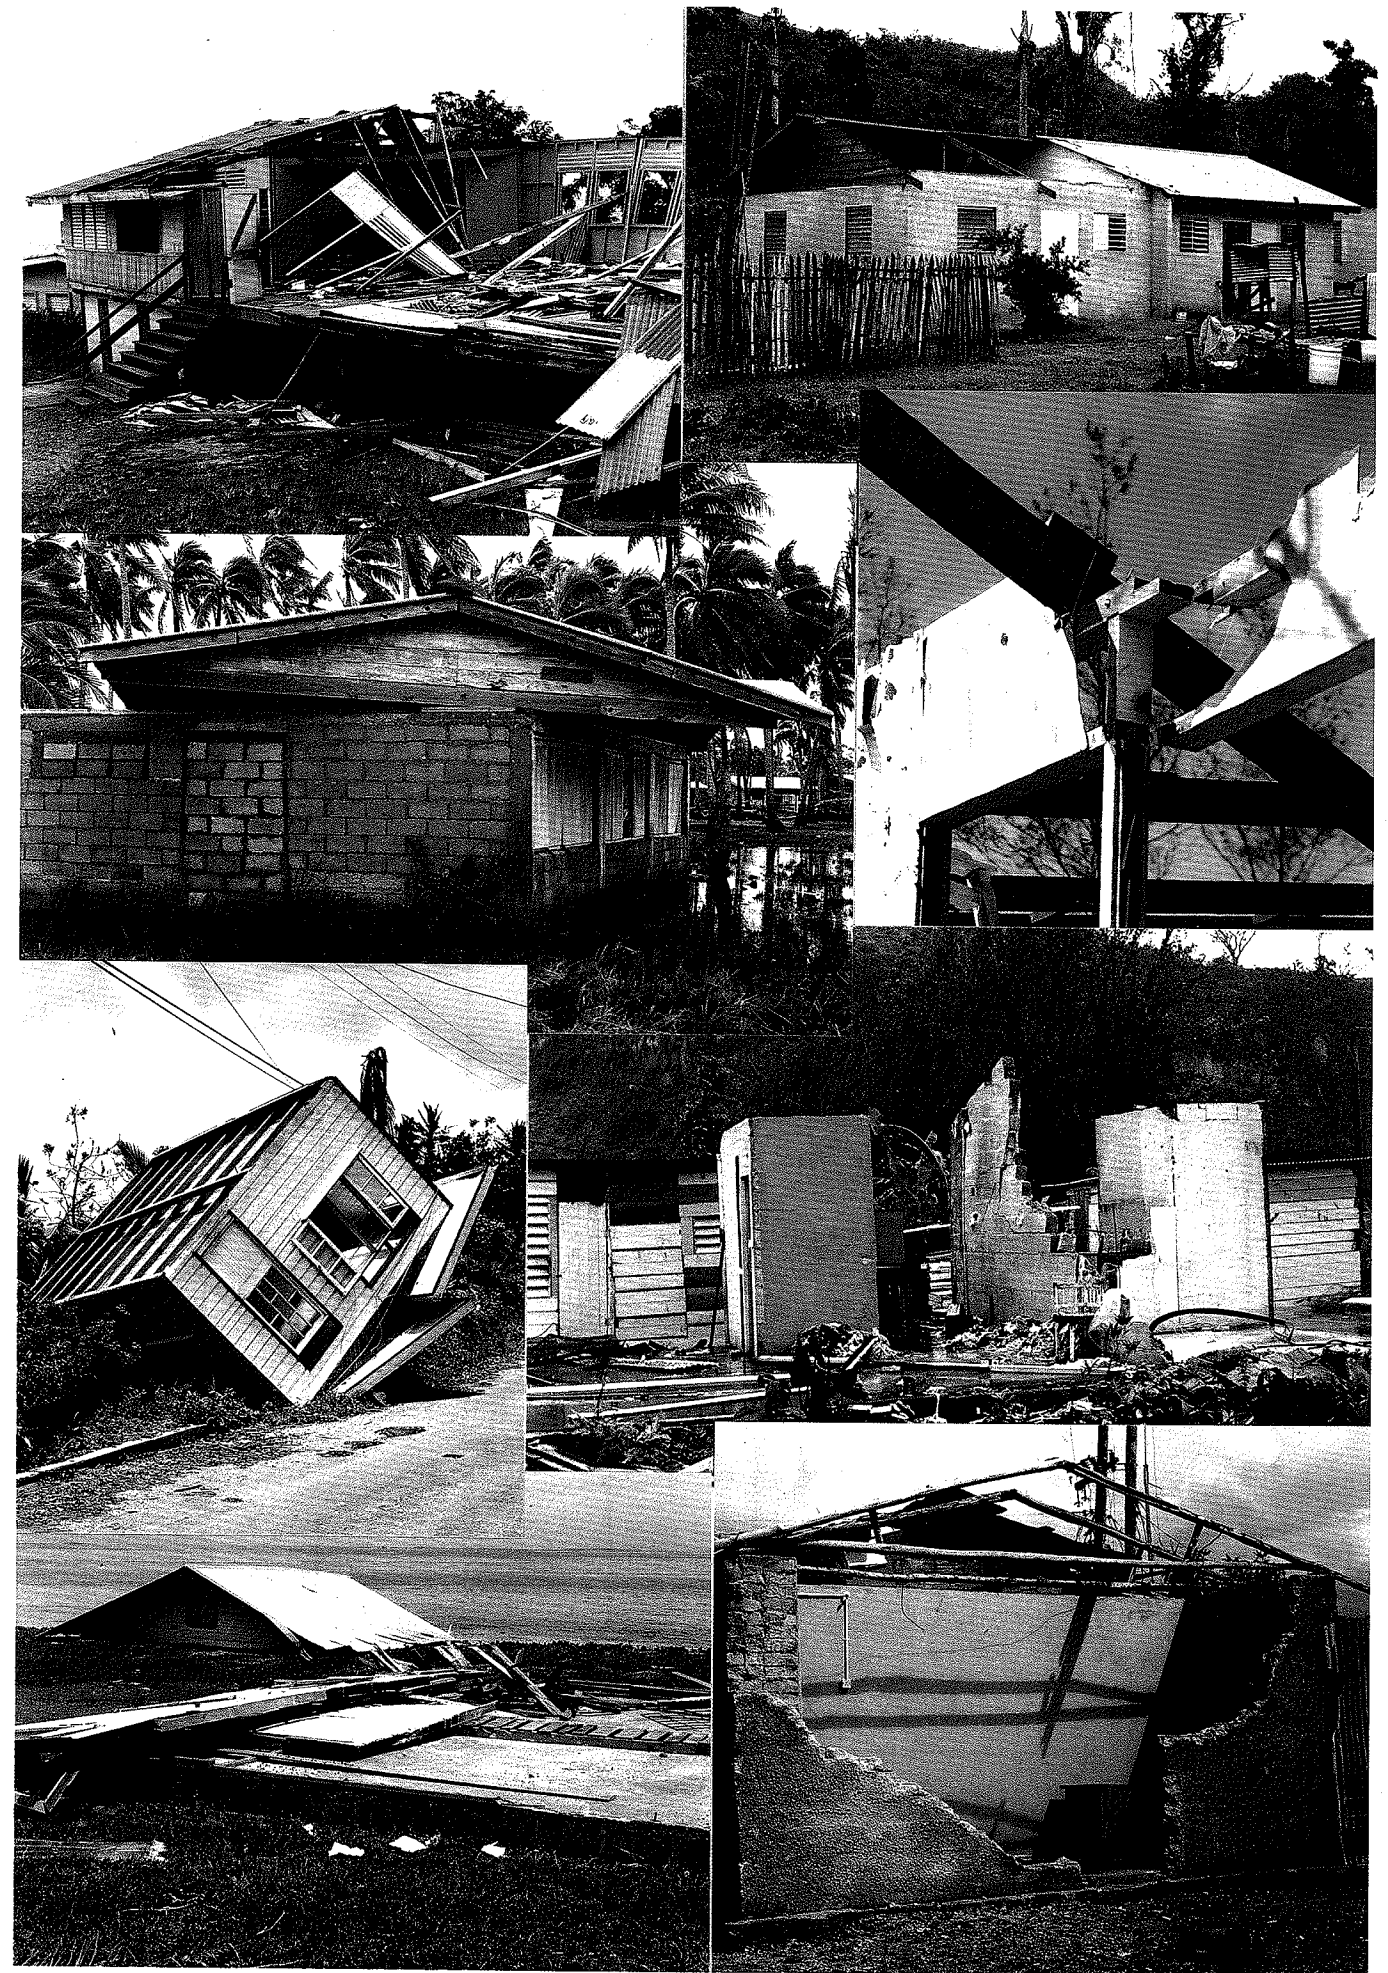
Figure 2 Examples of damage to buildings by cyclones

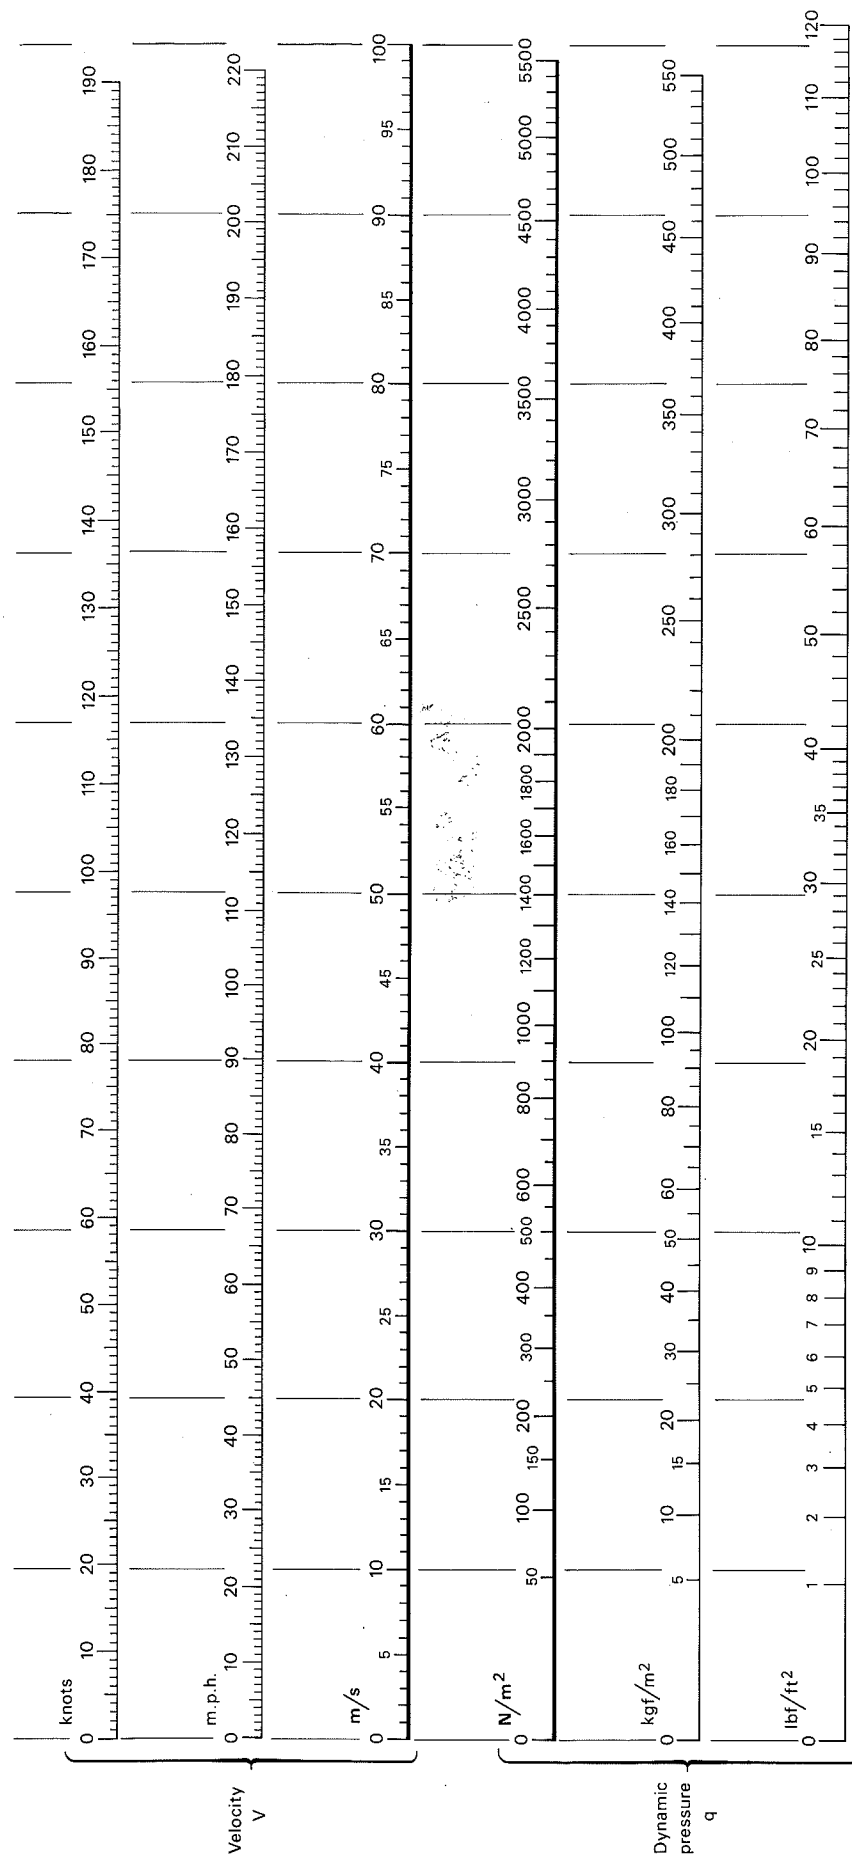
Table 1 Conversion chart for wind speed and dynamic pressure

1 m/s = 1.95 knots = 2.24 mph
 1 kgf = 9.81 Newtons (N) = 2.21 lbf

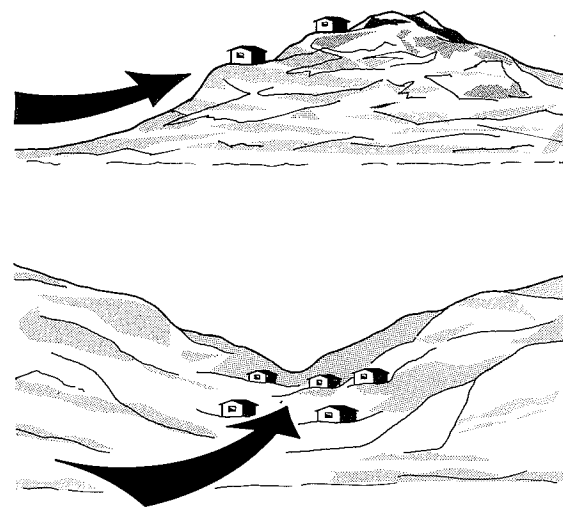
Figure 3 Hills and open-ended valleys increase wind speeds

Topography is an important factor influencing wind speeds, particularly near the tops of hills and along the bottoms of open-ended valleys where increases in wind speed of between 10 and 20% are common (Figure 3).

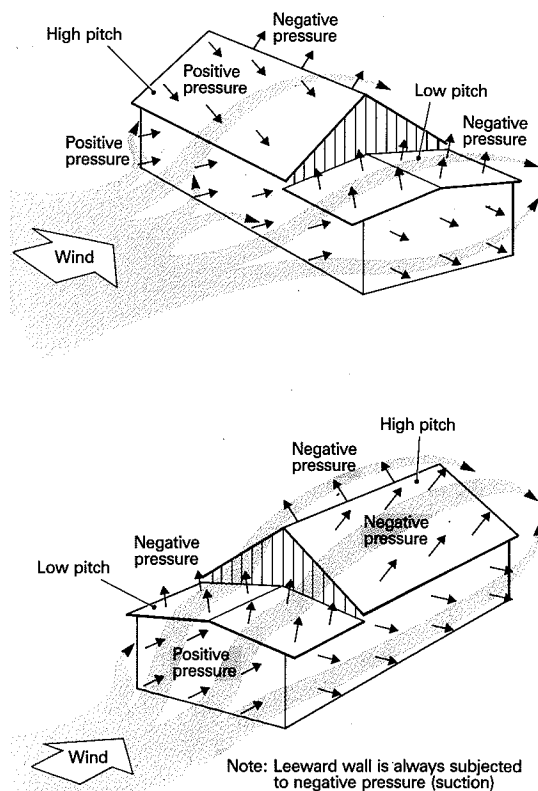
Figure 4 Wind forces on walls and roofs of buildings are affected by direction of wind and shape of buildings

The forces exerted by the wind on the walls and roof of a building are governed not only by the wind speed, but also by the shape of the building and the direction of the wind relative to the building (Figure 4).

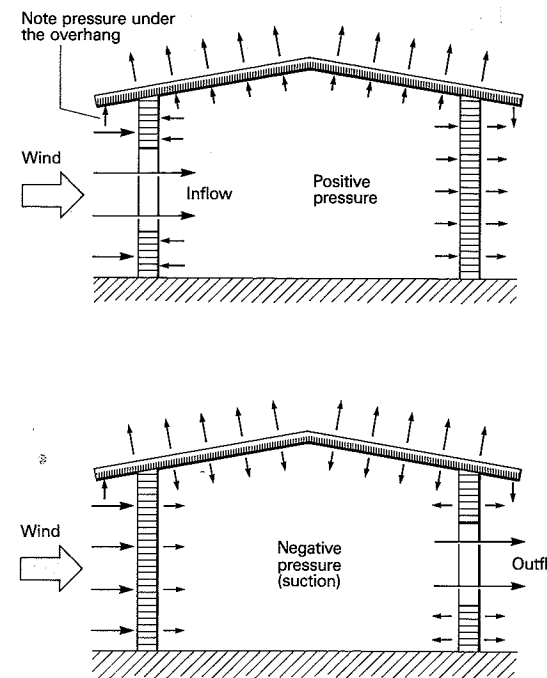
Figure 5 The effect of openings in windward and leeward faces

The total wind force on a wall or roof depends on the difference between the pressures on the inner and outer faces of the wall or roof. Open doors, windows and ventilators on the windward side of a building cause the air pressure to increase inside the building. This has the effect of increasing the total force on those elements of the building which experience external negative pressures, and reducing the total force on those elements subjected to external positive pressures (Figure 5).

Conversely, openings in walls in the lee or parallel to the wind direction cause a reduction in air pressure inside the building. This increases the total force on the windward wall and counteracts the external negative pressures on the remaining walls and the roof.

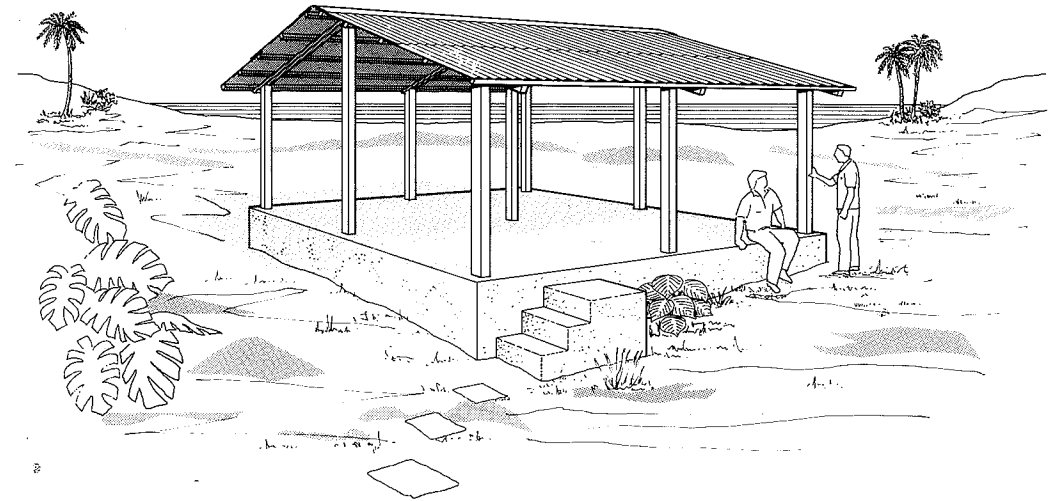
Figure 6 Building Research Establishment/Housing & Land Development Corporation St Vincent low-income house (type 1) — 45 square metres

House 1 (Figure 6) is 7.3 m × 6.1 m in plan with a solid concrete floor. The hardwood columns, beams, rafters and purlins are interconnected with rigid brackets and the roof clad with 'Onduline', a corrugated bitumen-fibre sheeting.

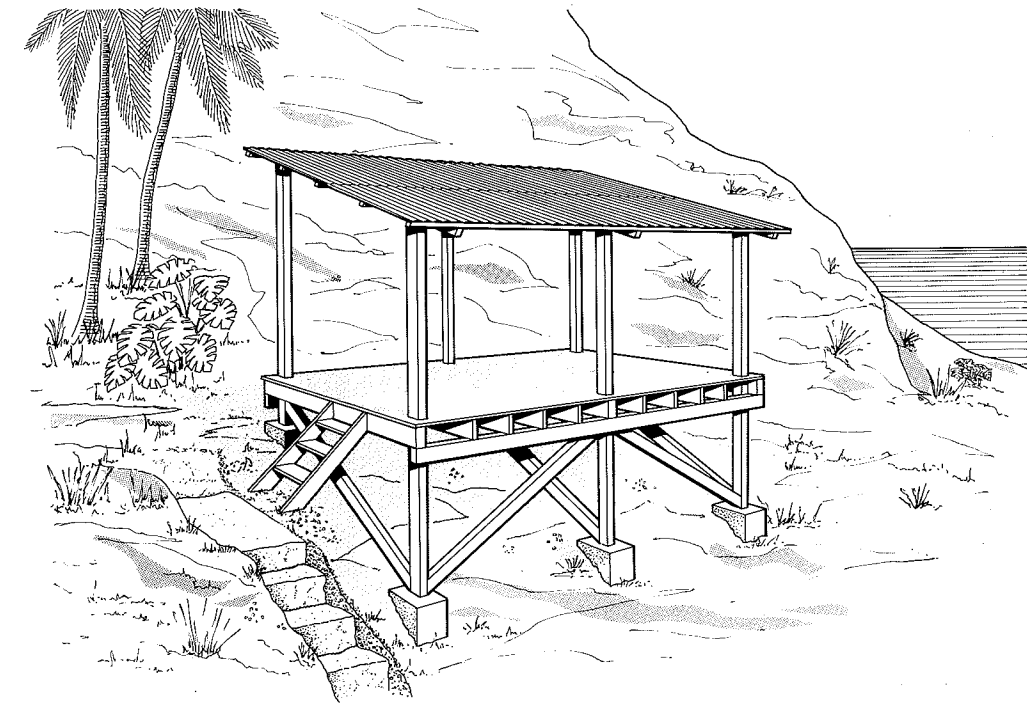
Figure 7 BRE-HLDC St Vincent low-income house (type 2) — 19 square metres

House 2 (Figure 7) is 6.1 m × 3.0 m in plan with a hardwood substructure and floor. Again, the hardwood columns, beams, rafters and purlins are all inter-connected with rigid brackets and the roof clad with 'Onduline' sheeting.

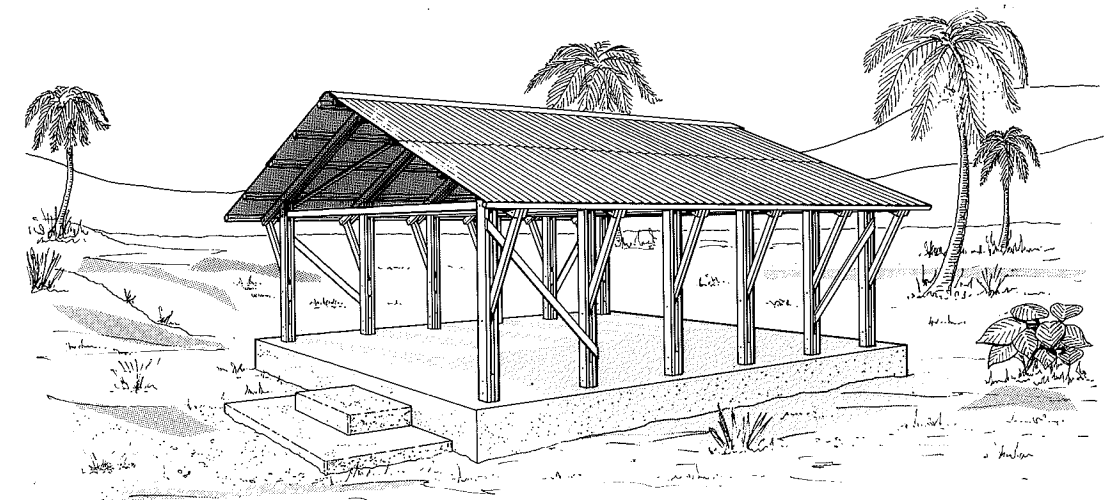
Figure 8 BRE-HLDC St Vincent low-income house/community building — 51 square metres

House 3 (Figure 8) is 7.3 m × 6.1 m in plan with a solid concrete floor. It has reinforced hollow-concrete block columns with a hardwood ring-beam, trusses and purlins, all rigidly interconnected and supporting 'Onduline' roof sheeting.

Subsequently, a fourth design was developed and a trial house constructed (Figures 8 and 9). The main features of this design are the structural strength, ie resistance to earthquakes and hurricanes; the low cost and ease of construction — permitting considerable prefabrication with the frames assembled in a jig; the use of single-size timber (50 × 100 mm) and single-size bolted joints throughout; a wide clear span up to 6.1 m, and unlimited length providing a building capable of many uses from single-family housing to community buildings such as schools and medical centres.

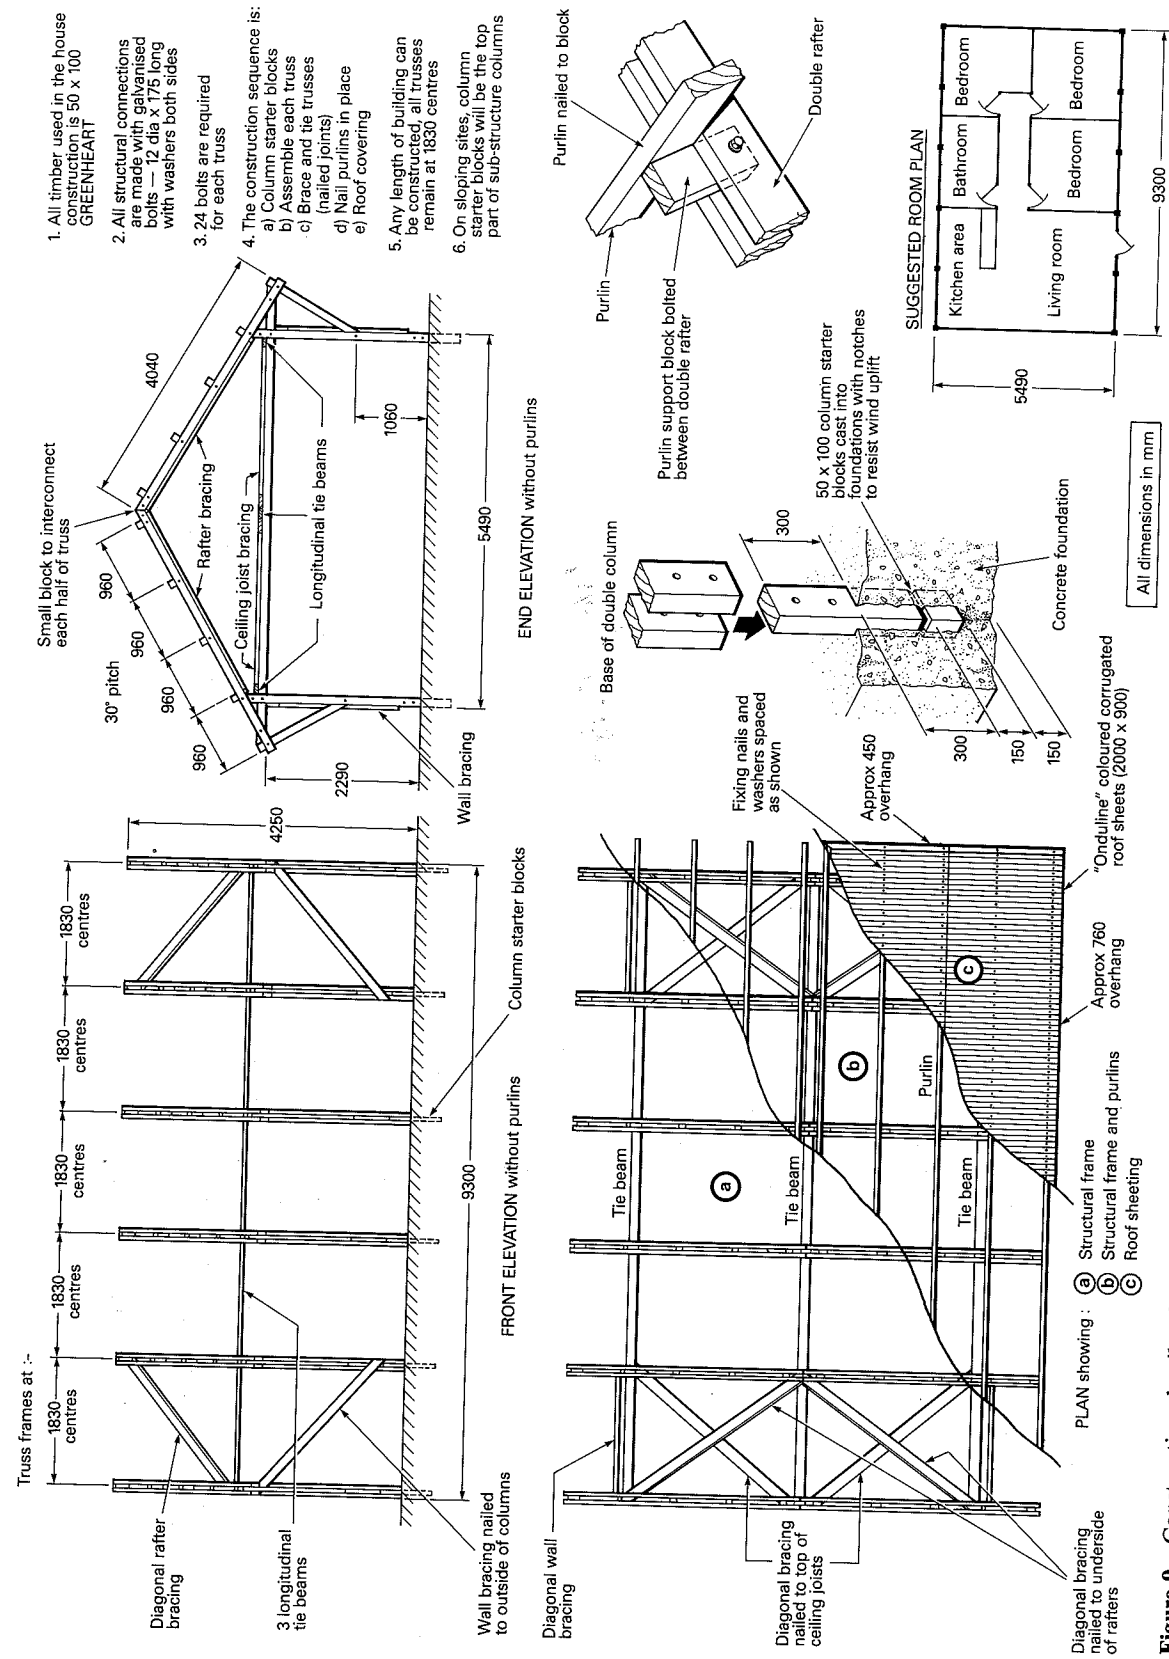
Figure 9 Construction details of St Vincent low-income house/community building

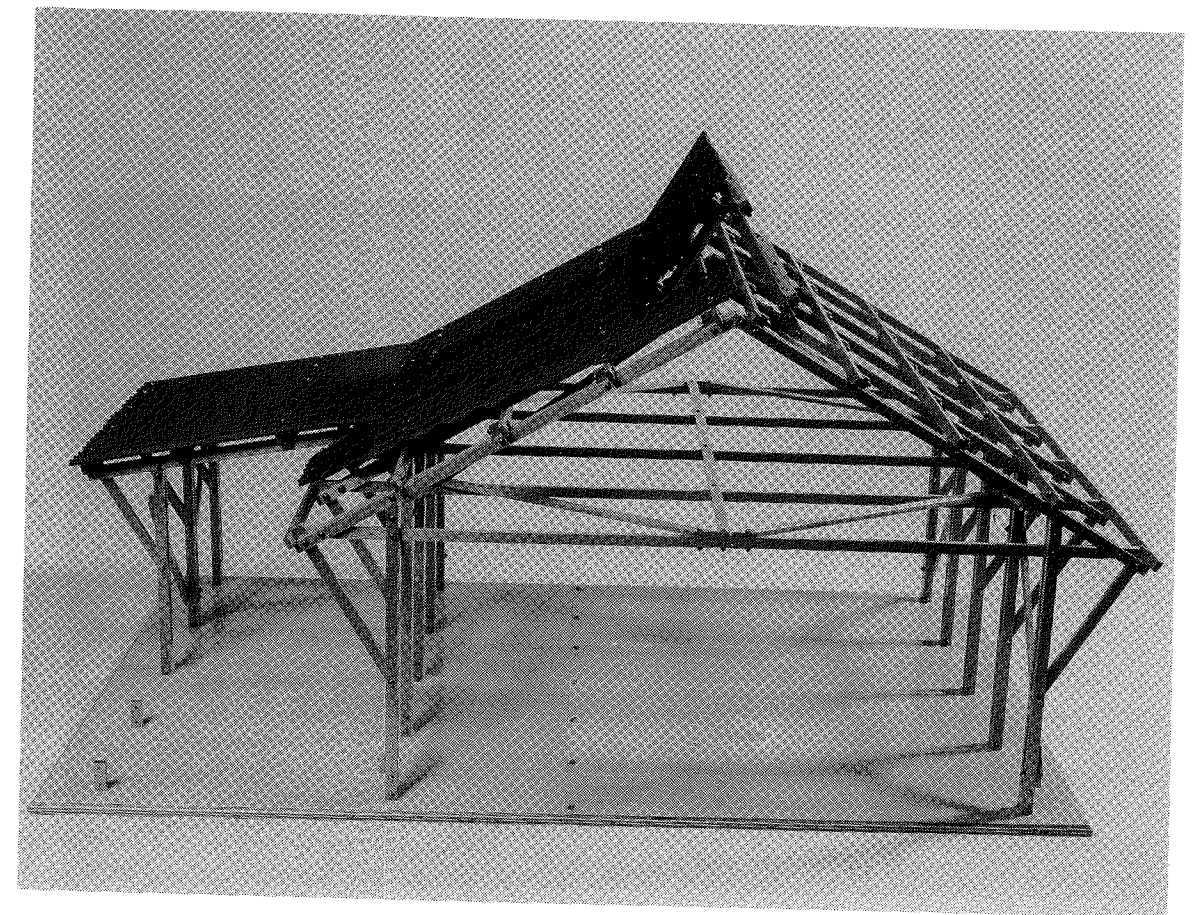
Figure 10 Model of Fiji house with high-aspect roof and side extension

SOUTH PACIFIC. BRE has examined the problems associated with cyclone damage to buildings in Fiji, Tonga, Vanuatu and the Solomon Islands. Where appropriate, detailed technical advice has been given concerning risk assessment and cyclone-resistant construction methods. An example of low-cost cyclone-resistant building design suitable for single family housing was demonstrated to the Fiji Housing Authority using a scale model. This was based on experience gained in the Caribbean, the structure being a development of the St Vincent low-income house/community building (Figure 8) modified to meet specific housing requirements in Fiji (Figure 10).

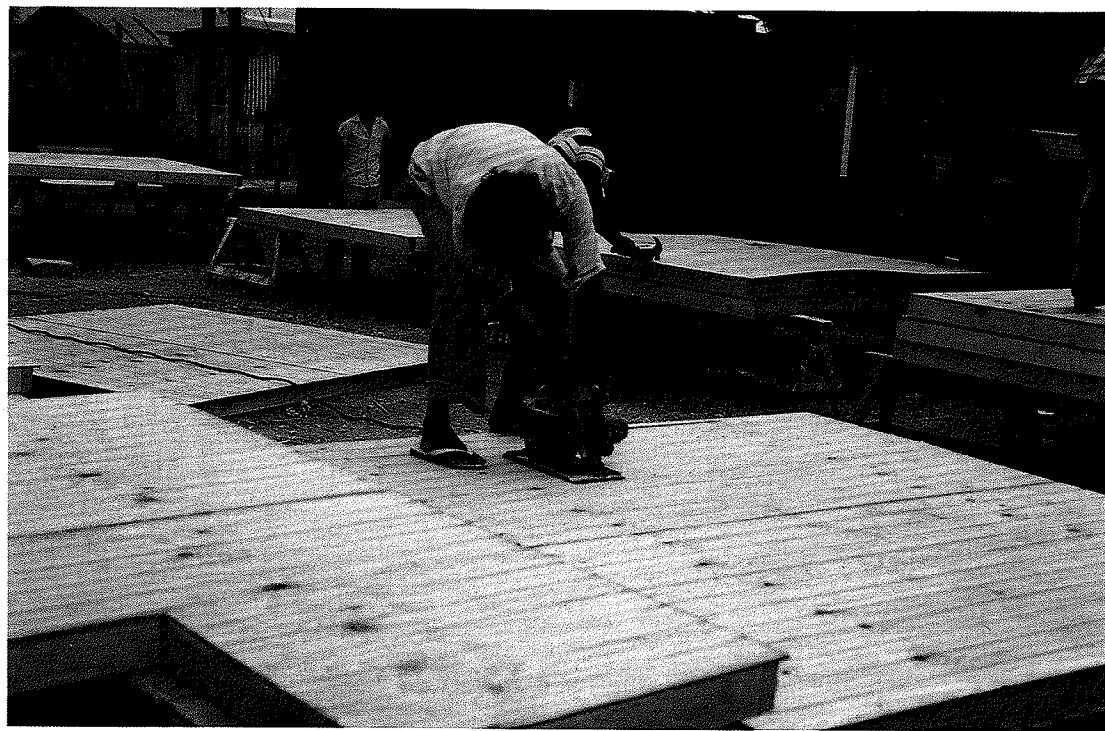
Figure 11 Factory prefabrication of Tongan housing

Following the devastation caused on islands of the Kingdom of Tonga by cyclone 'Isaac' in March 1982, a major house-building programme was undertaken using timber frame construction methods with the panels prefabricated under factory conditions (Figures 11 and 12).

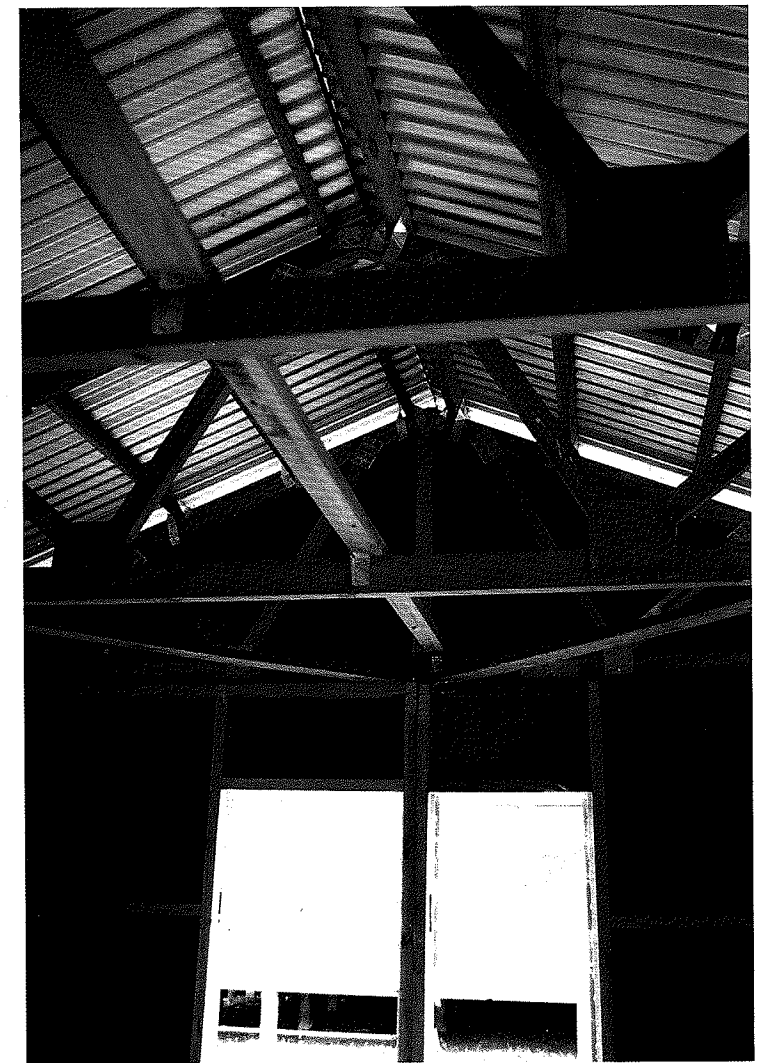
Figure 13 Construction details of Tongan house

The design was developed jointly by the Tongan Ministry of Works and BRE with specialised advice provided by the Cyclone Testing Station in Townsville, Queensland¹³. The walls were formed with modular panels 2.4 m long, fabricated with 50 × 100 mm studs at 600 mm centres and sheathed with plywood or fibre cement boards. The roofs were constructed with timber trusses jointed with plywood gussets or hammer-in type metal tooth plates, and clad with corrugated galvanised steel sheets. Proprietary steel straps (framing anchors) were used to fix the roof purlins to the trusses, and the trusses to the wall panels (Figure 13). Examples of the finished houses are shown in Figures 14 and 15.

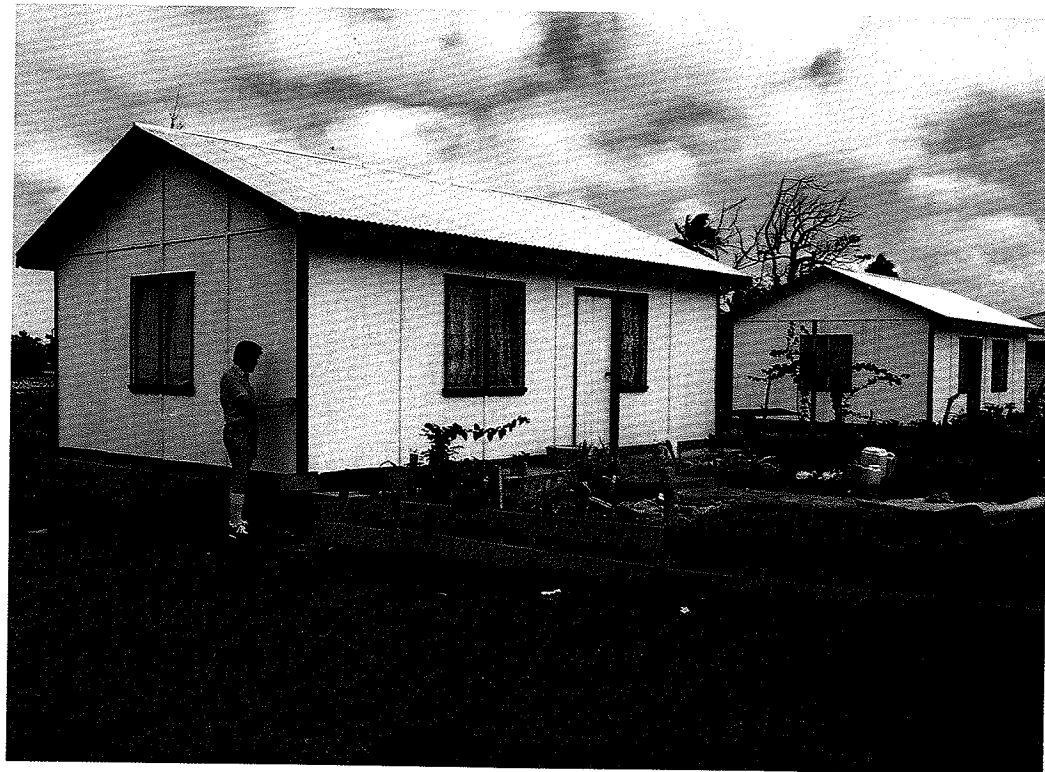
Figure 15 Basic Tongan house with solid concrete raft ground floor

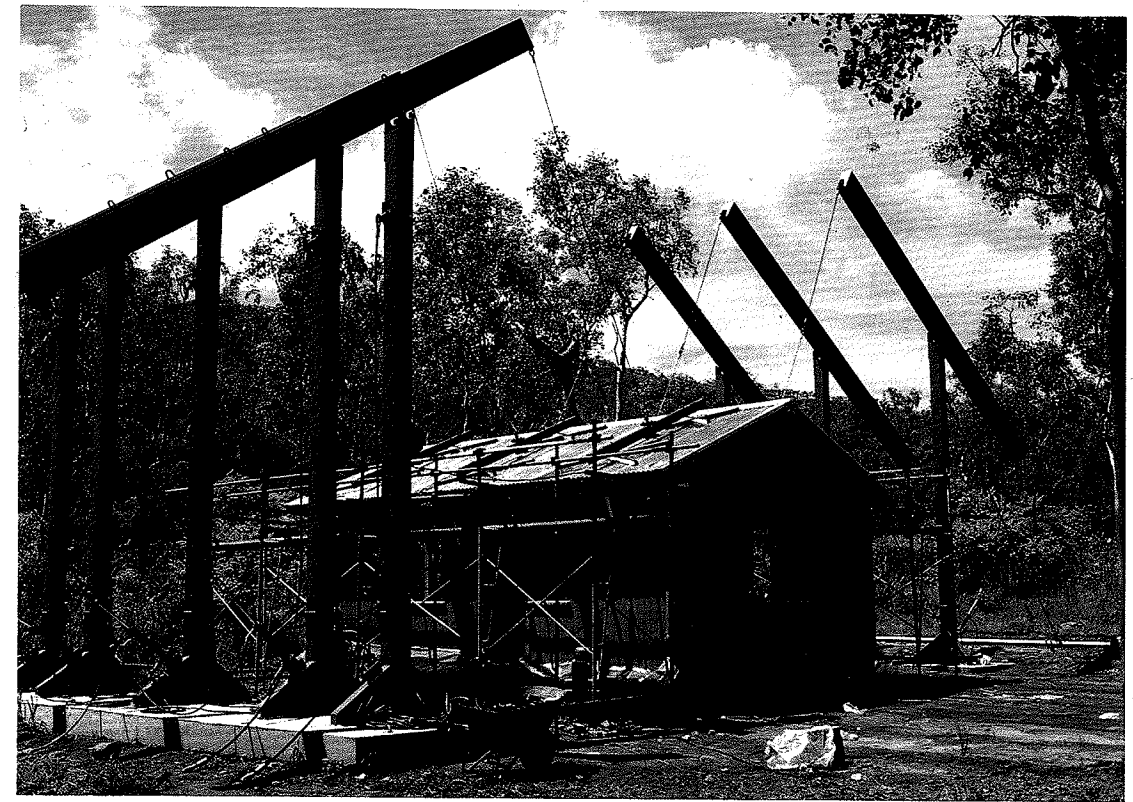
Figure 16 Cyclic loading tests on basic Tongan house

At an early stage of the house building programme, a complete kit of house components was shipped from Tonga to the Cyclone Testing Station in Queensland where it was erected using the same construction techniques as used in Tonga. A series of cyclic loading tests¹⁴ was made on this test house (Figure 16).

These tests showed that the size and location of the steel straps tying the roof trusses to the wall panels were critical details so they were replaced by a timber batten placed over the ends of the trusses and bolted through to the top plates of the wall panels. Following this modification, further tests showed that the basic house design could safely resist a simulated four-hour cyclone with wind gusts up to a design velocity of 62 m/s.

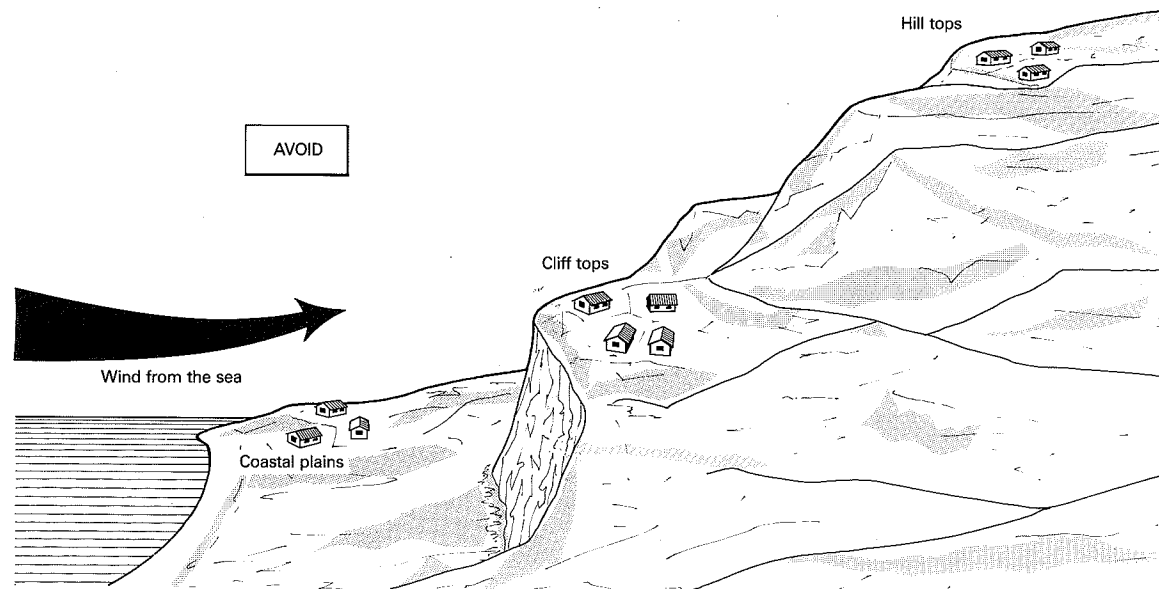
Location. Avoid building in exposed areas and on sites that are close to abrupt changes in ground level.

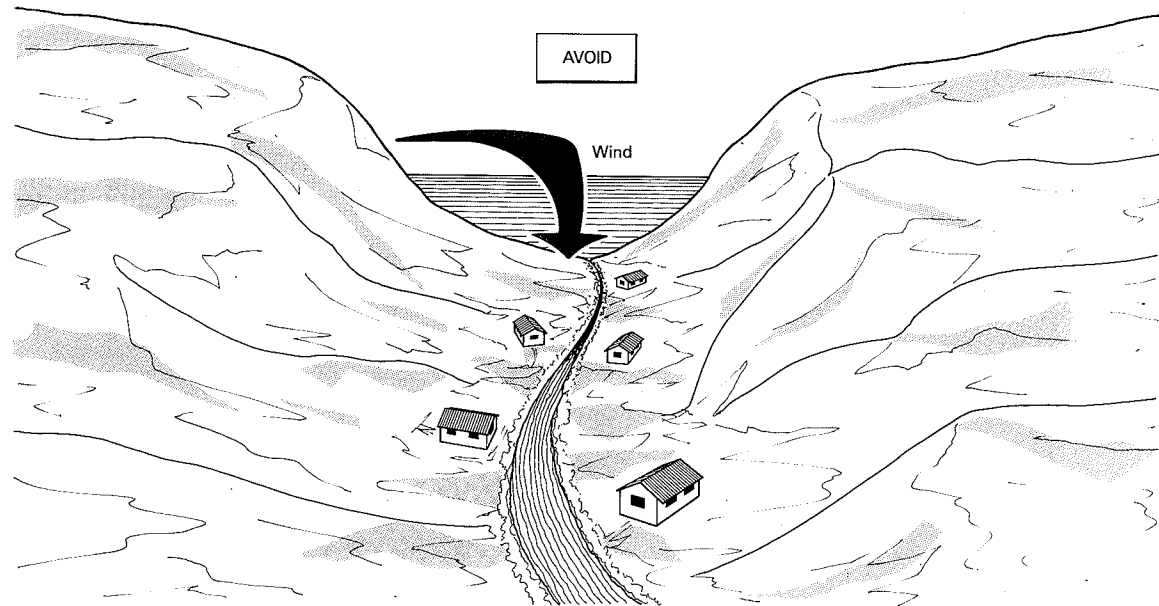
Avoid building in steep-sided valleys which open onto a beach and sea.

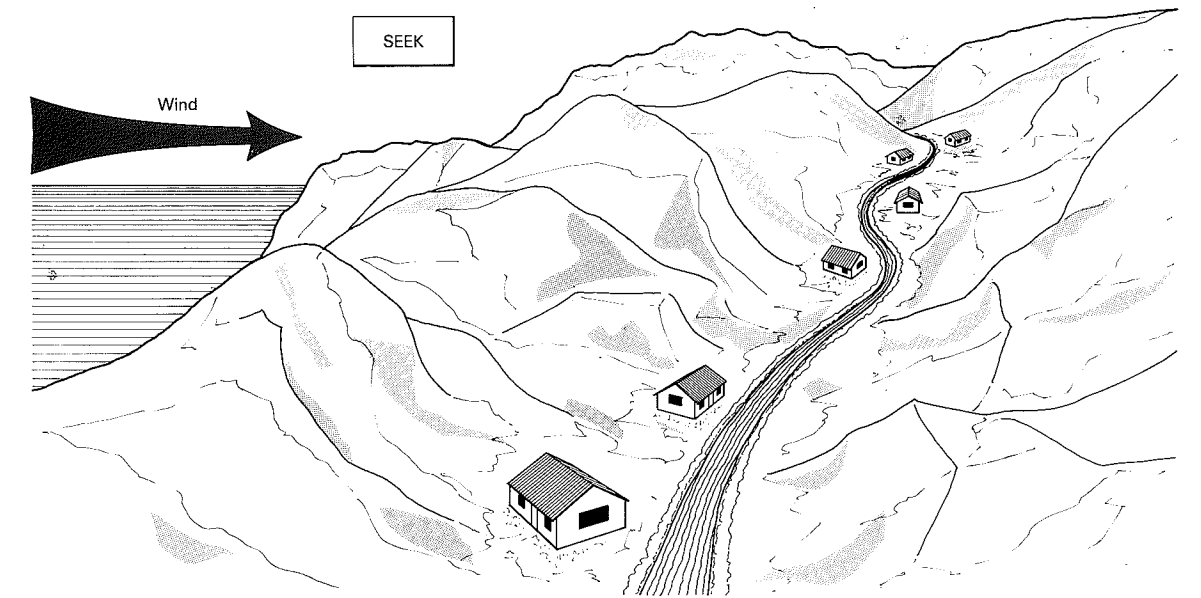
Take advantage of natural shelter provided by enclosed valleys not open to the sea, even though for some wind directions shelter will be much reduced.

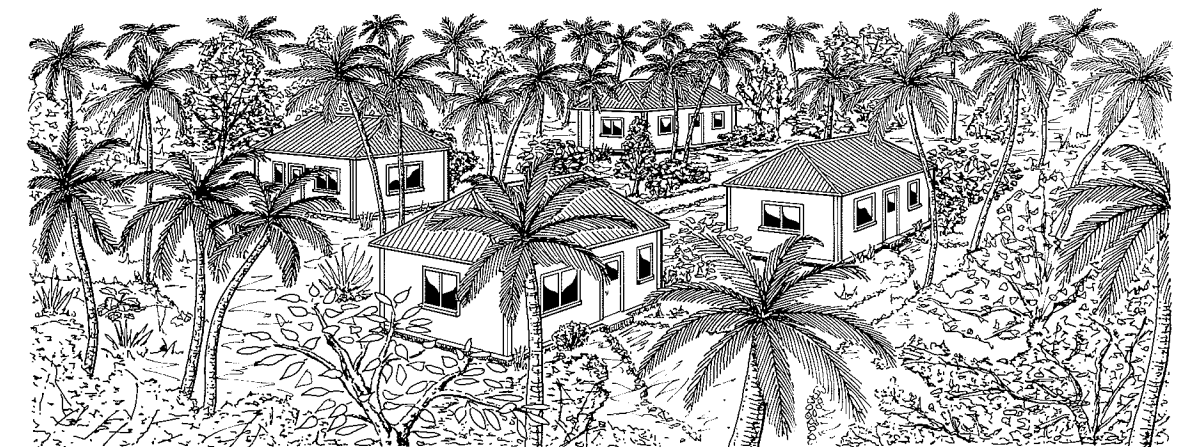
Site buildings in groups' making use of natural vegetation to provide limited but significant wind breaks.

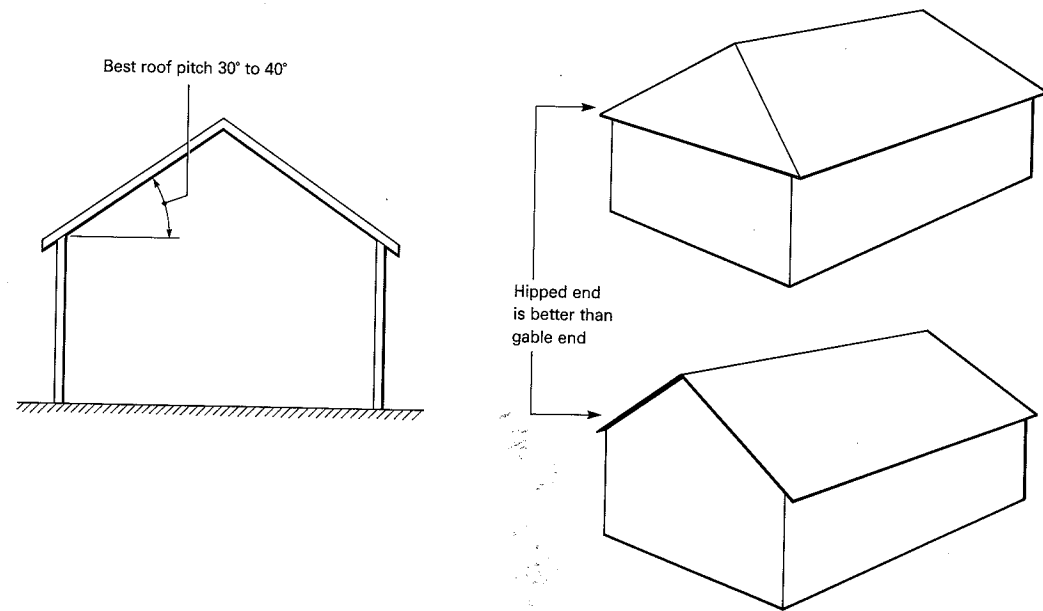
Shape. To reduce the uplift forces, build roofs with pitches between 30° and 40° and if possible provide high-level ventilation at the ridge. When possible, use hipped ends rather than gable ends.

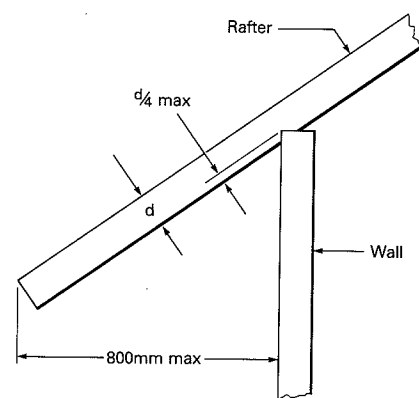
Restrict unsupported eaves overhangs to not more than 800 mm from the wall and do not notch rafters over walls by more than one-quarter of the rafter depth.

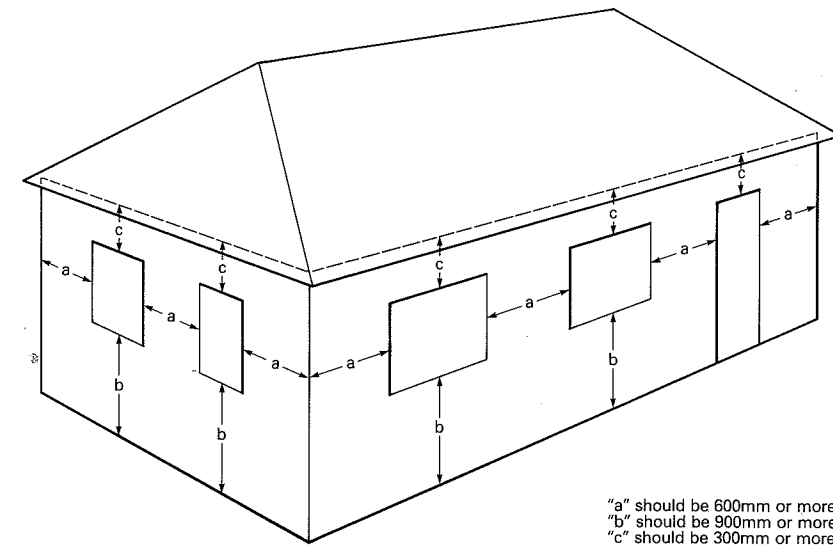
Openings. To minimise the reduction in strength caused by openings in walls for doors and windows, openings should not be positioned close to corners, the eaves or the floor.

"a" should be 600mm or more
 "b" should be 900mm or more
 "c" should be 300mm or more

For each wall, the sum of the lengths of wall between openings (ie dimension 'a' should be not less than half the overall length of the wall.

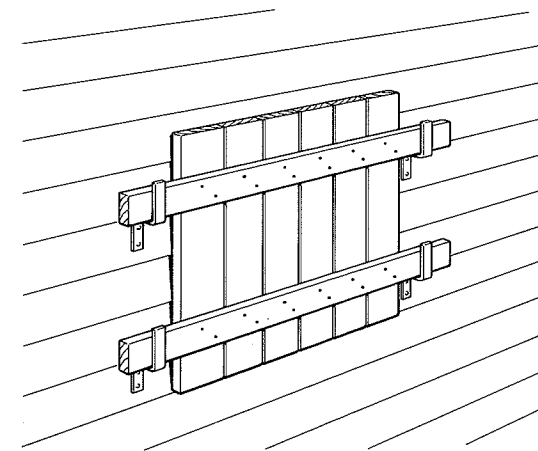
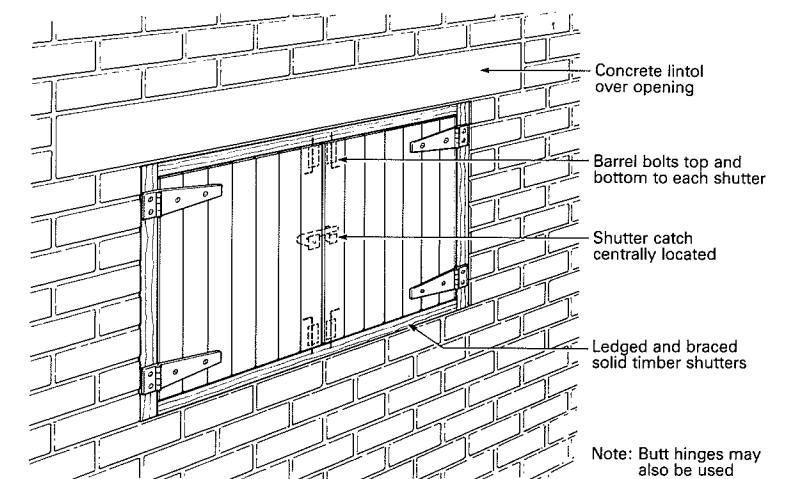
Keep the size of windows as small as possible in the most exposed walls, eg those facing seaward, and position doors in other walls.

During cyclones, secure all windows and cover with removable or hinged shutters to avoid damage and prevent the build-up of high internal pressures.

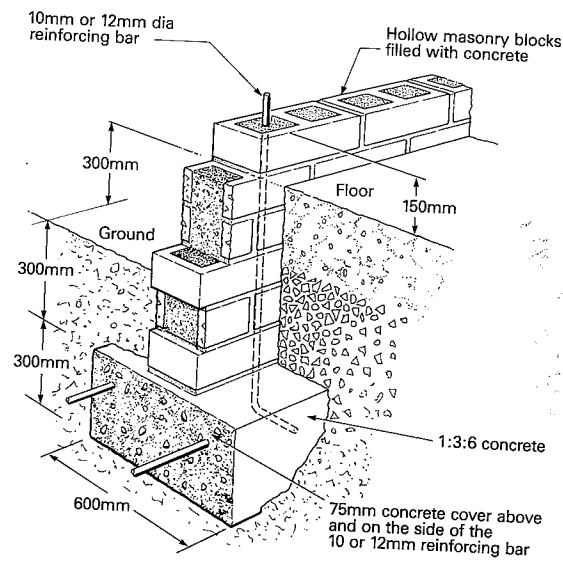
Foundations. For masonry walls use concrete strip footings and hollow masonry blocks filled with concrete to 150 mm above floor level. The concrete should be 1 part cement to 3 parts fine aggregate (sand) to 6 parts coarse aggregate.
