Cyclone-resistant houses for developing countries

Alan Mayo

Building Research Station

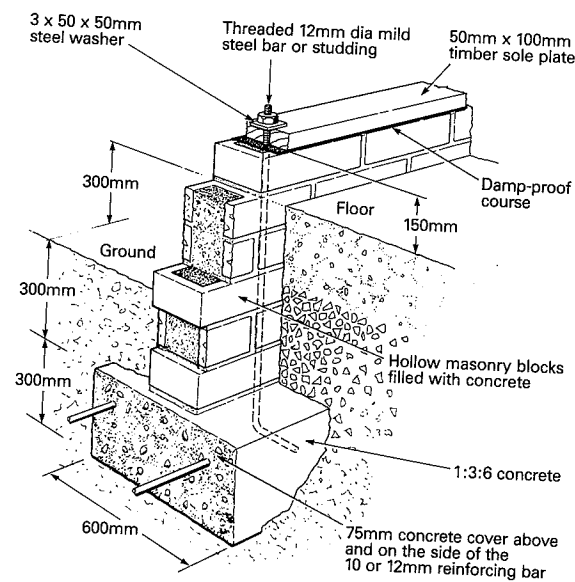
Reinforcing bars should be positioned at every corner and intersection between walls, near each side of every door and large window opening and at intermediate positions not more than 1.2 m apart. For timber-panel walls, use foundations similar to those for masonry walls but use 12 mm diameter threaded steel bar instead of reinforcing bars and bolt the timber sole plate down tight to the masonry. These hold-down fixings should be positioned at every corner and intersection between walls, near each side of every door and at intermediate positions not more than 600 mm apart.

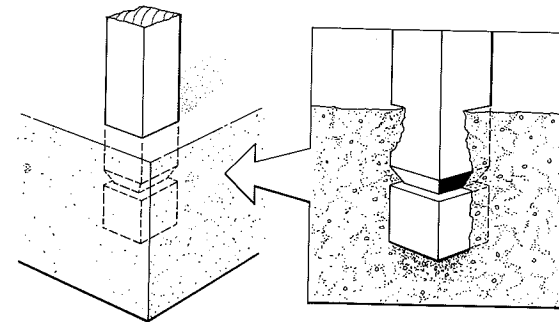
When timber columns are cast in situ in concrete foundations, use timber with good natural durability or treat the foot of the column with preservative. The foot of each column should be notched to a depth of 25 mm to form a key to resist uplift.

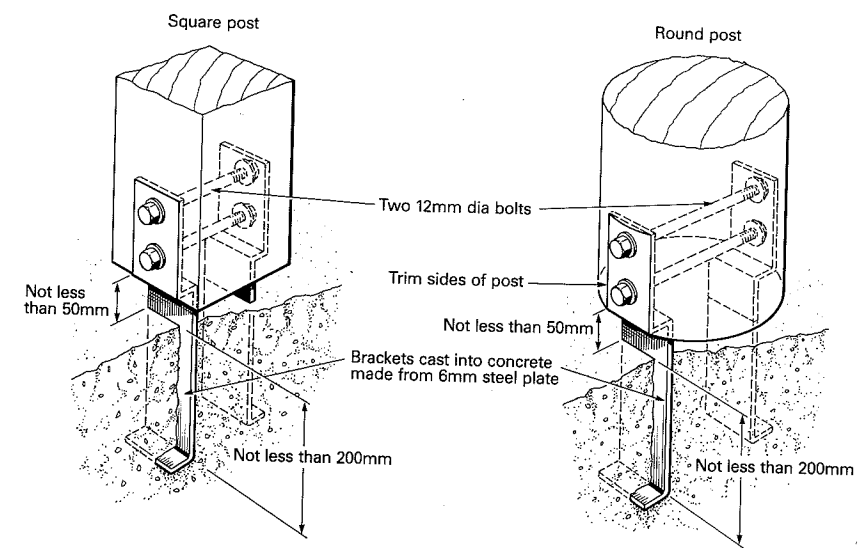
Alternatively, steel brackets can be cast into the concrete to support the foot of each timber column which should be bolted into the brackets with two 12 mm diameter bolts. This method should be used for timber columns with moderate or low durability.

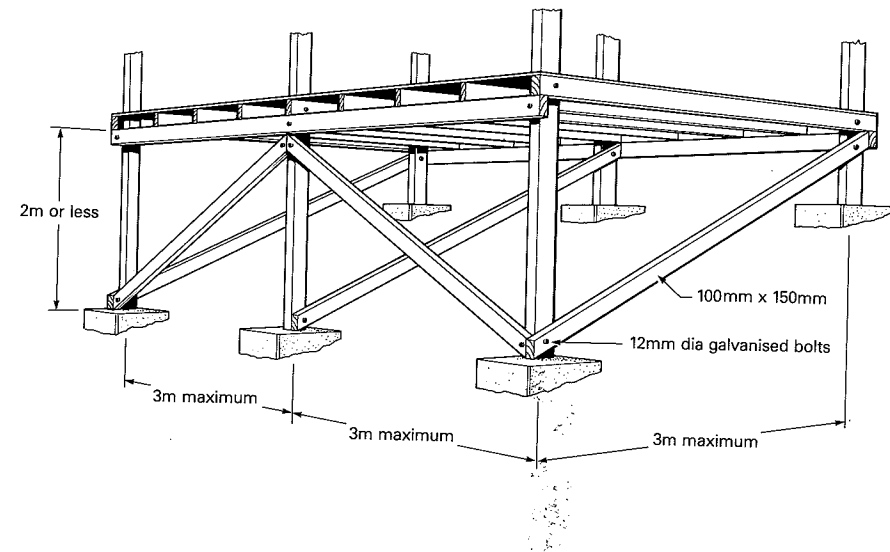
On sloping ground, support the timber floor on braced timber columns set in concrete in the ground. The spacing of the columns should be 3 m or less and the height of any column between the top of the concrete and the underside of the floor joists should be not more than 2 m.

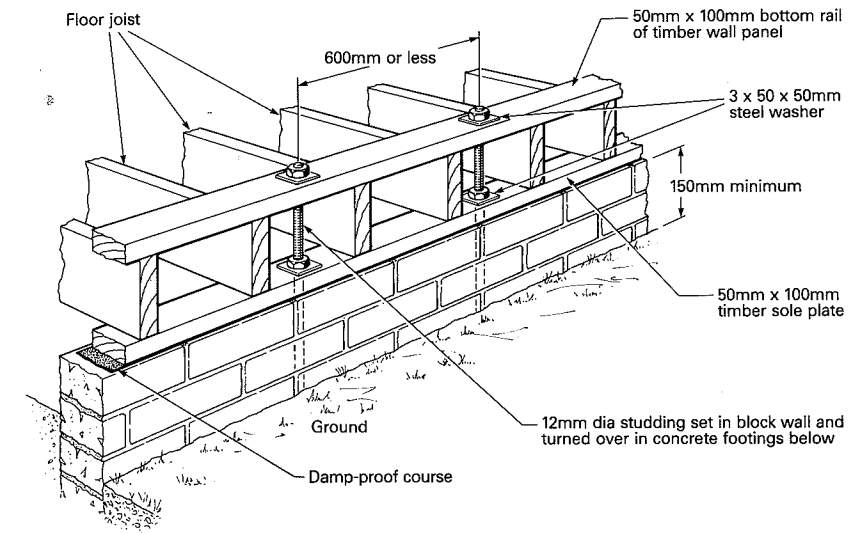
- (1) bolting down the bottom rail of the timber wall panel on top of the joists, with studding cast into the concrete footings, or —

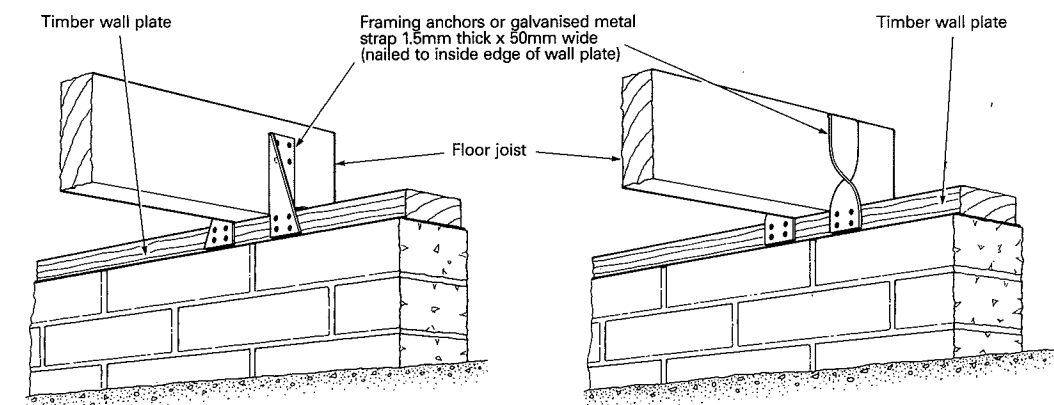
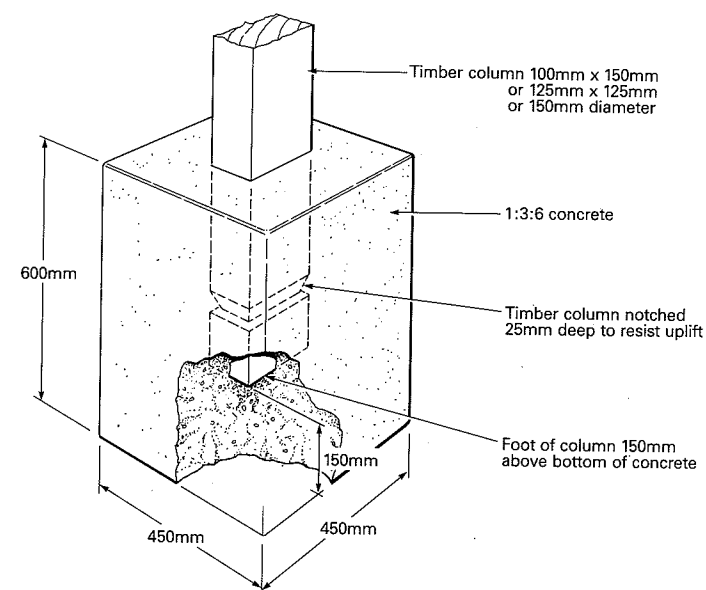
- (2) by fixing to the wall plate with metal framing anchors or galvanised metal straps.

NOTE: Make sure the wall plate is firmly fixed to the foundations.

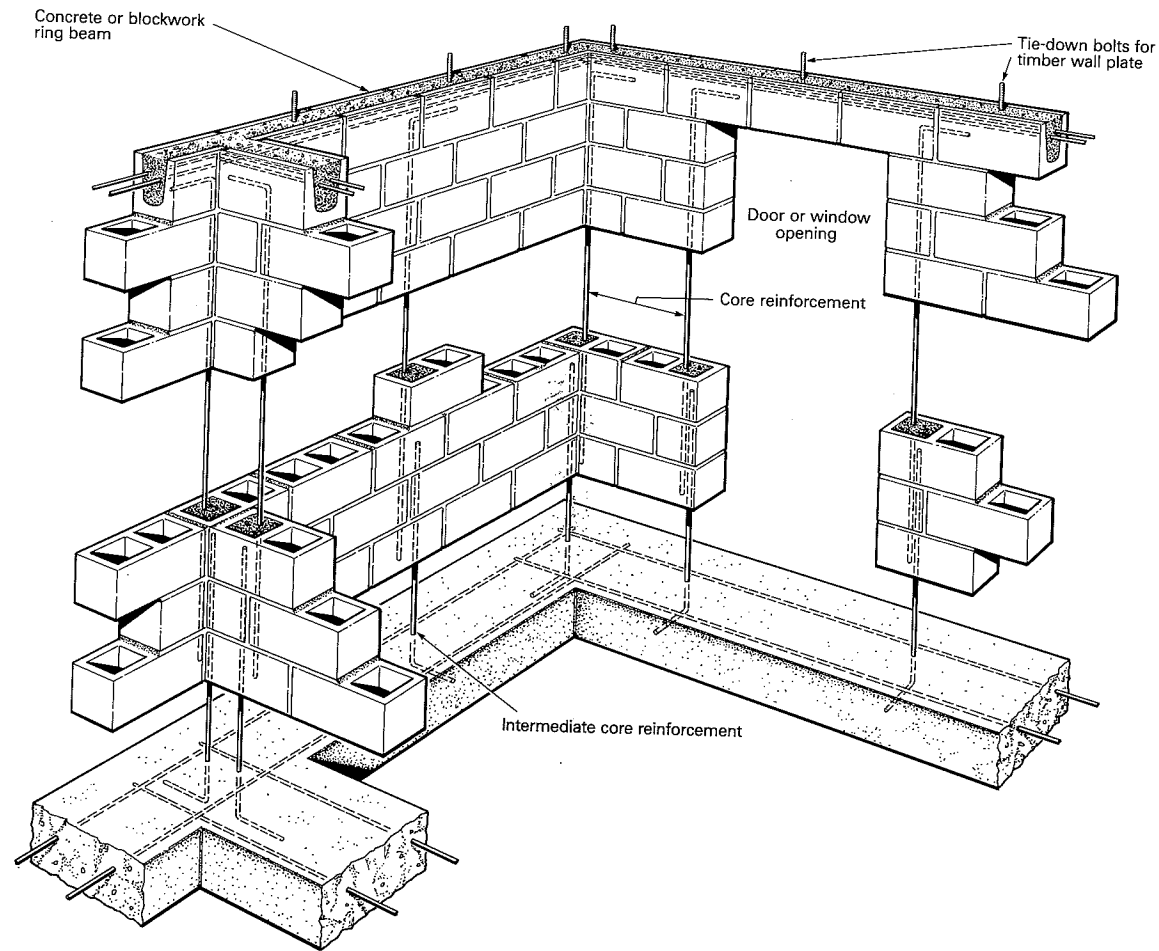
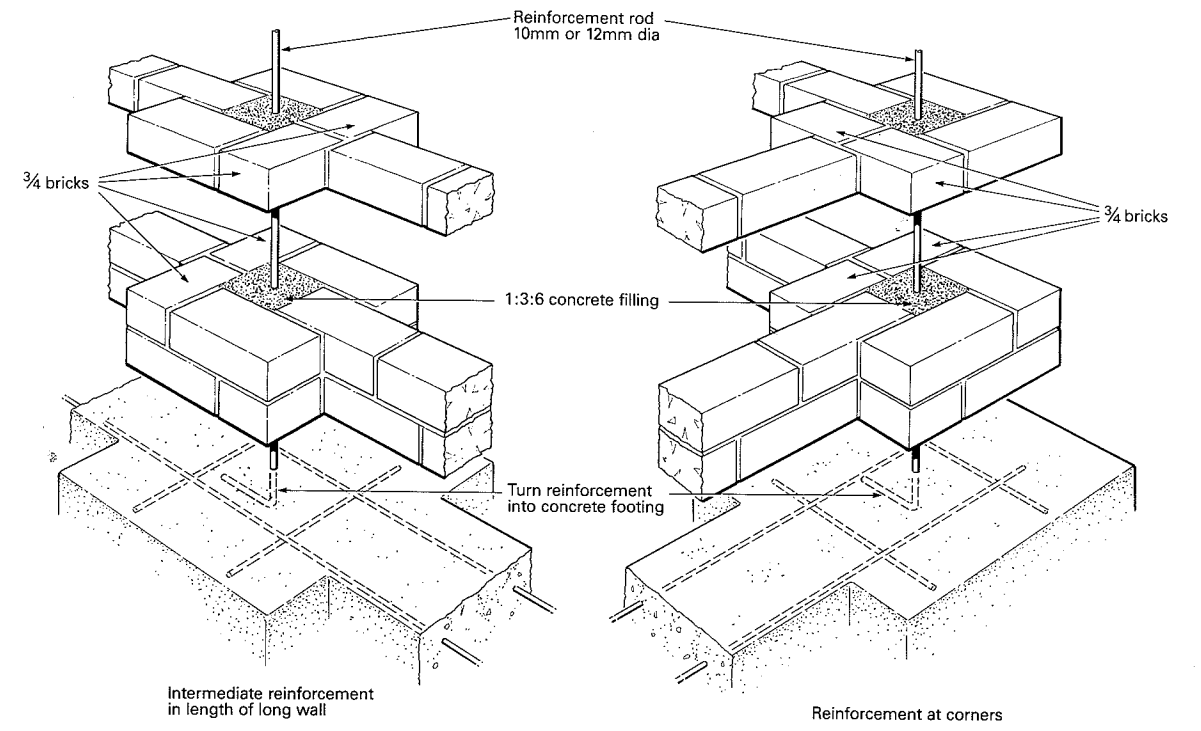
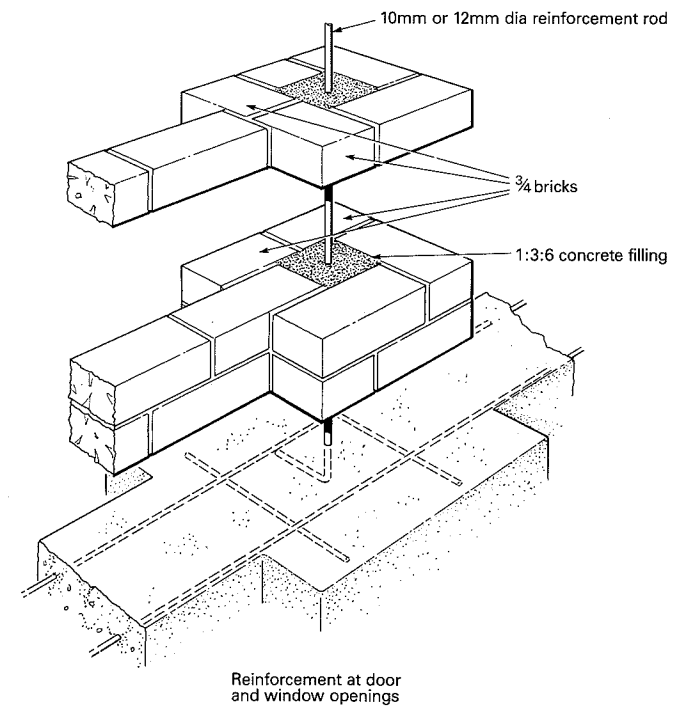
Walls. All masonry walls must be reinforced at all corners and junctions as well as at the sides of the doors and window openings. On long walls without junctions or openings, reinforced sections should be constructed at intervals of not more than 1.2 m for hollow block walls and not more than 2.0 m for solid block walls.

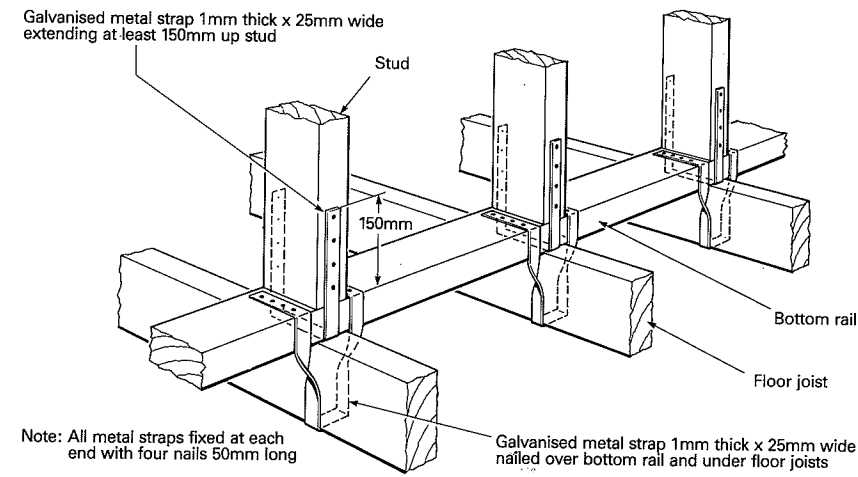
For timber-framed walls, ensure that the bottom rail of every wall panel is securely fixed down to the floor joists, sole plate or concrete foundation with galvanised metal straps, framing anchors or bolts. In addition reinforce every joint in each wall panel frame with metal strapping.

Note: All metal straps fixed at each end with four nails 50mm long

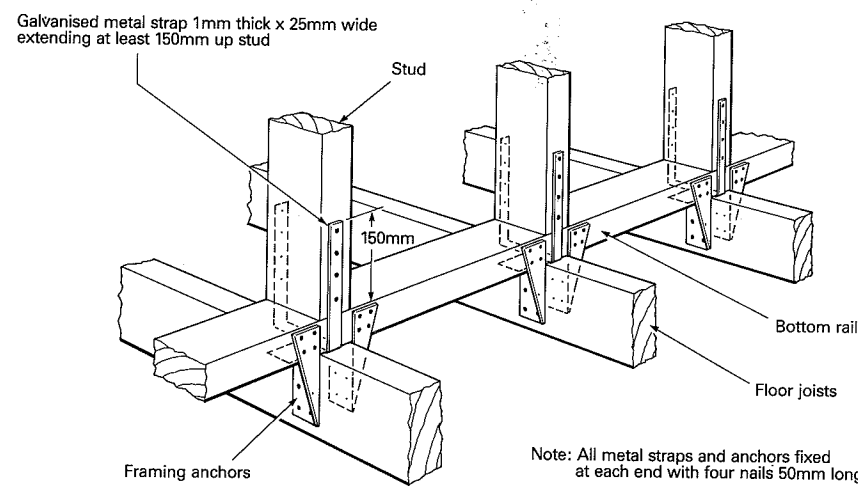
Note: All metal straps and anchors fixed at each end with four nails 50mm long

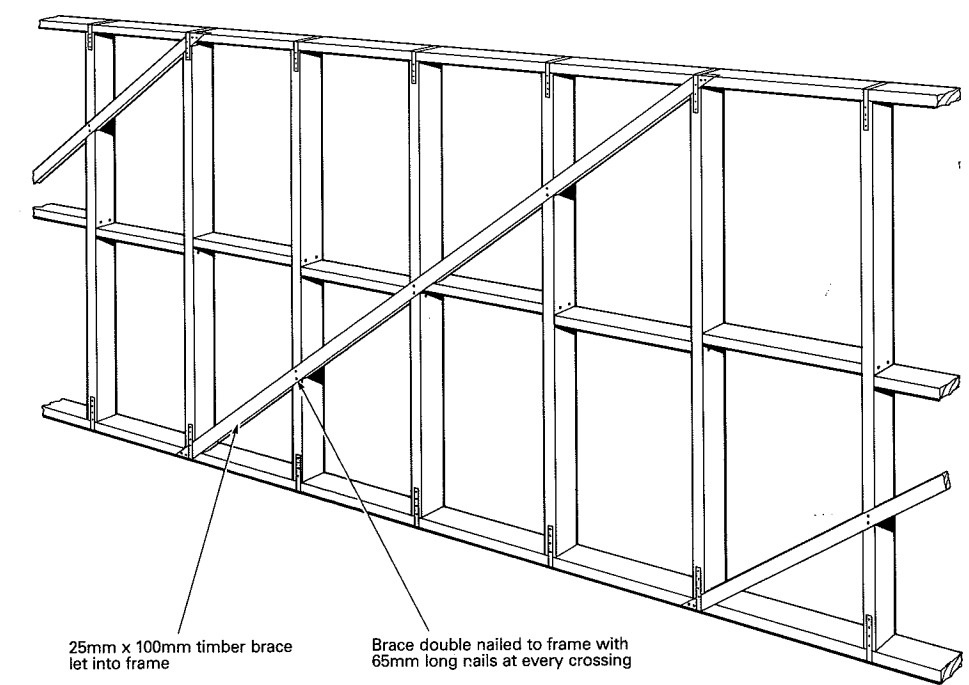
Unless timber-framed walls are fully sheathed with well nailed rigid boarding such as plywood or similar, they should be fitted with diagonal timber braces let into the framing.

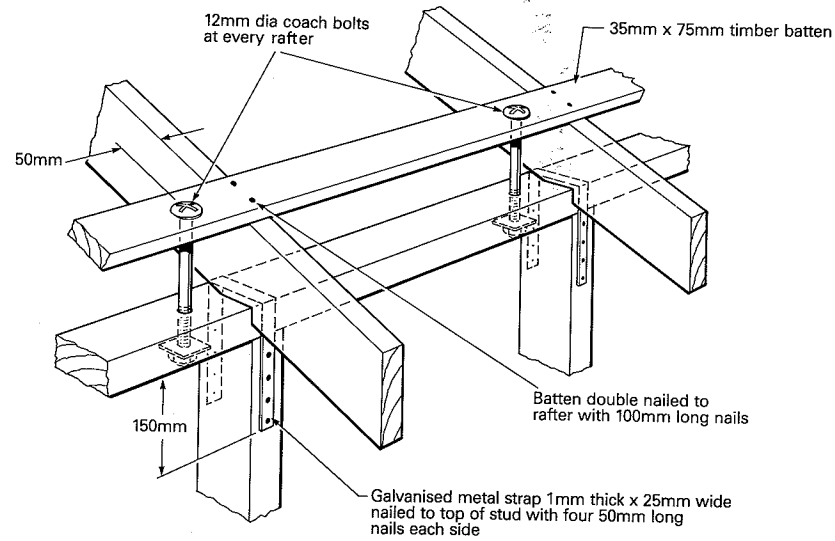
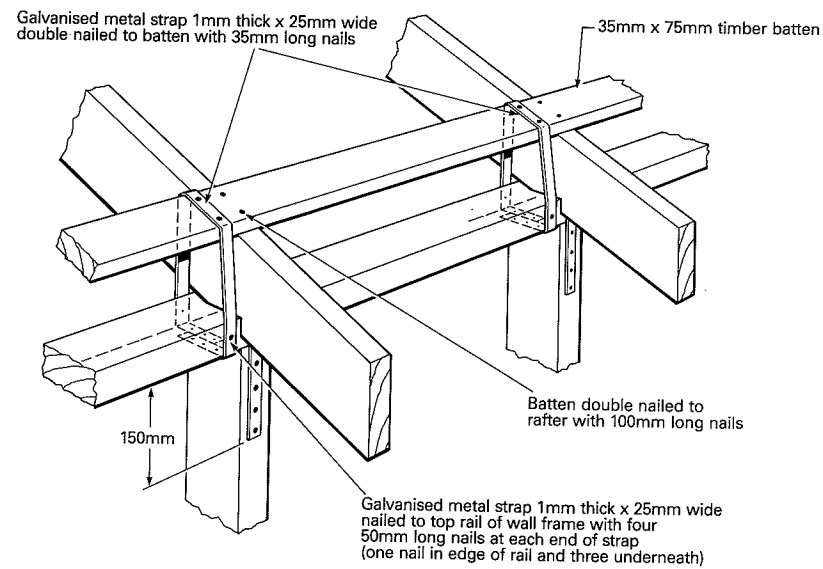
Rafter to timber frame wall connections

For the same reason, the whole roof structure must be firmly tied down to the timber frame or masonry walls with metal straps or bolts and diagonal timber braces should be nailed to the undersides of the rafters at each end of the roof to prevent sideways movement.

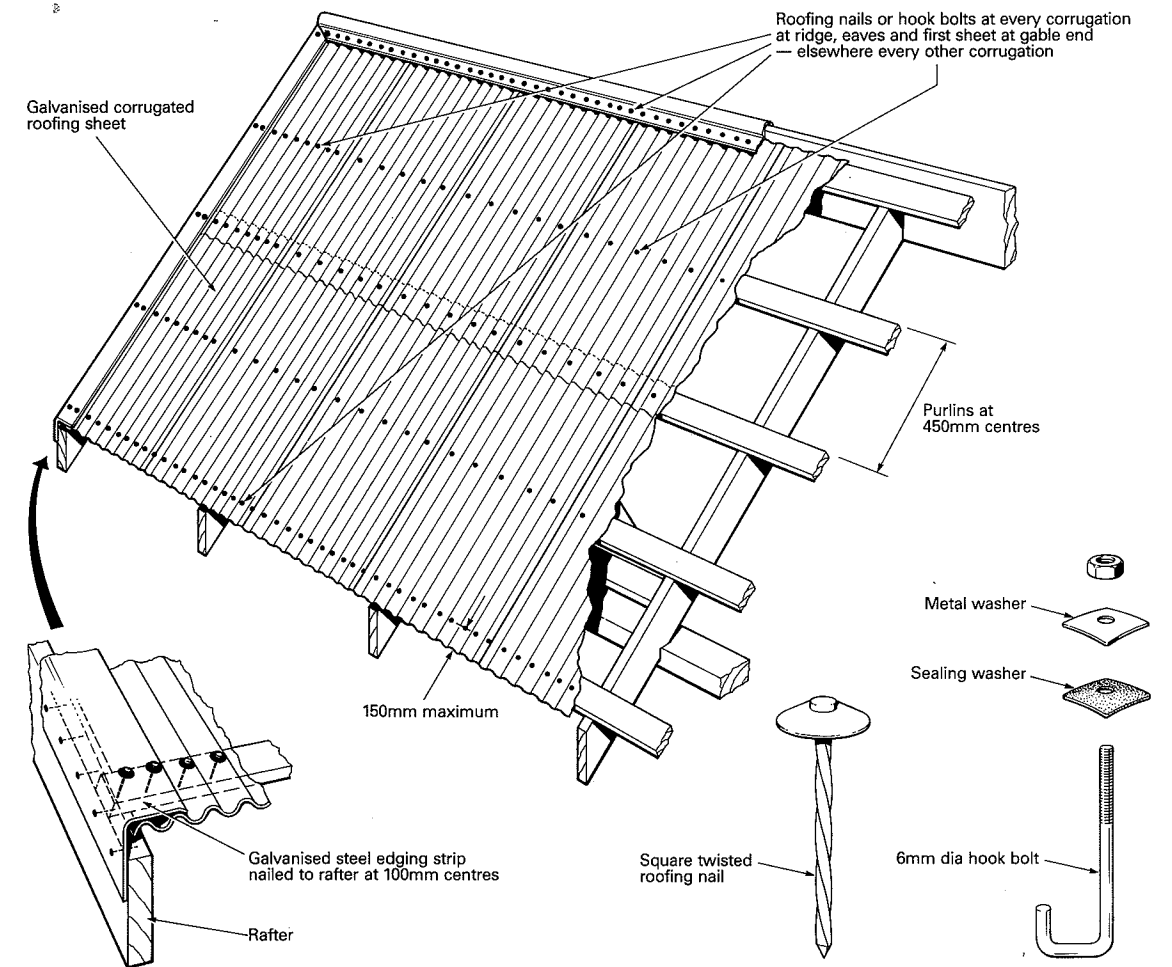
Where lightweight corrugated roofing sheets are used to cover a roof, every sheet should be securely fixed down to the purlins with galvanised hook bolts or special square twisted roofing nails. Particular attention should be given to the edges of a roof where wind uplift forces are greatest and fixings should be more frequent to prevent roofing sheets being 'peeled back'.

- (4) Fixings for lightweight roof sheeting should be checked to see if they have vibrated loose, particularly round the edges of the roof and at the ridge.
