# Satellite-Based Damage Assessment for Village of Yan Thei, Mrauk-U Township

Assessment based on satellite imagery recorded on morning of 3 November 2012

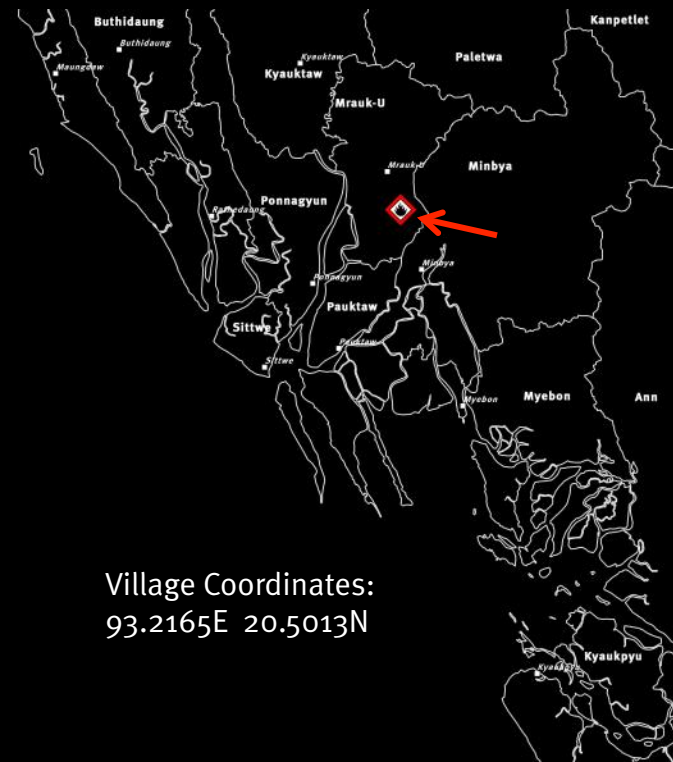
Summary of main findings: A total of 344 destroyed and severely damaged buildings were identified within the village of Yan Thei in Mrauk-U township, likely caused by arson attacks occurring before 3 November 2012. This zone of near total destruction measures 26.3 hectares (ha) in area, and represents near 100% of village structures. There are no indications of building damages in the surrounding villages.

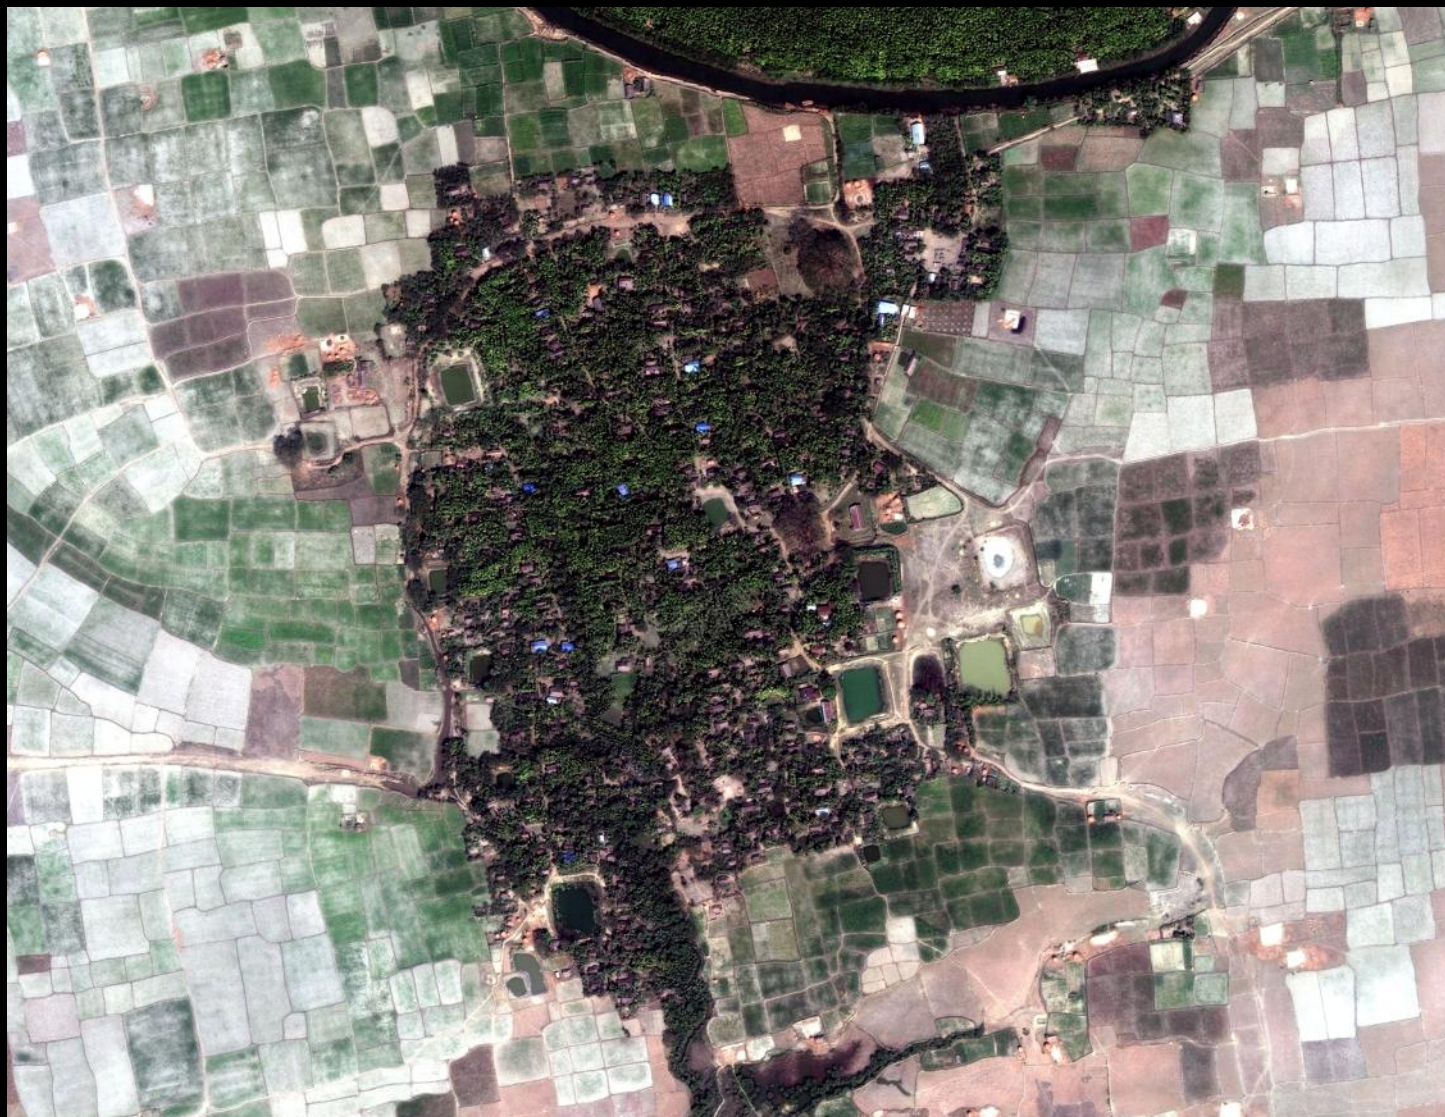
# Yan Thei Village, Mrauk-U Township, on 11 February 2012

Pre-attack view of village in satellite imagery

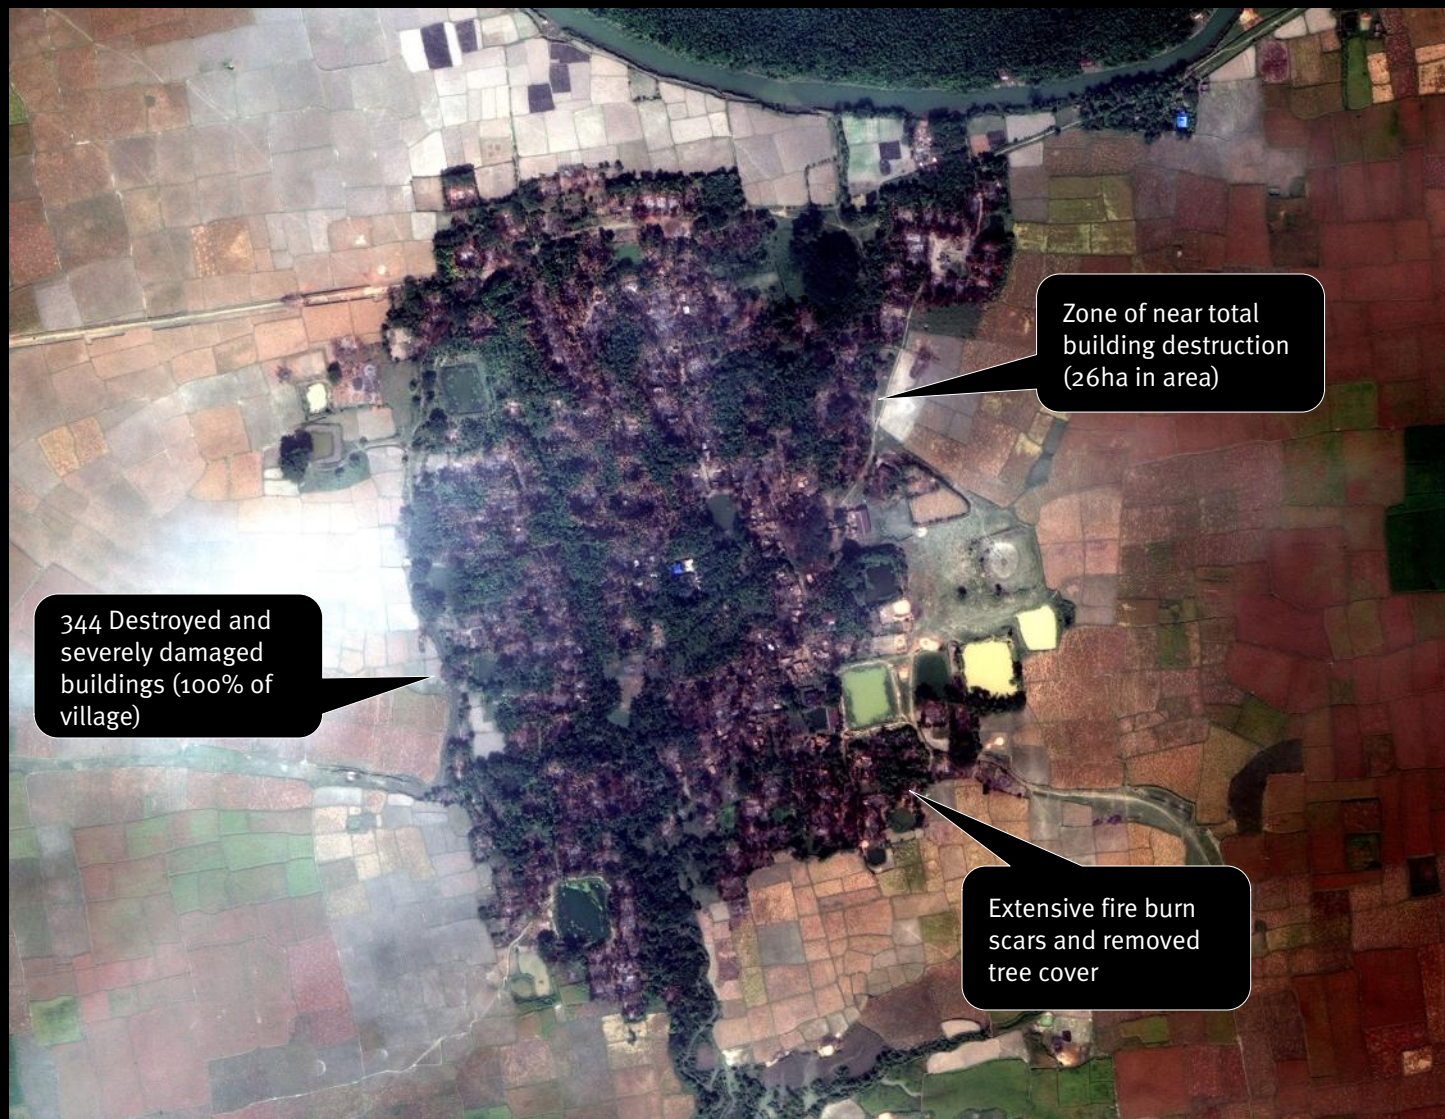
# Yan Thei Village, Mrauk-U Township, on 3 November 2012

Post-attack view of village in satellite image without annotated building damages

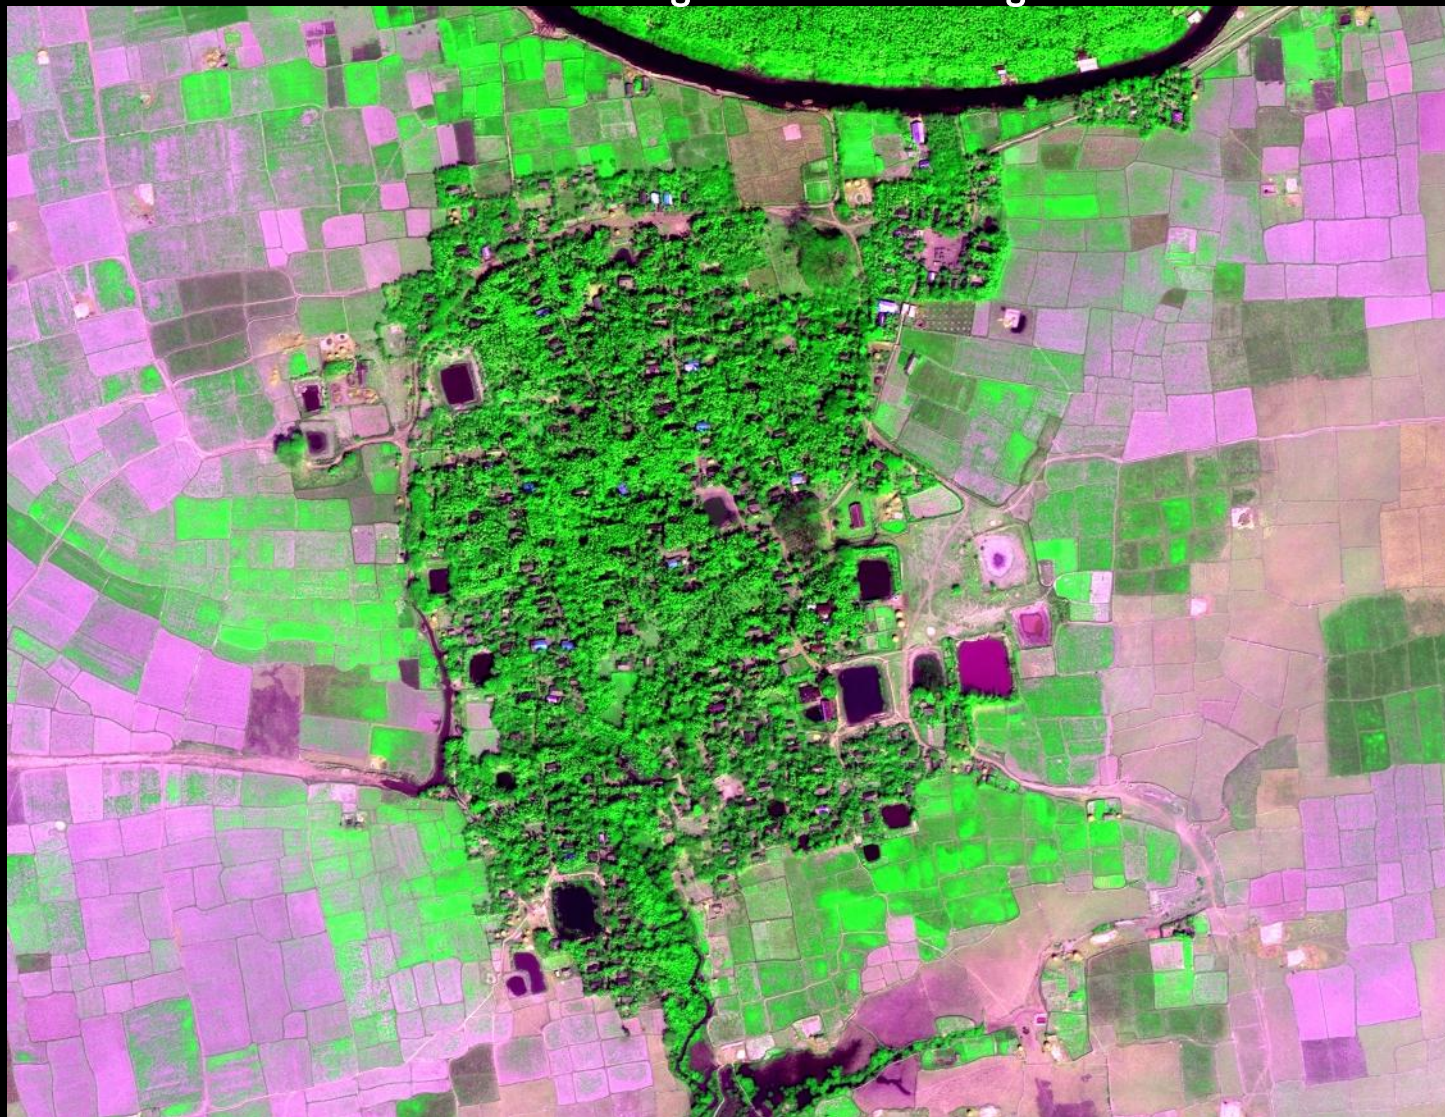
# Yan Thei Village, Mrauk-U Twonship, on 11 February 2012

Pre-attack view of village with satellite imagery displayed in false-color, near-infrared in order to highlight areas of extensive fire-related damages within the village

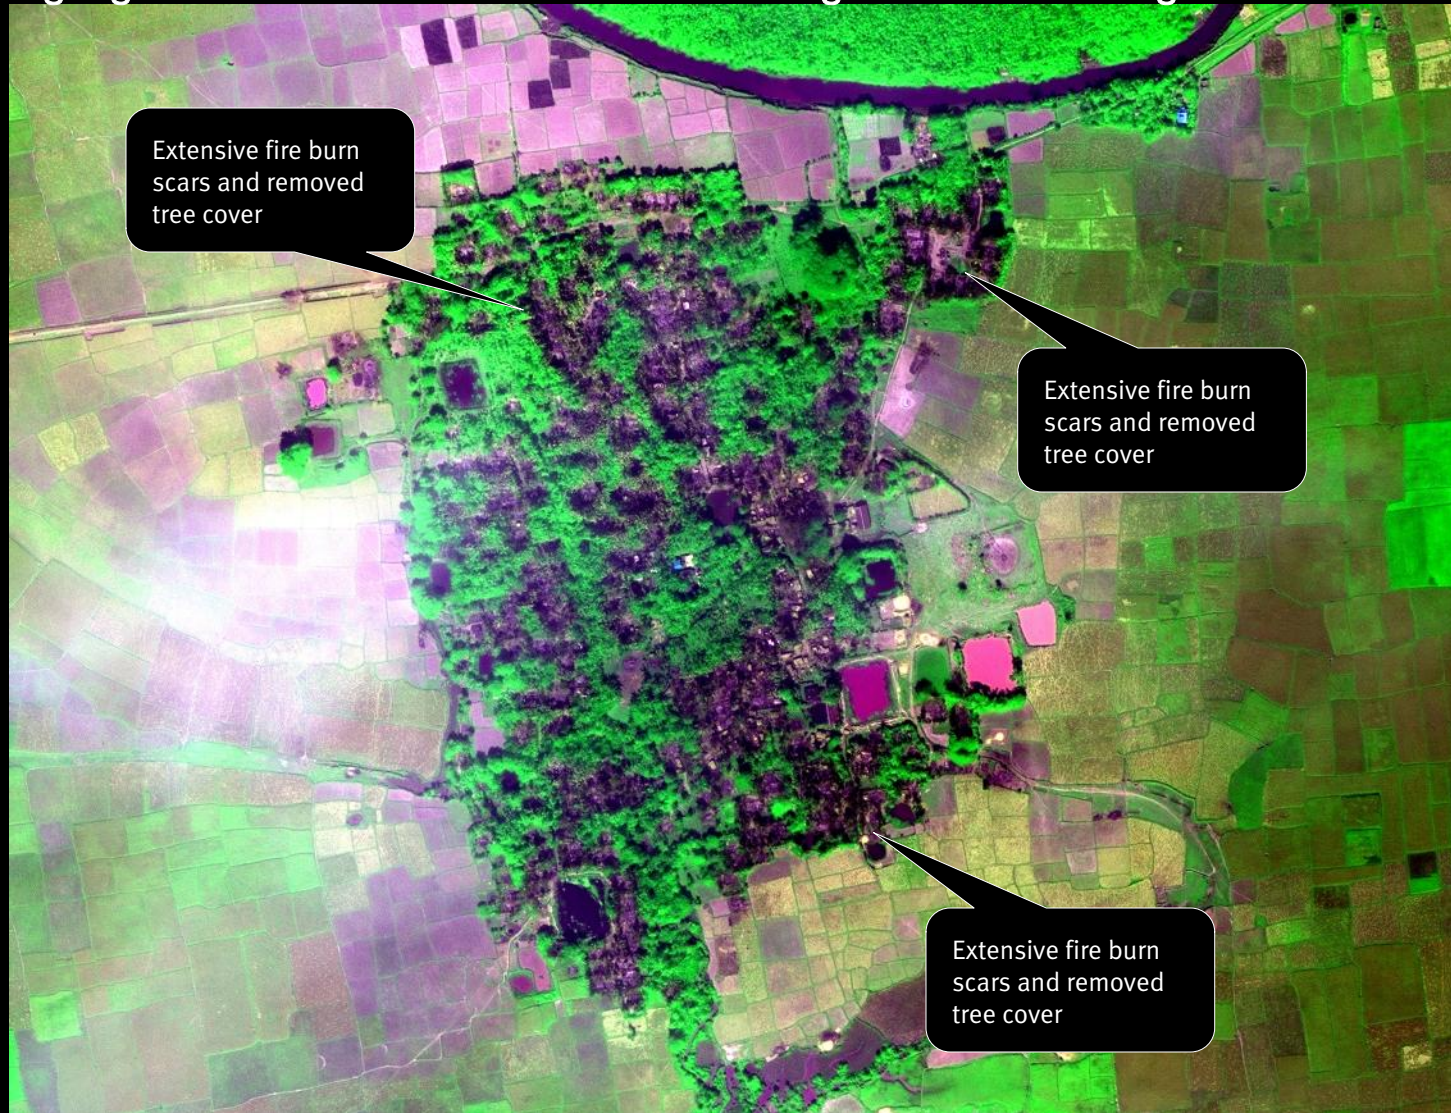
# Yan Thei Village, Mrauk-U Township, on 3 November 2012

Post-attack view of village with satellite imagery displayed in false-color, near-infrared in order to highlight areas of extensive fire-related damages within the village
