Satellite-Based Damage Assessment for Town of Myebon, Myebon Township

Assessment based on satellite imagery recorded on morning of 3 November 2012

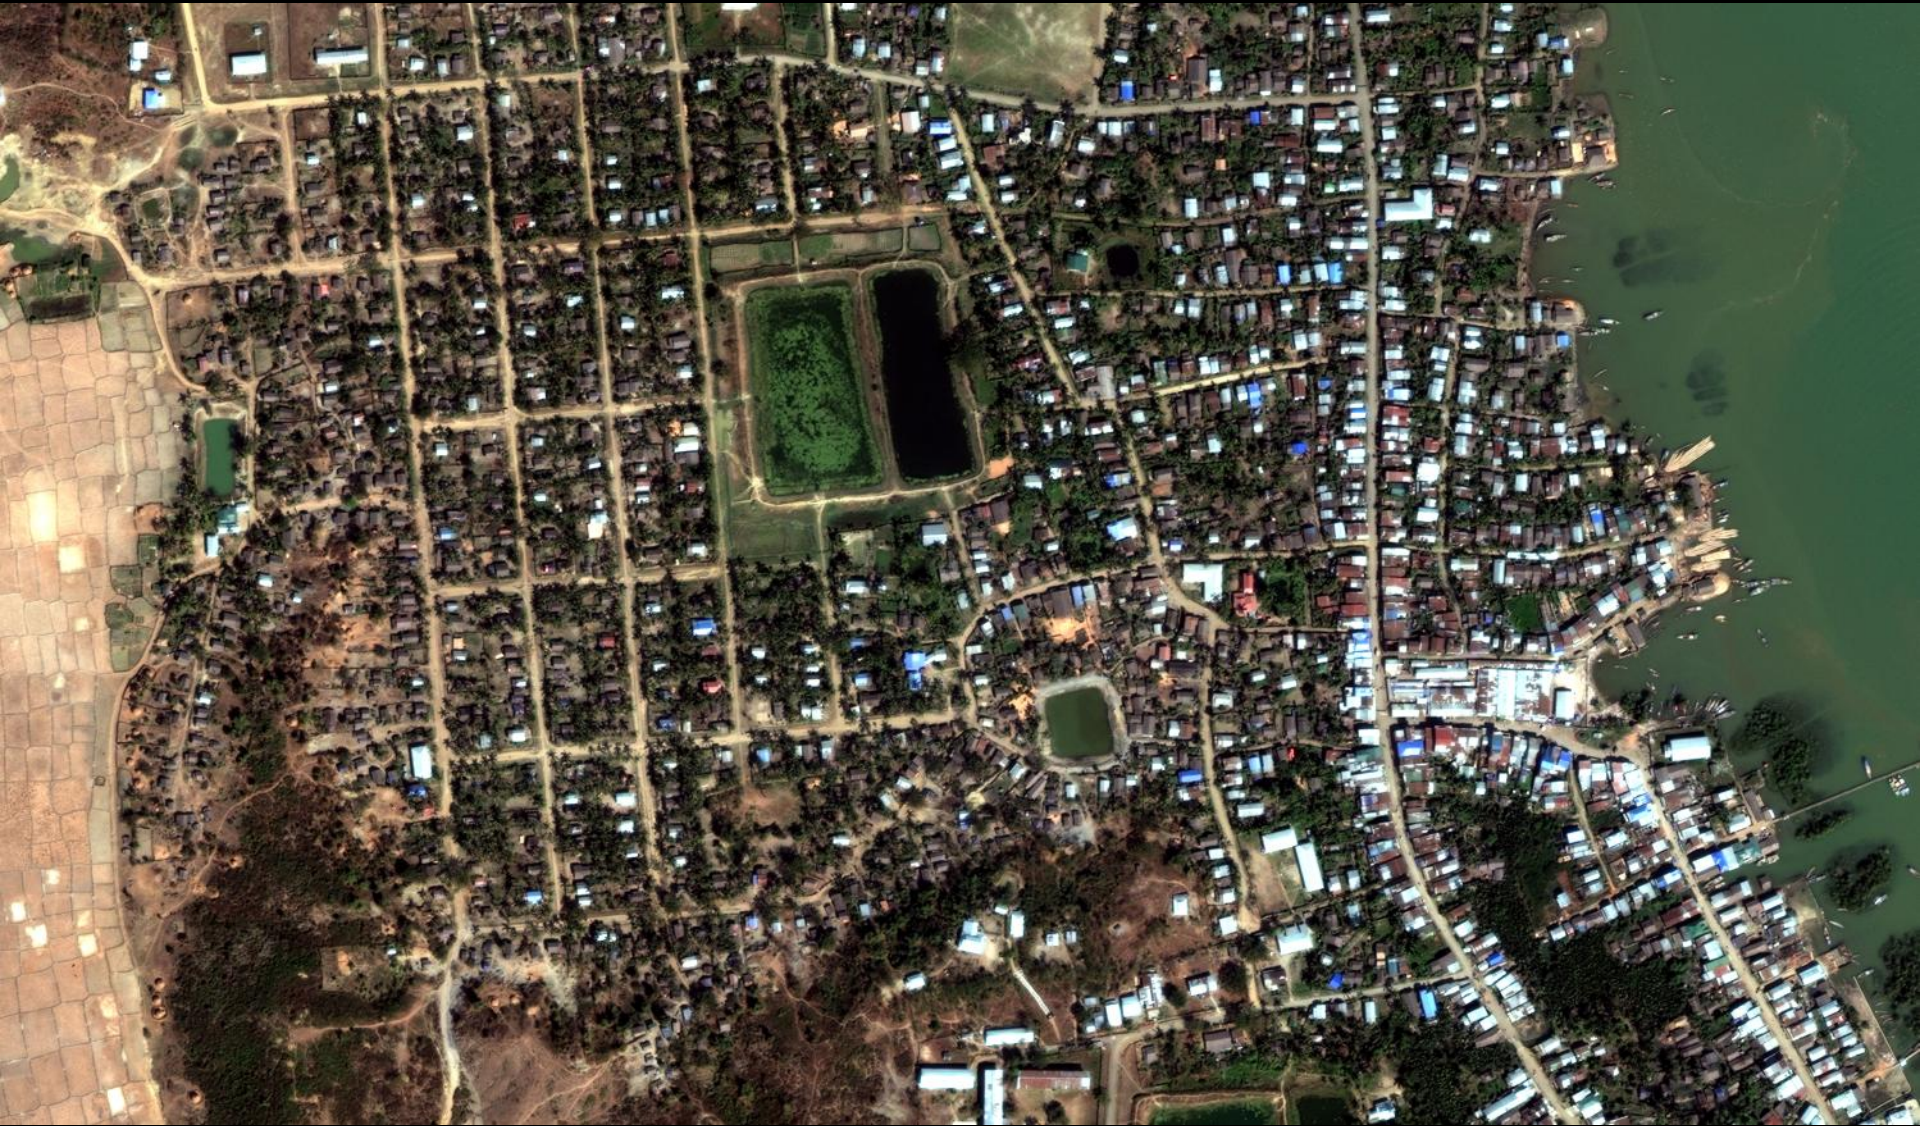
Town of Myebon on 8 February 2012

Pre-attack view of village in satellite imagery

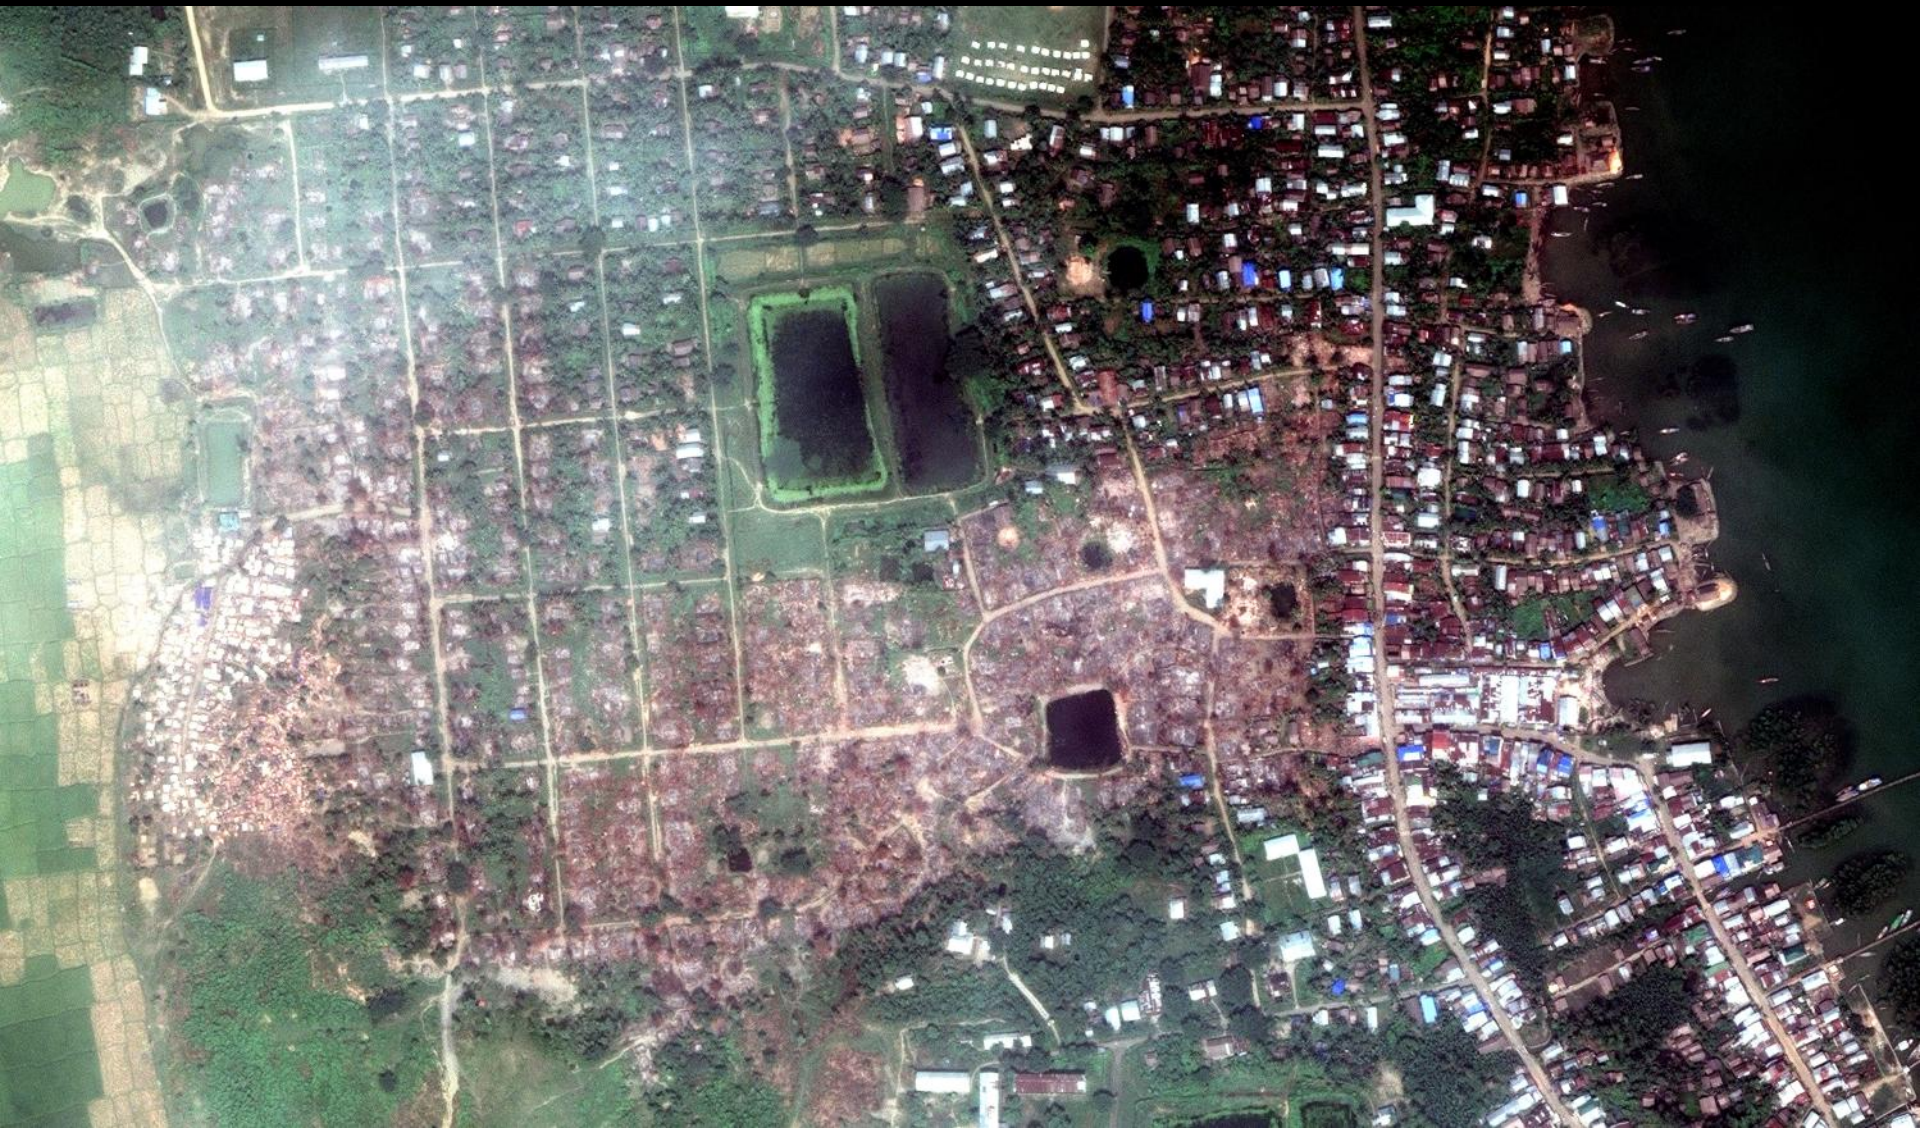
Town of Myebon on 3 November 2012

Post-attack view of village in satellite image without annotated building damages

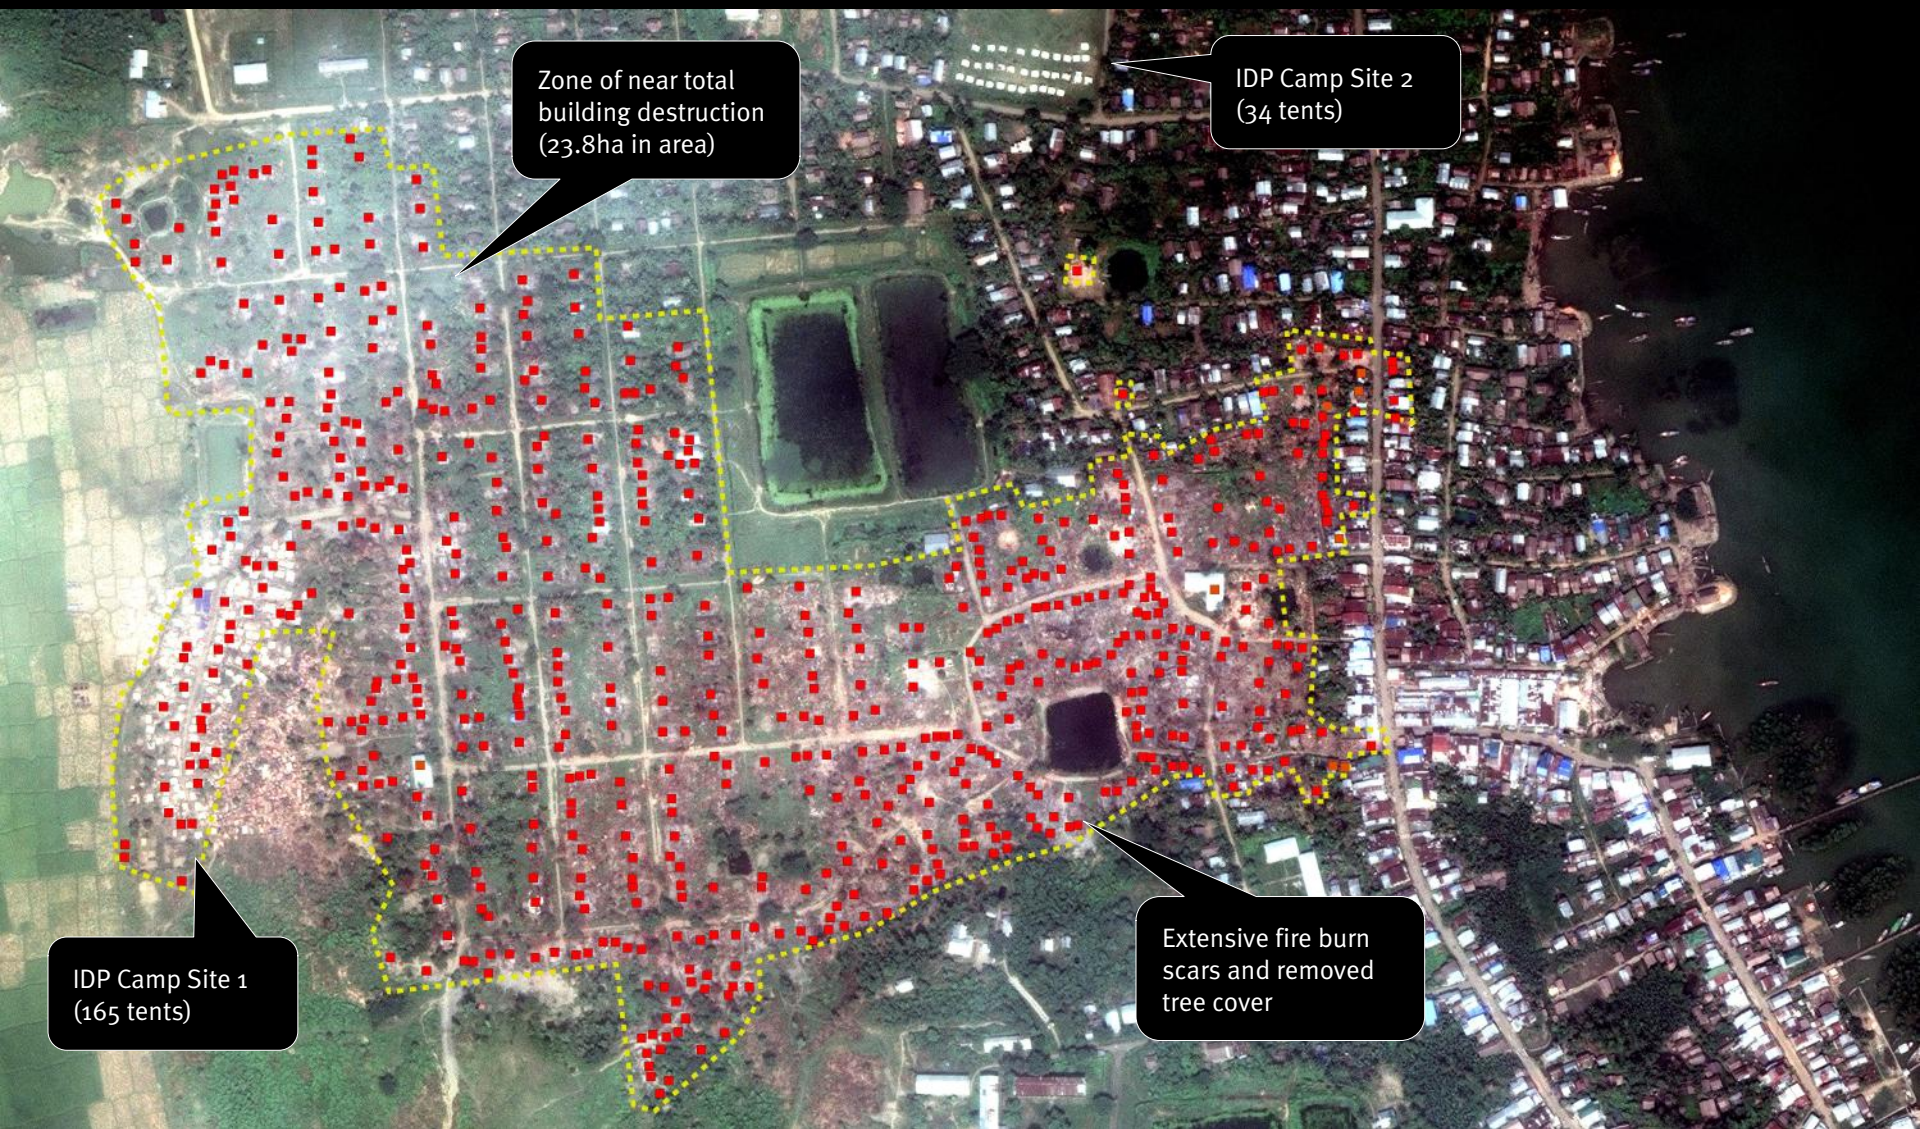
Town of Myebon on 3 November 2012

Post-attack view of village in satellite image with annotated building damages

Zone of near total building destruction (23.8ha in area)

IDP Camp Site 2 (34 tents)

IDP Camp Site 1 (165 tents)

Extensive fire burn scars and removed tree cover

Summary of main findings: A total of 657 destroyed and severely damaged buildings were identified within the village of Myebon in Myebon Township, likely caused by arson attacks occurring before 3 November 2012. All damages are spatially concentrated within a well-defined zone of near total destruction measuring 23.8 hectares (ha) in area, located on the western side of town. There are no indications of building damages outside of this zone. Following the probable arson attacks, two campsites were erected for internally displaced people (IDP) by the destruction of their homes. The first camp site is composed of 165 tent shelters (approximately 256 square meters in area), located on building ruins within the zone of destruction, and the second is composed of 35 similar tent shelters located on an open field to the north, outside of the destruction zone.

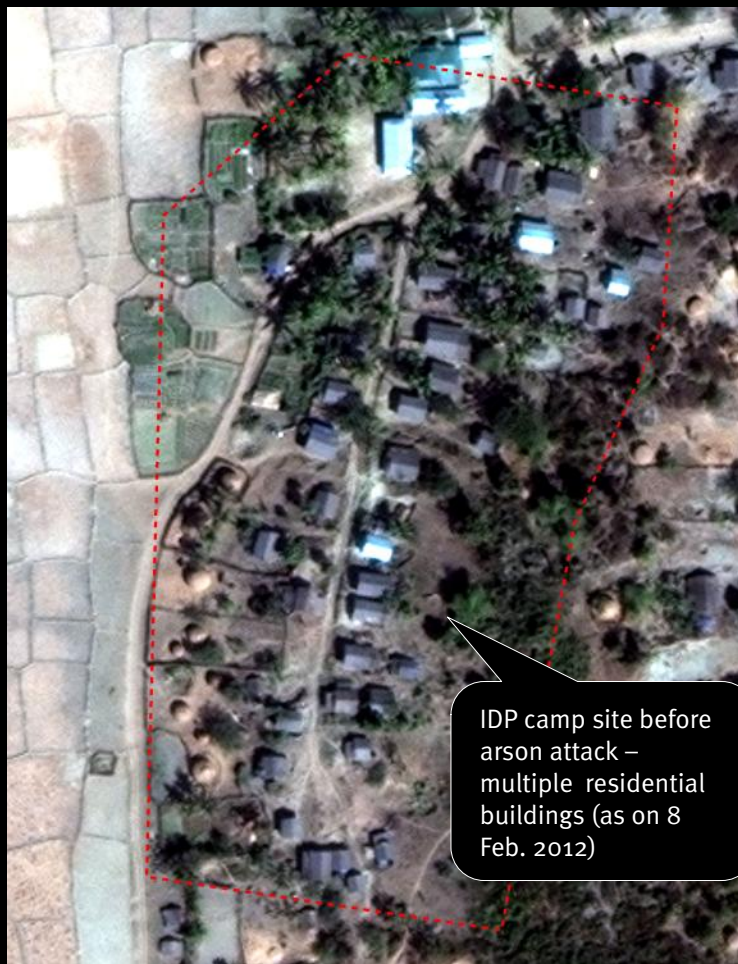
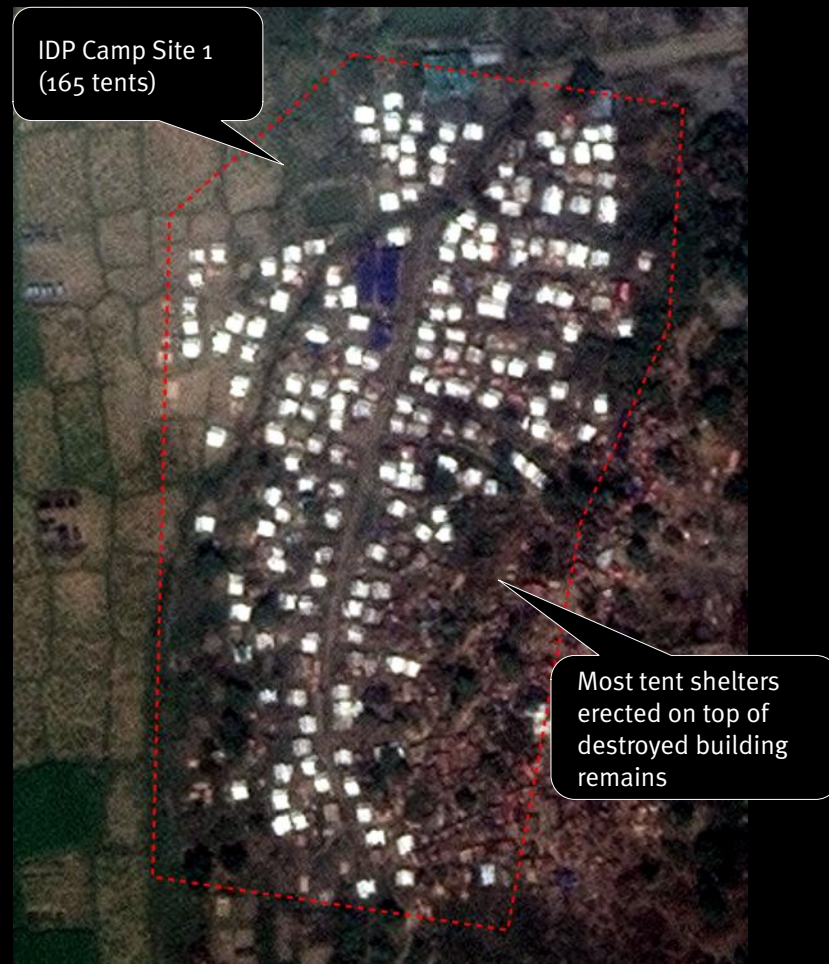
Town of Myebon on 3 November 2012

Pre and Post-attack view of IDP camp site 1 in satellite image

IDP Camp Site 1 Coordinates: 93.3672E 20.0474N

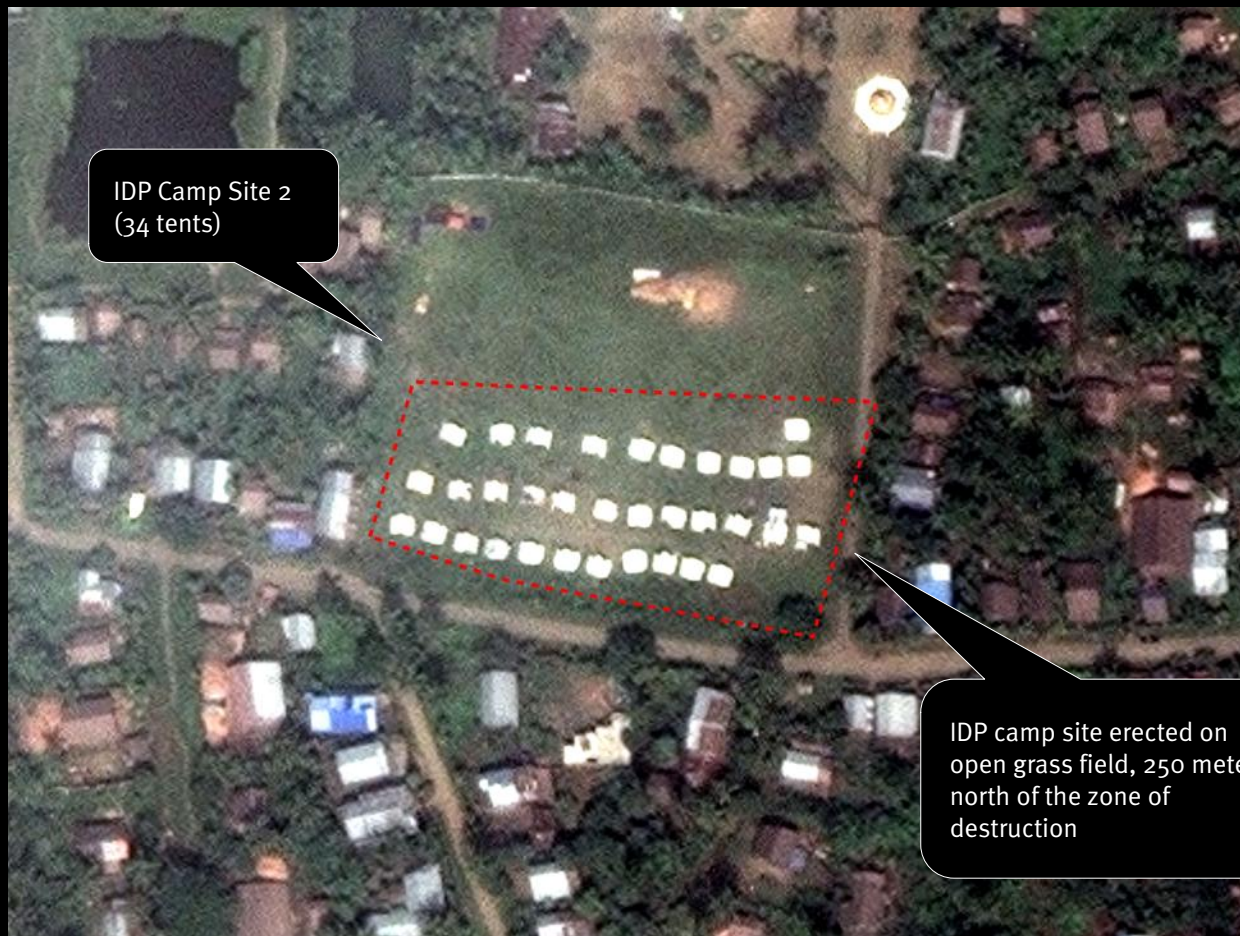
Town of Myebon on 3 November 2012

Post-attack view of IDP camp site 2 in satellite image

IDP Camp Site 2 Coordinates: 93.372E 20.0508N

IDP Camp Site 2
(34 tents)

IDP camp site erected on
open grass field, 250 meters
north of the zone of
destruction
