ATTACK ON THE OMAR IBN AL-KHATAB MOSQUE

Authorities' Failure to Take Adequate Precautions

APRIL 2017

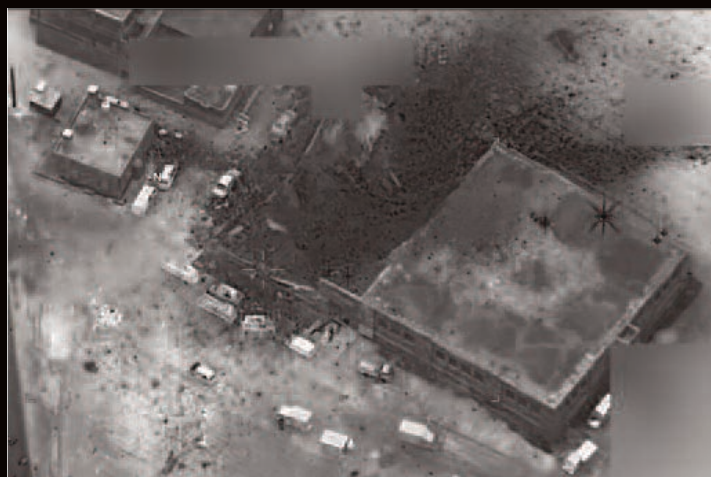
An aerial photograph released by the US Department of Defense after a March 16, 2017 US airstrike in al-Jinah, Syria, showing damage to part of a mosque.

A US military spokesperson circulated to journalists an aerial photograph of the building taken shortly after the attack, which shows the entire northern half of the mosque was reduced to rubble. Multiple video clips and photographs, compiled and analyzed by Bellingcat, show the destruction from the ground.¹⁵

Photographs and video footage of the impact sites, as well as the US aerial photograph, suggest that the guided bomb used delayed action fuzing. Delayed action fuzing allows the munition to penetrate the structure and detonate inside it. This technique collapses the targeted structure into itself and limits the amount of blast and fragmentation damage to neighboring objects. For example, the vehicles parked near the structure showed signs of thermal damage (damaged exterior paint) from the bomb blast but did not show fragmentation or blast damage (for example the windshields were intact).
